2016 DAM AND DIKE INSPECTION REPORT CCR PONDS COMPLEX

GERs-16-168

**OKLAUNION POWER STATION
VERNON, TEXAS**

INSPECTION DATE November 1,2 & 3, 2016

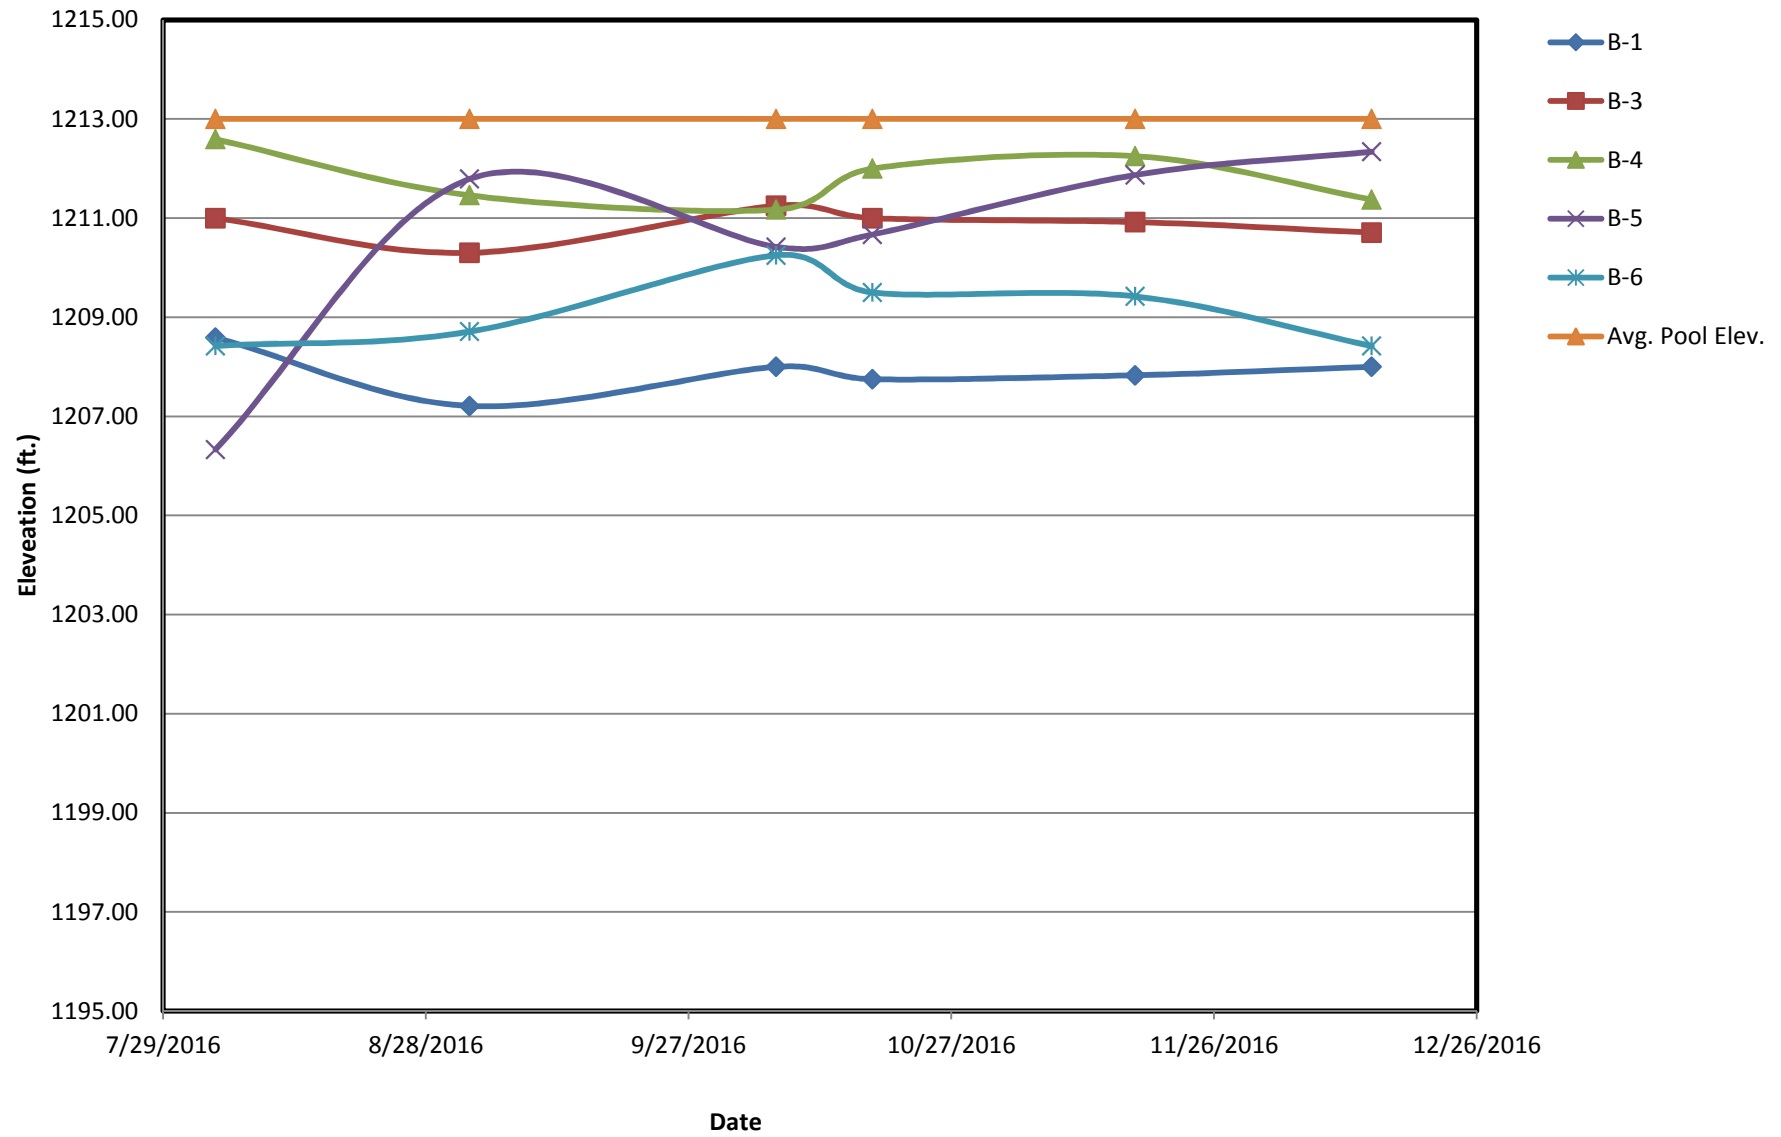
FIGURE - 1
CCR Ponds Piezometer Data
Pond 21, Pond 22, Pond 23 and WWSP

Five piezometers (B-1, B-3, B-4, B-5, and B-6) were installed in July 2016 around the Pond 21, 22, 23 and WWSP. Each piezometer was installed at the crest surrounding the ponds. See the piezometer location map located in Appendix A. Figure-1 shows the static water levels of those piezometers and ponds pool levels measured during monthly plant inspections beginning in August, 2016. All of the ponds (#21, 22, 23, and WWSP) pool level were found to be consistent at an elevation 1,213 feet. During a short period from monthly measurement data, the static water levels in the piezometers have indicated some fluctuations. In the future, it is expected that the readings will normalize producing consistent static water levels. The current readings fall below the average pool levels (1,213 ft.) of each pond and will continue to be monitored. Should the readings fall above the pool level, plant maintenance is to contact AEP Civil Engineering Services and further analysis will be conducted. The current readings and their anticipated patterns do not show a threat to the stability of the slopes, and meets the requirements of the Factor of Safety limits provided by the CCR rules.

- Piezometer B-1508A shall be monitored monthly for at least next 6 months for further evaluation due to the increase in water levels since 8/2016.
- Piezometers B-1, B-3, B-4, B-5, and B-6 surrounding Ponds 21, 22, 23 and the WWSP shall continue to be monitored monthly and AEP Civil Engineering services to be immediately notified should the piezometer readings shift above pool levels.

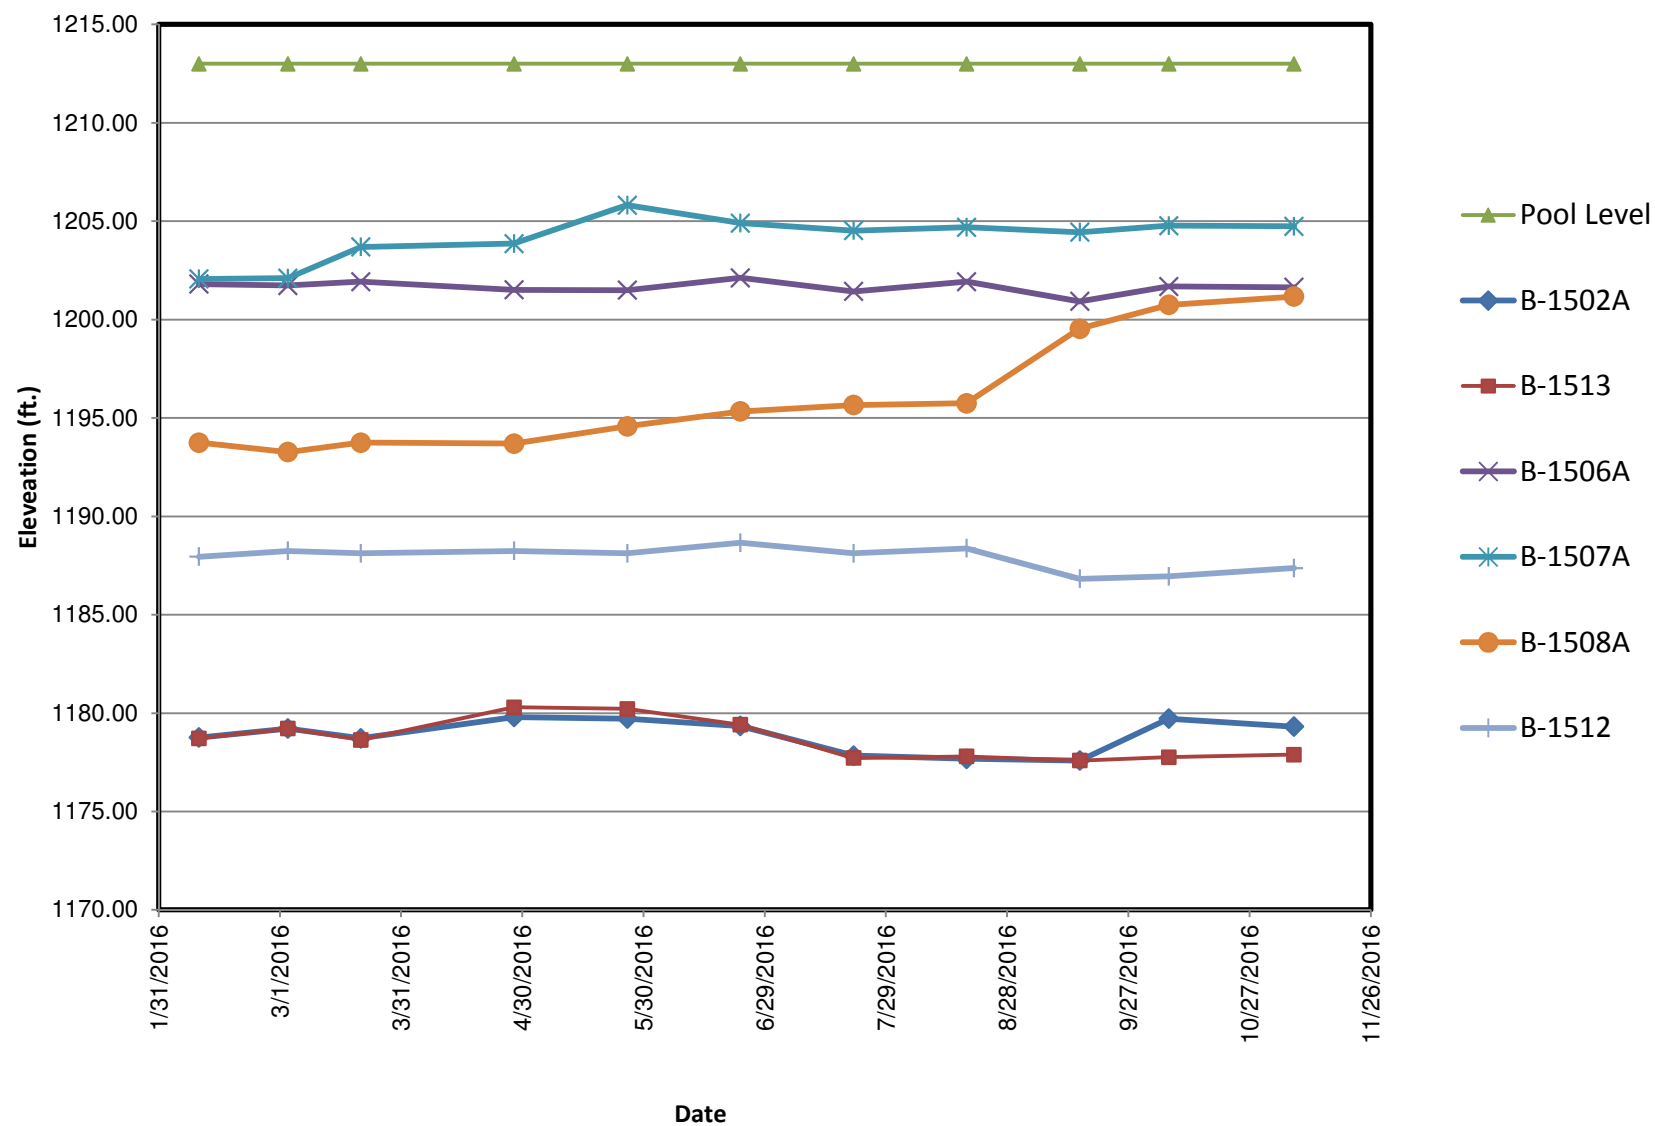
FIGURE - 2
Pond 6 Piezometer Data

Piezometers (B-1502A, B1513, B-1506A, B-1507A, B-1508A, and B1412) were installed in various locations along the crest of Pond 6 after raising the dikes in 2015. See the Piezometer Location map located in Appendix A. The chart located in Figure-2 shows the static water levels of those piezometers measured during monthly plant inspections, along with the measured pool levels of Pond 6. All of the piezometers indicated static water levels below the pond pool level (1,213 feet). All piezometers indicated static water levels within expected tolerance except B-1508A. Piezometer B-

1508A indicated about 5-foot increase in the water level since 8/2016. This increase in the static water shall be monitored for at least next 6 months for further evaluation.

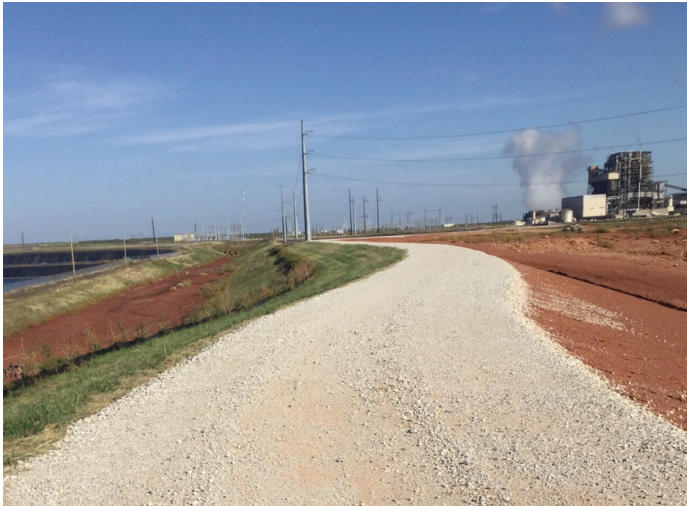
Photo #1

The crest of the embankment appeared to be in good condition with no unusual cracking, rutting, settlement, deformation, or misalignment. (Observation 1, Photos 1-4)

The exterior slopes of the south and west dikes were in overall good condition (Observation 2, Photos #1-2). No signs of slope failure, slumping, or seepage were observed on the downstream slopes and no burrowing animal activity was noted. The slopes were adequately vegetated and no erosional features were noted. All slopes were free of woody vegetation.

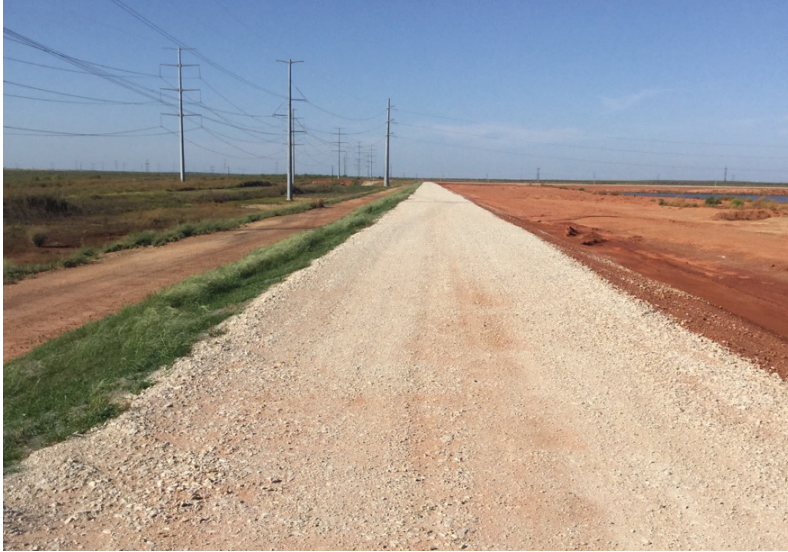
Photo #3

Notes: Typical Crest in Good Condition.

Location: South Dike

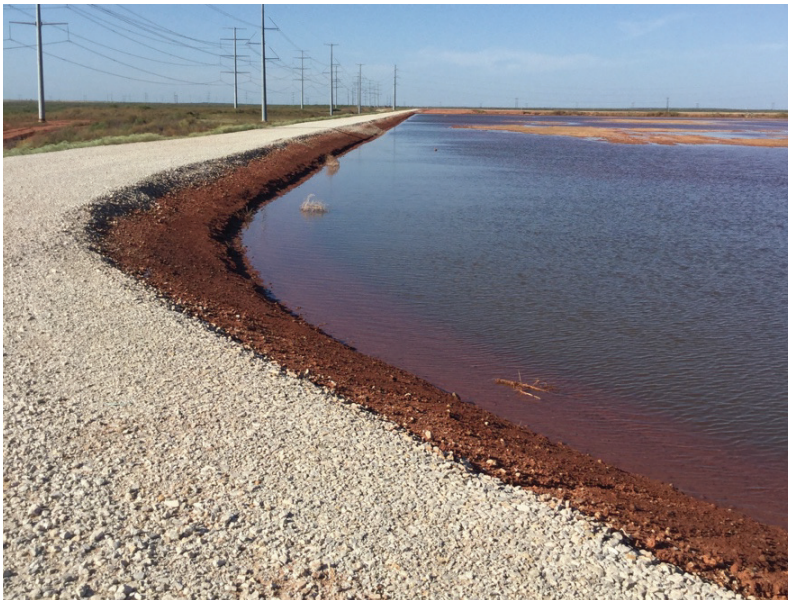
Photo #4

Notes: Typical Interior Slope in Good Condition.

Location: Pond 6 Raised Dike

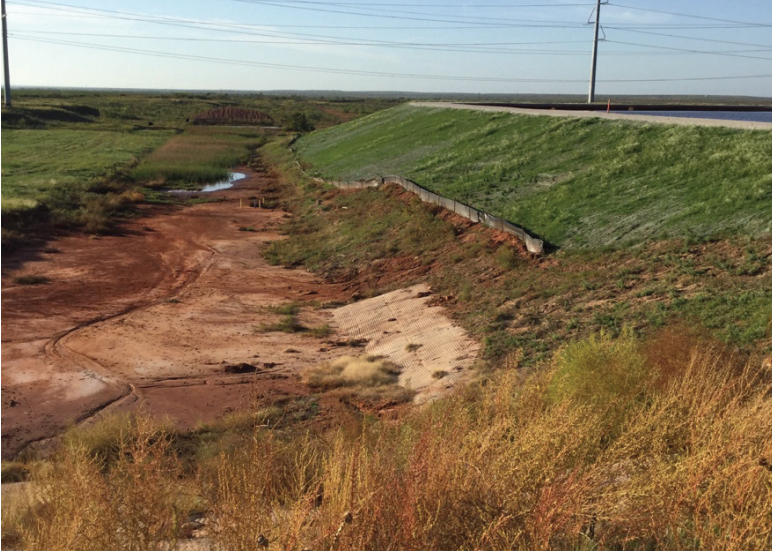
The eastern slope of Pond #6 is also the western slope of the Pond #7 spillway discharge channel. The channel was in fair condition. The spillway of the adjacent Pond #7 has been substantially blocked and no discharge can occur. However, the discharge channel below, shown in Observation 2, Photo #3 and #4, also receives runoff from the surrounding area and should be monitored for erosion as part of the periodic visual inspections.

Notes: East Exterior Slope in Fair Condition. Note that the channel receives run off from surrounding area. Plant to Monitor

Location: Pond 6 East Exterior Slope

- Drainage along the toe of Pond 6 east exterior dike is considered fair and requires visual inspections of the area to continue with the weekly/monthly inspections.

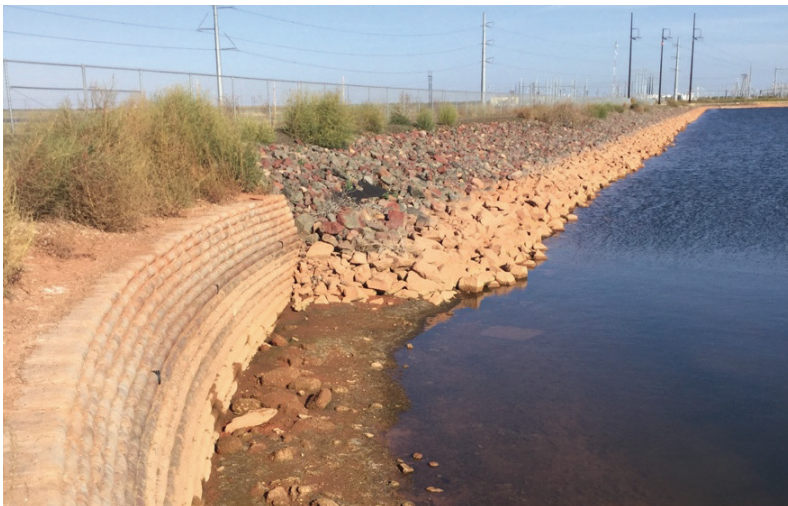
Photo #4

Notes: Typical Interior Slope and Retaining wall in Good Condition

Location: Interior Slope after 2015 Dike Raising

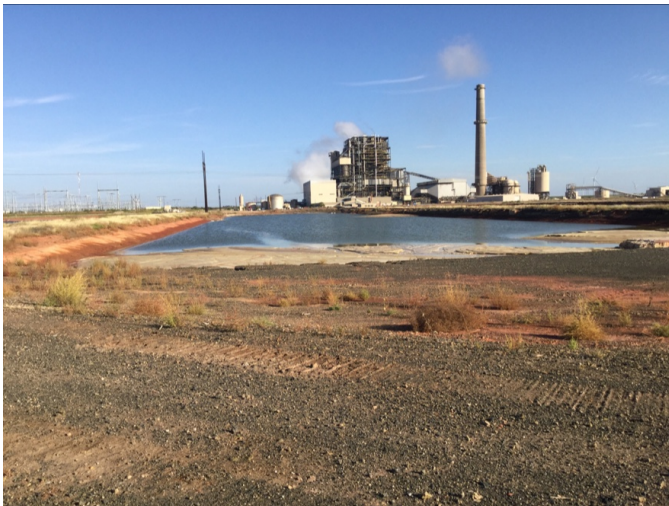
Photo #1

Notes: Interior Slopes in Good Condition

Location: South of Pond 21. Looking North.

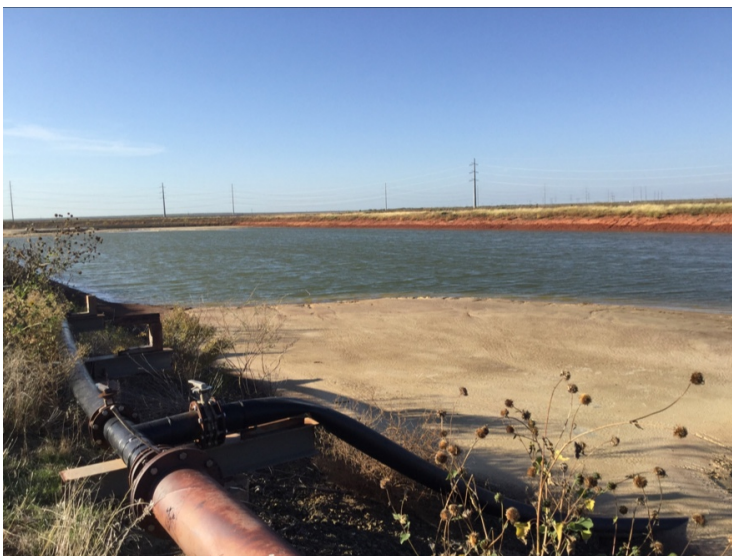
Photo #2

Notes: Interior Slope in Good Condition

Location: Interior Slope of Pond 21. Looking West

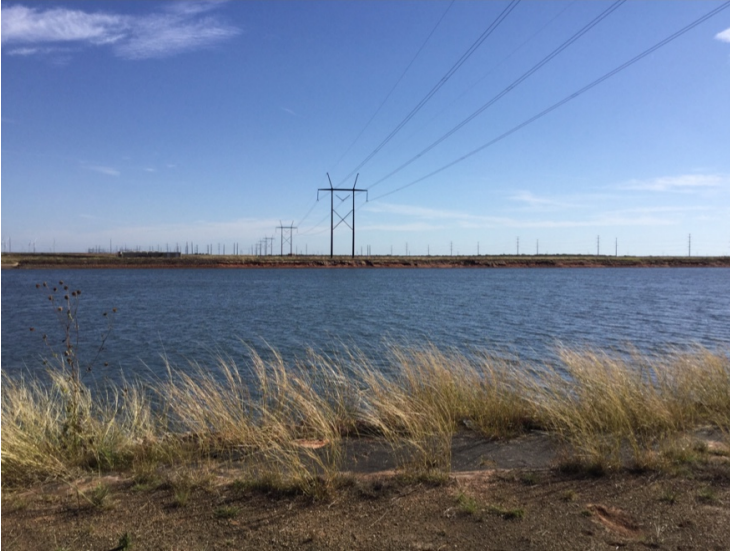
Photo #3

Notes: Pond 21 Exterior Slope and Interior Slope of Makeup Water Pond

Location: Makeup Water Interior Slope Looking West.

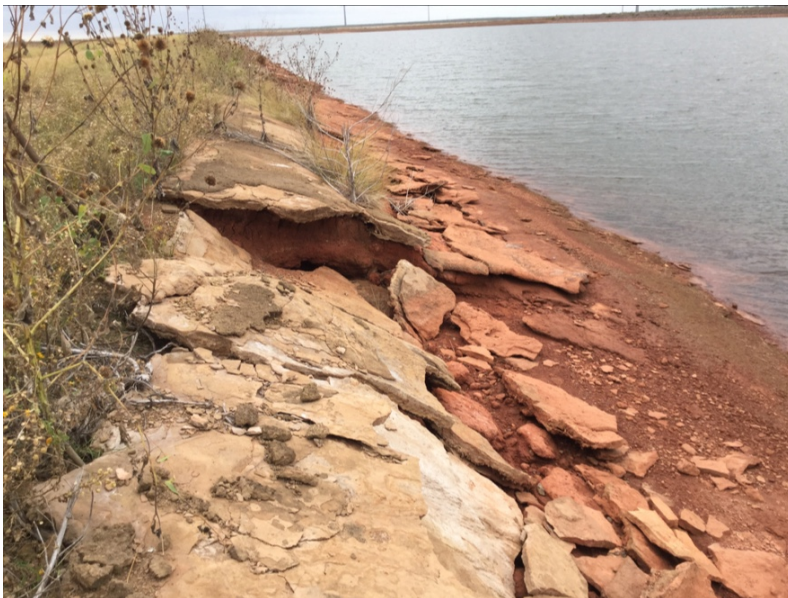
Photo #4

The slopes of Pond 21 are in good condition. Pond 21 is an incised 5.1 acre bottom ash pond. The only visible dike portions are 3-5 ft above the normal pool levels. During the inspection there was some erosion damage was noticed on the interior slope of the Makeup Water Pond which is the exterior slope of Pond 21, see Observation 3, Photo #4. The plant will continue to monitor the exterior slope until the repair is performed.

Notes: Damage on the Makeup Water Pond Slope. Plan to install rip rap to prevent future Slope failure.

Location: Pond 21 Exterior Slope

- The exterior slope of Pond 21 (the interior slope of the Make-Up Water Pond) is to be visually inspected periodically. Should further erosion occur the plant will take preventative actions by installing rip rap along the eroded area in order to protect slope.

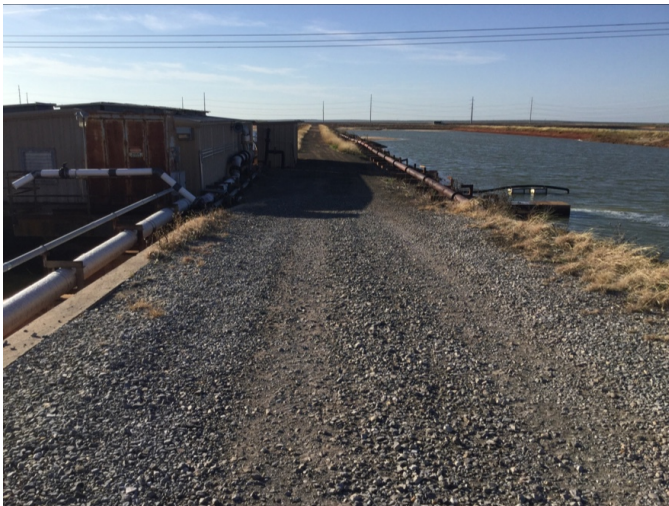
Photo #1

Notes: Crest in Good Condition

Location: Dike between Pond 21 and Pond 22. Looking South

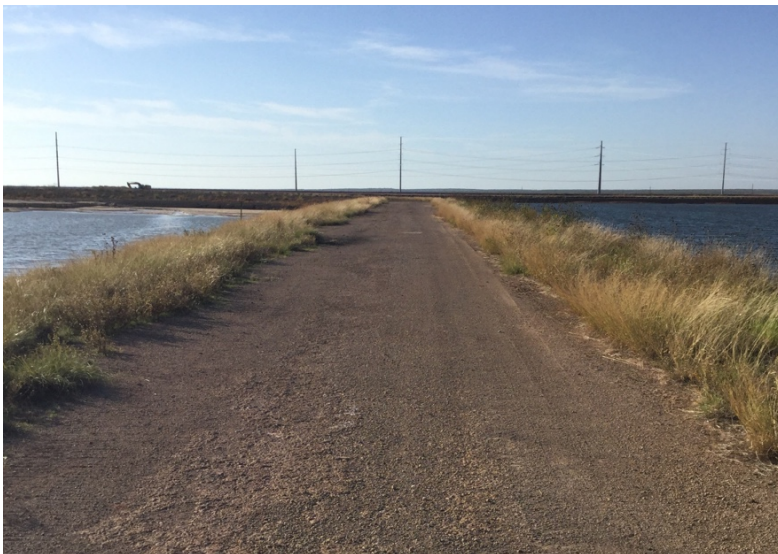
Photo #2

Notes: Crest in Good Condition

Location: Between Pond 21 and Makeup Water Pond. Looking South.

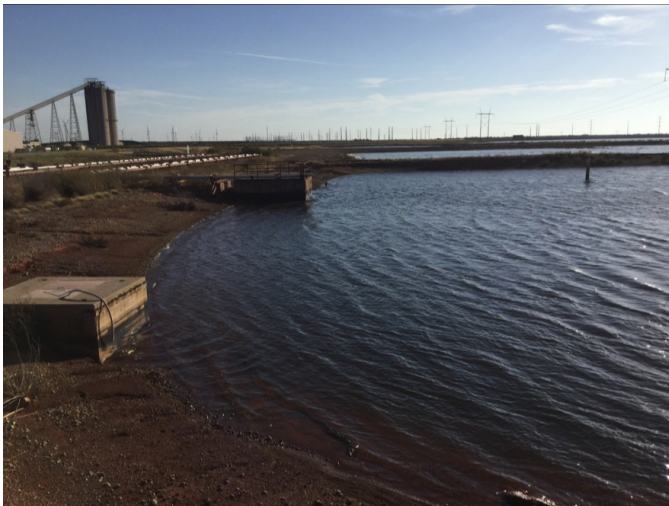
Photo #1

Notes: Typical Interior Slope in Good Condition.

Location: North Side of Pond 22

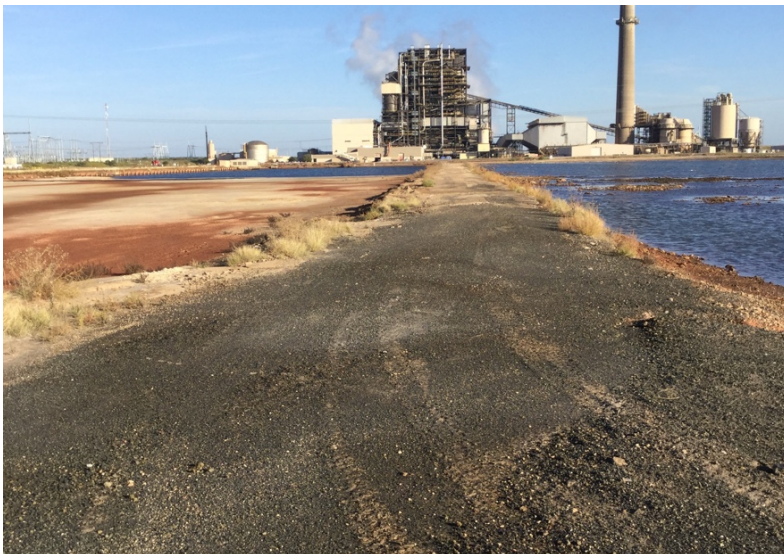
Photo #2

Notes: Typical Crest in Good Condition

Location: Dike between Pond 22 and Pond 23.

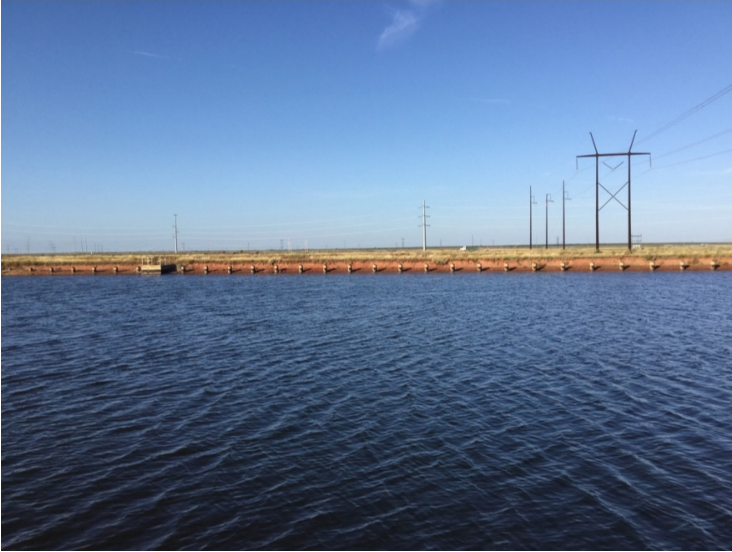
Photo #3

Notes: Typical Interior Slope in Good Condition

Location: West Interior Slope

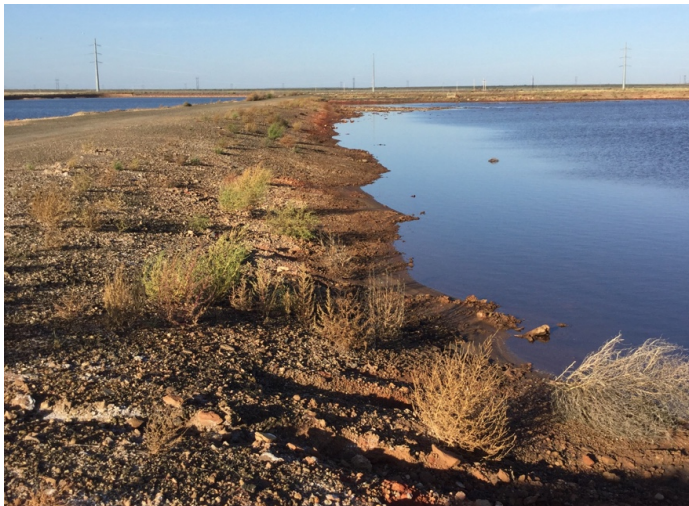
Photo #1

Notes: Interior Slope in Good Condition

Location: South Side Interior Slope

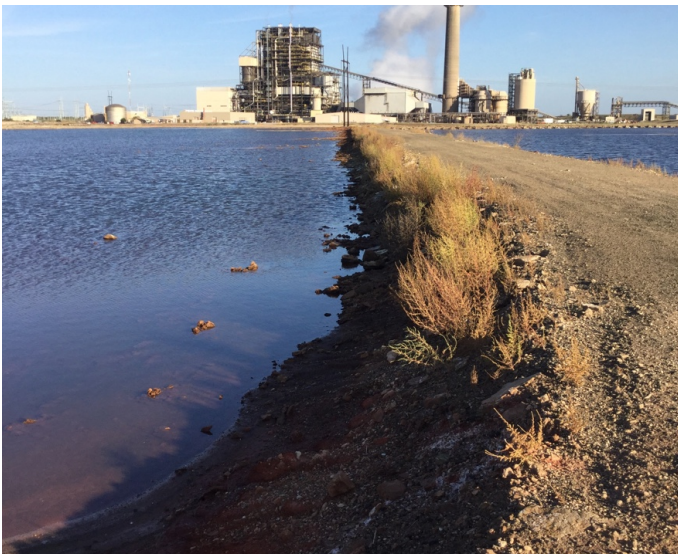
Photo #2

Notes: Interior Slope in Good Condition

Location: East Interior Slope. Looking North

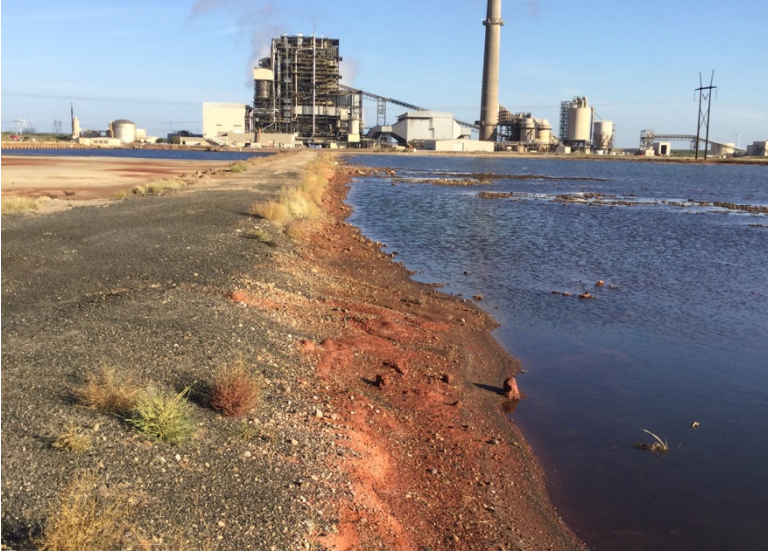
Photo #3

Notes: Interior Slope in Good Condition

Location: West Interior Slope. Looking North

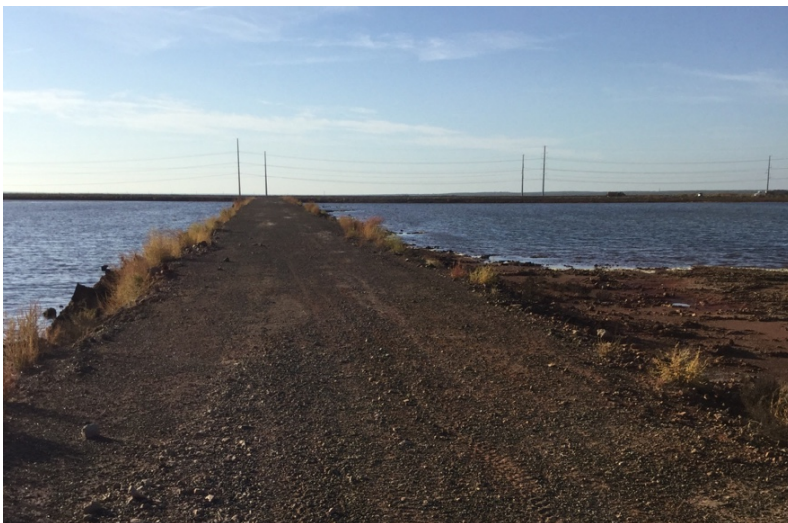
Photo #4

Notes: Typical Crest in Good Condition

Location: Dike between Pond 23 and WWSP

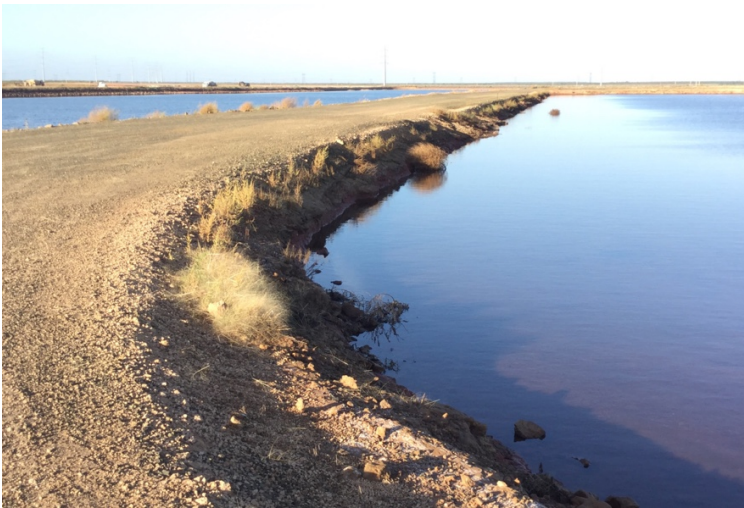
Photo #1

Notes: Interior Slope in Good Condition

Location: South Interior Slope

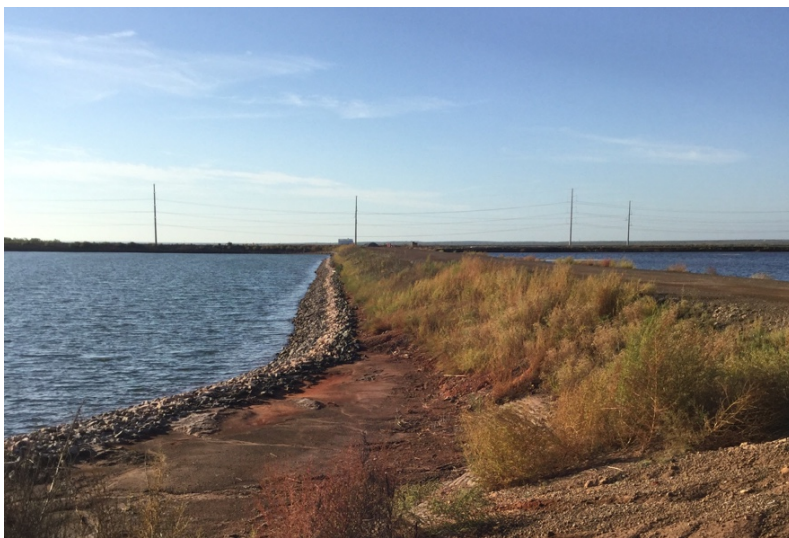
Photo #2

Notes: Interior Slope in Good Condition

Location: West Interior Slope Looking South.

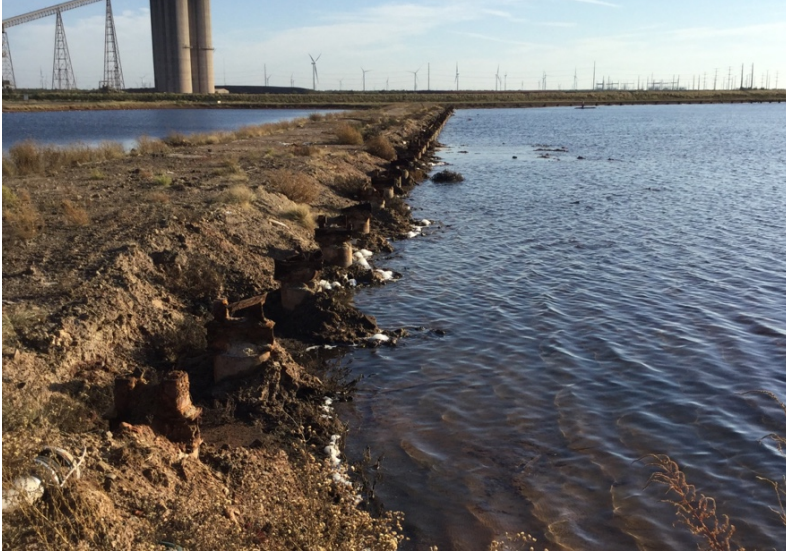
Photo #3

Notes: Interior Slope in Good Condition

Location: North Interior Slope. Looking East

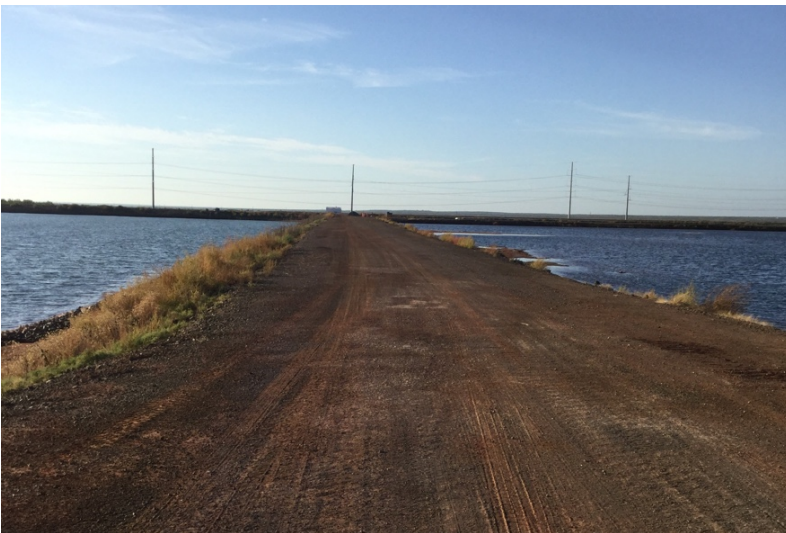
Photo #4

Notes: Typical Crest in Good Condition

Location: Dike between WWSP and Pond 7
