# **2017 ANNUAL DAM AND DIKE INSPECTION REPORT**

**CCR PONDS COMPLEX**

**OKLAUNION POWER STATION  
VERNON, TEXAS**

**November, 2017**

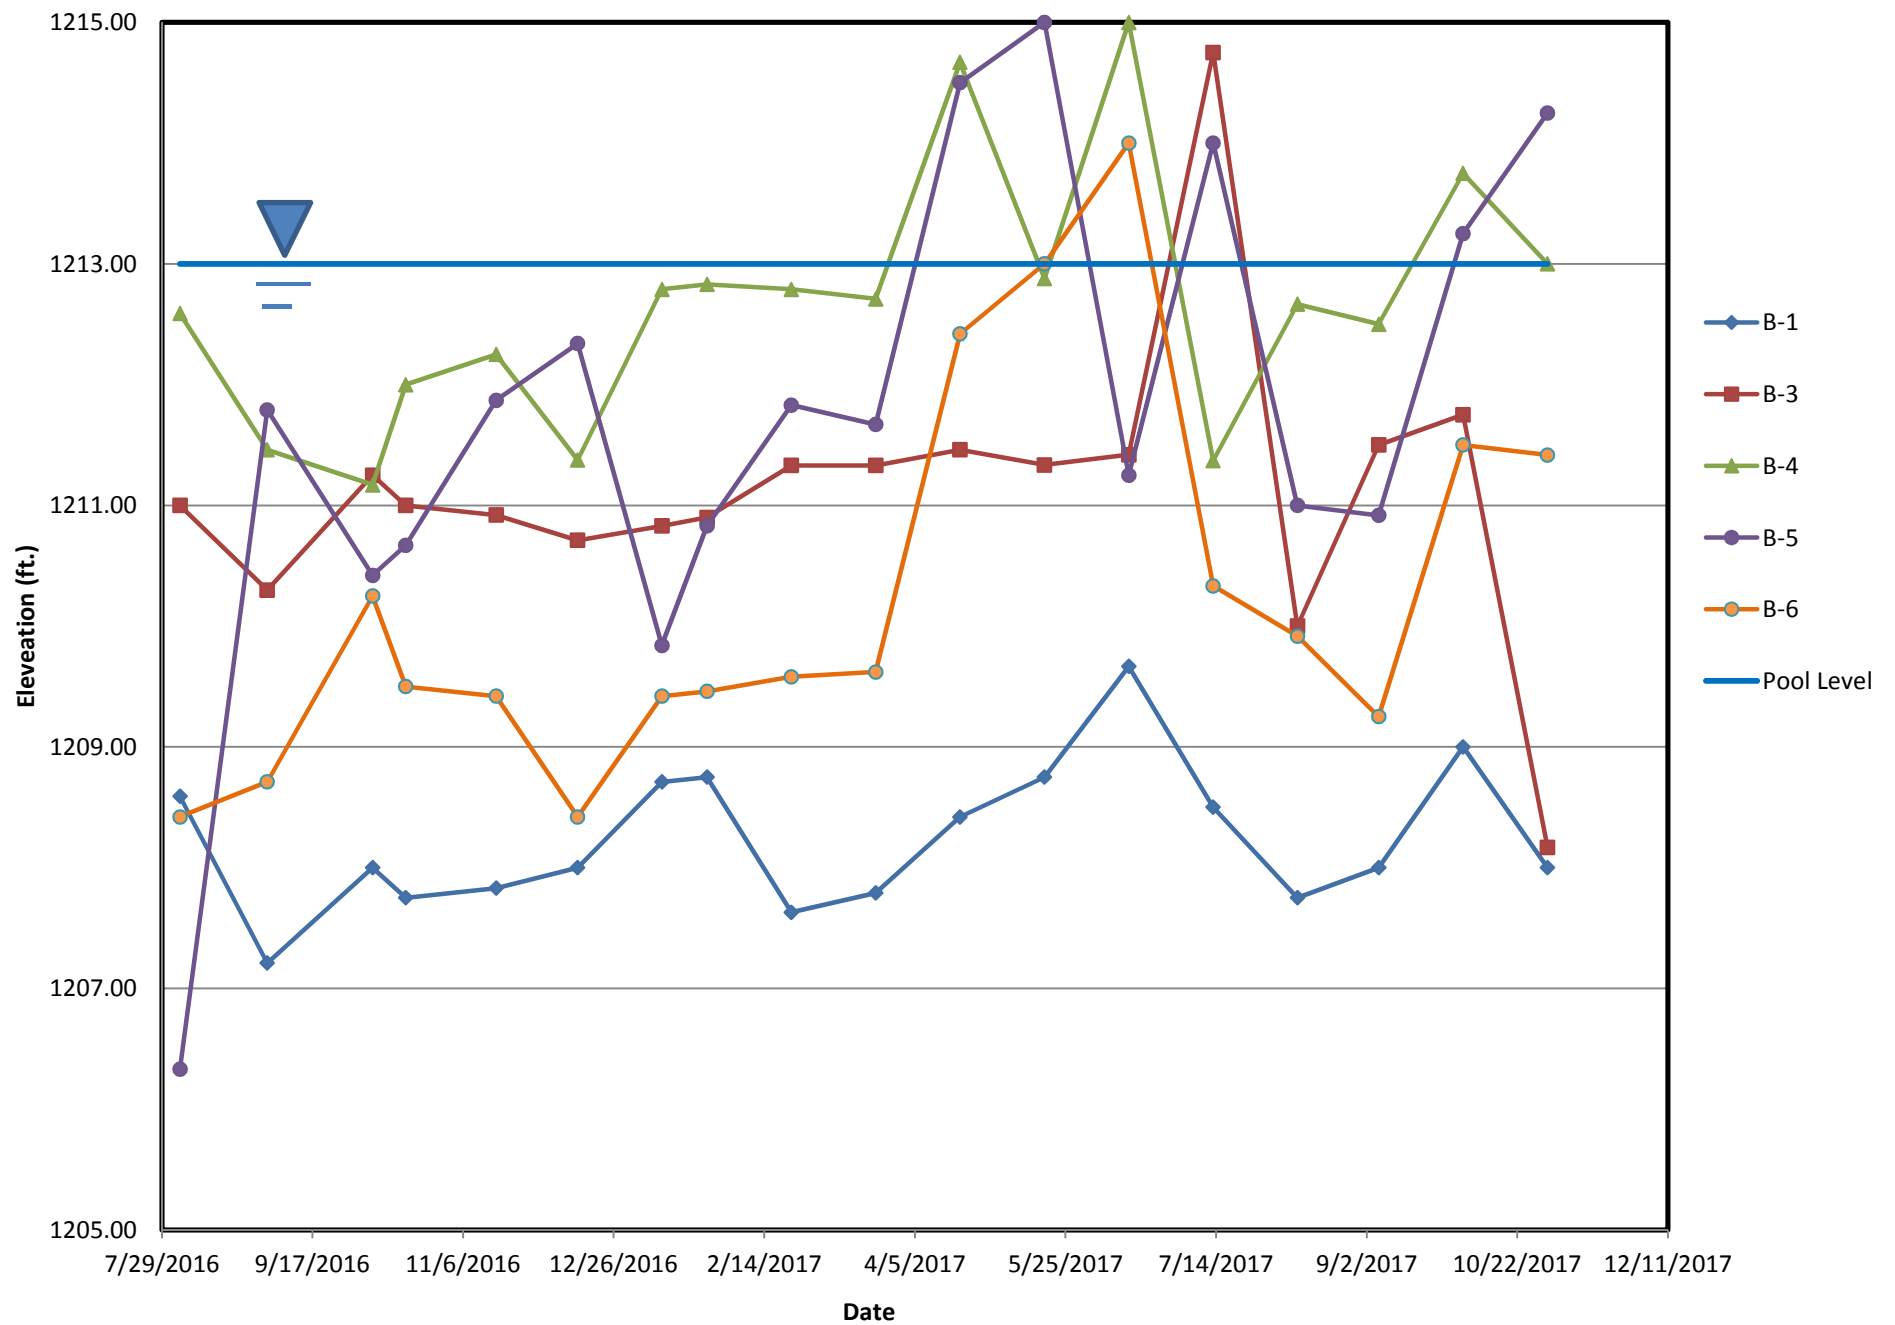
**FIGURE 4. CCR Ponds Piezometer Data Pond 21, Pond 22, Pond 23 and WWSP**

Five piezometers (B-1, B-3, B-4, B-5, and B-6) were installed in July 2016 around the Pond 21, 22, 23 and WWSP. Each piezometer was installed at the crest surrounding the ponds. Figure 4 shows the static water levels of those piezometers and ponds pool levels measured during monthly plant inspections beginning in August, 2016. All of the ponds (#21, 22, 23, and WWSP) pool level were found to be consistent at an elevation 1,213 feet. Over periods of monthly measurement data, the static water levels in the piezometers have indicated some fluctuations. The readings of the 4 out of the 5 piezometers indicated higher than pool elevation which may indicate that rain/surface water is entering the pipes. When the readings fall above the pool level, plant maintenance is to contact AEP Civil Engineering Services which will be conducting further evaluation.

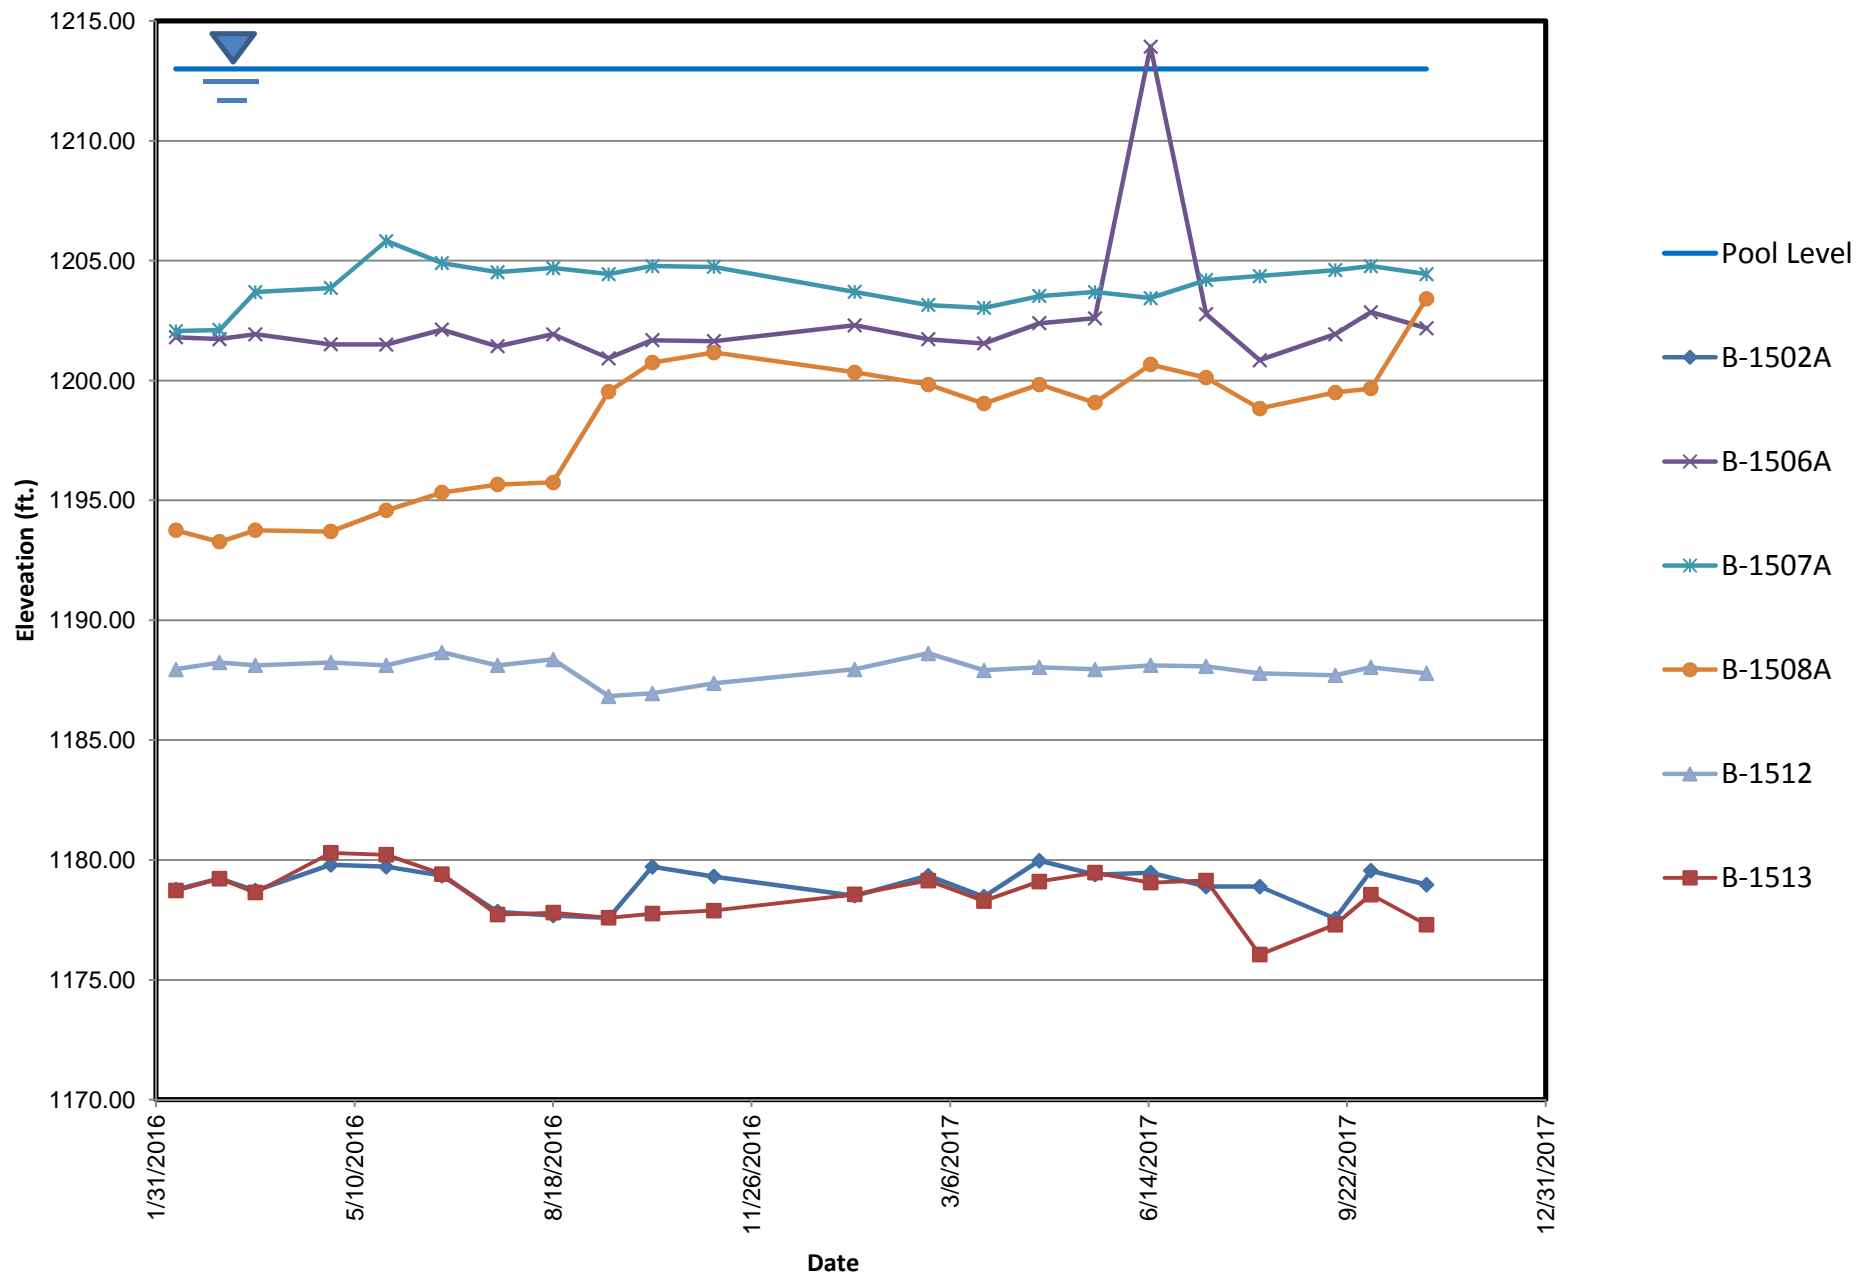
FIGURE 5. Pond 6 Piezometer Data

Piezometers (B-1502A, B-1506A, B-1507A, B-1508A, B1512, and B1513) were installed in various locations along the crest of Pond 6 after raising the dikes in 2015. Figure 5 shows the static water levels

of those piezometers measured during monthly plant inspections, along with the measured pool levels of Pond 6. All of the piezometers indicated static water levels below the pond pool level (1,213 feet). All piezometers indicated static water levels within expected tolerance except B-1508A. Piezometer B-1508A indicated about 10-foot increase in the water level since 8/2016. This increase in the static water shall be monitored for continuing evaluation.

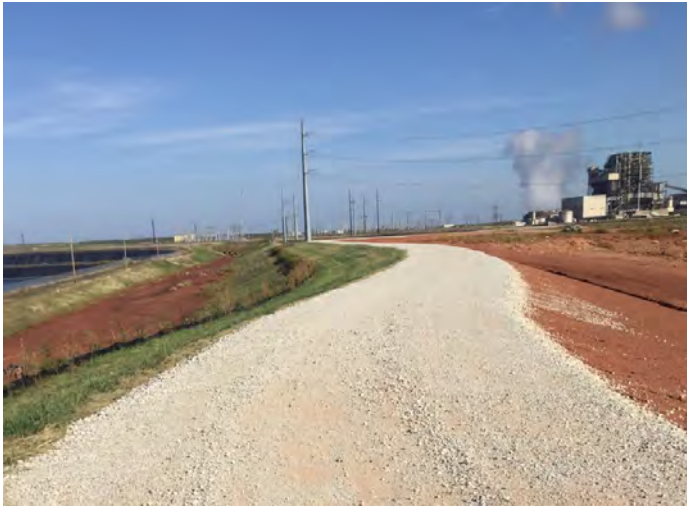
## Photo #1

Description: Crest

Notes: Typical Crest in Good Condition.

Location: West Dike

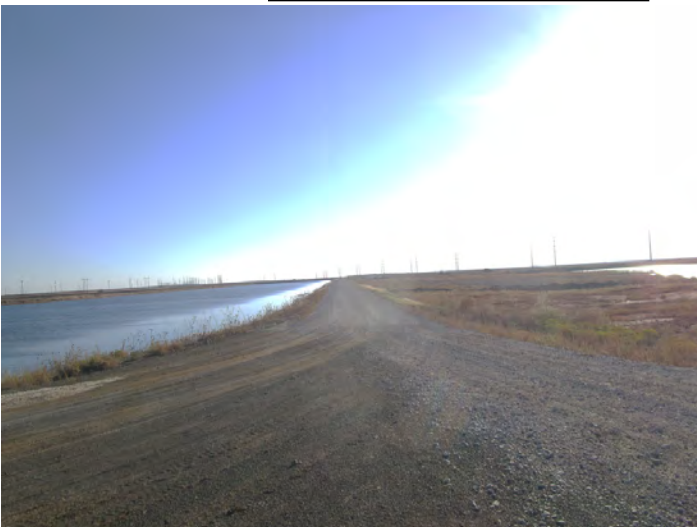
## Photo #2

Description: Crest

Notes: Typical Crest in Good Condition.

Location: North Dike. Between Pond 6 and Make-Up Water Pond

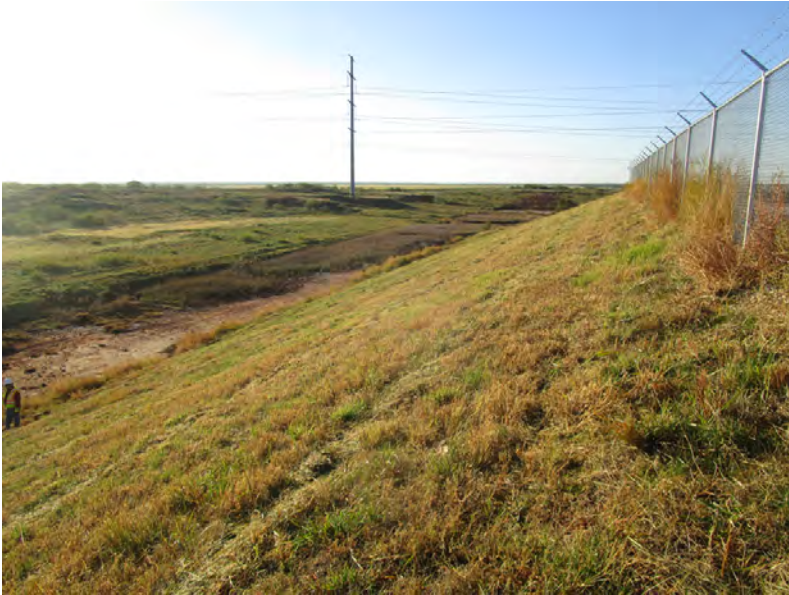
### Photo #3

The eastern slope of Pond #6 is also the western slope of the Pond #7 spillway discharge channel. The channel was in fair condition. The spillway of the adjacent Pond #7 has been substantially blocked and no discharge can occur. However, the discharge channel below, shown in Observation 2, Photo #3 and #4, also receives runoff from the surrounding area and should be monitored for erosion as part of the periodic visual inspections.

Description: Exterior Slope

Notes: East Exterior Slope in Fair Condition. Note that the channel receives run off from surrounding area. Plant to Monitor

Location: Pond 6 East Exterior Slope

- Drainage along the toe of Pond 6 east exterior dike is considered fair and requires visual inspections of the area to continue with the weekly/monthly inspections.
- Vegetation management for the facility is considered good. Grassed areas should continue to be mowed regularly. Any areas that are not accessible to mowing equipment should be controlled by the use of weed trimmers, power brush cutters, or other suitable vegetation control method.
- Plant inspection and monitoring procedures, maintenance activities, and reporting with respect to the dikes should be implemented in coordination with AEP Civil Engineering.

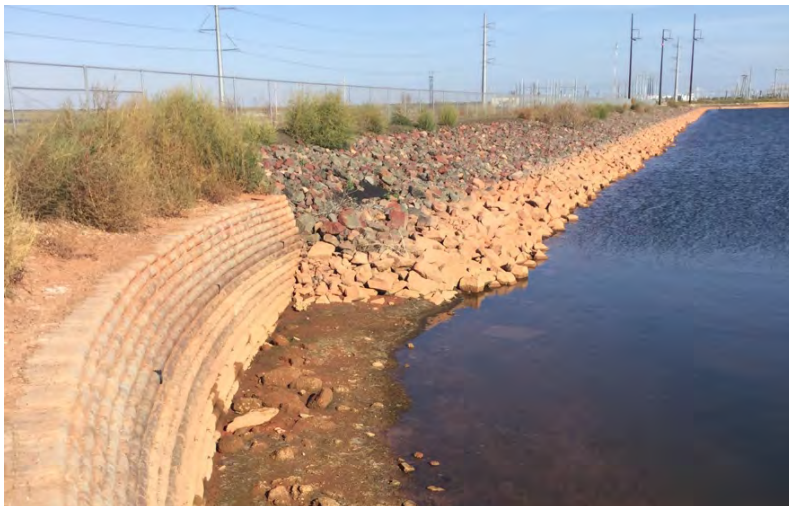
### Photo #4

Description: Exterior Slope

Notes: Typical Exterior Slope and Retaining wall in Good Condition

Location: Exterior Slope after 2015 Dike Raising

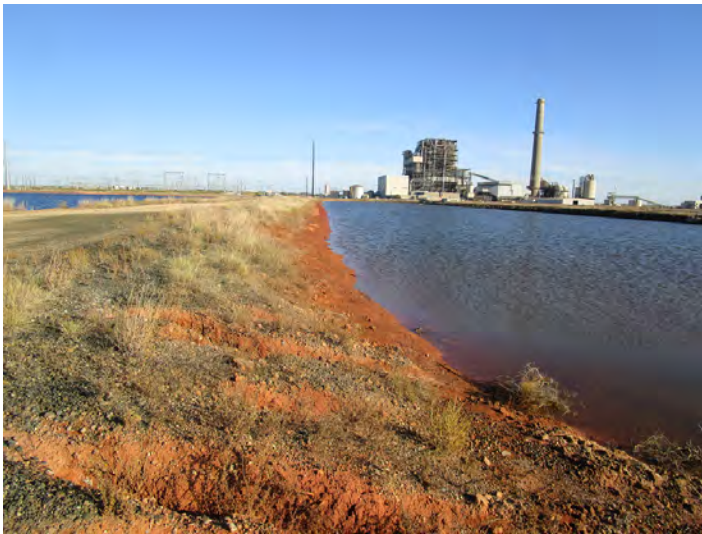
### Photo #1

Description: Interior Slope

Notes: Interior Slopes in Good Condition

Location: South of Pond 21. Looking North.

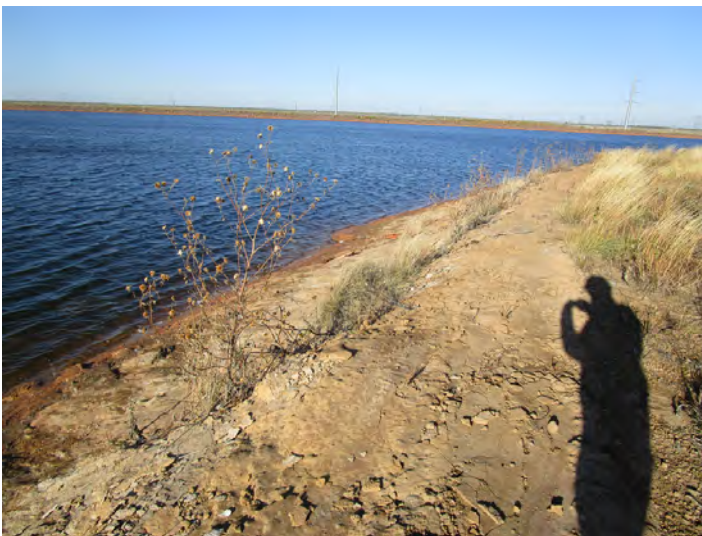
### Photo #2

Description: Interior Slope

Notes: Interior Slope in Good Condition

Location: Interior Slope of Pond 21. Looking West

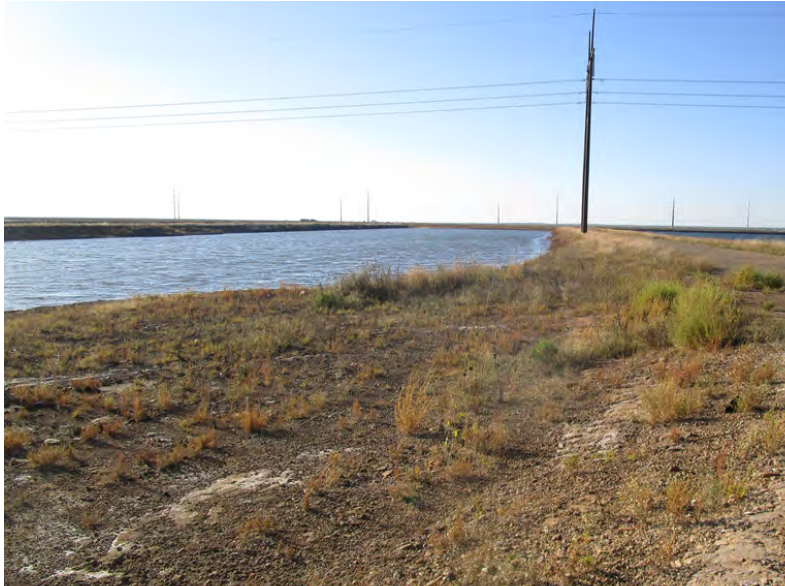
**Photo #3**

Description: Interior Slope

Notes: Pond 21 Exterior Slope and Interior Slope of Makeup Water Pond

Location: Makeup Water Interior Slope Looking West.

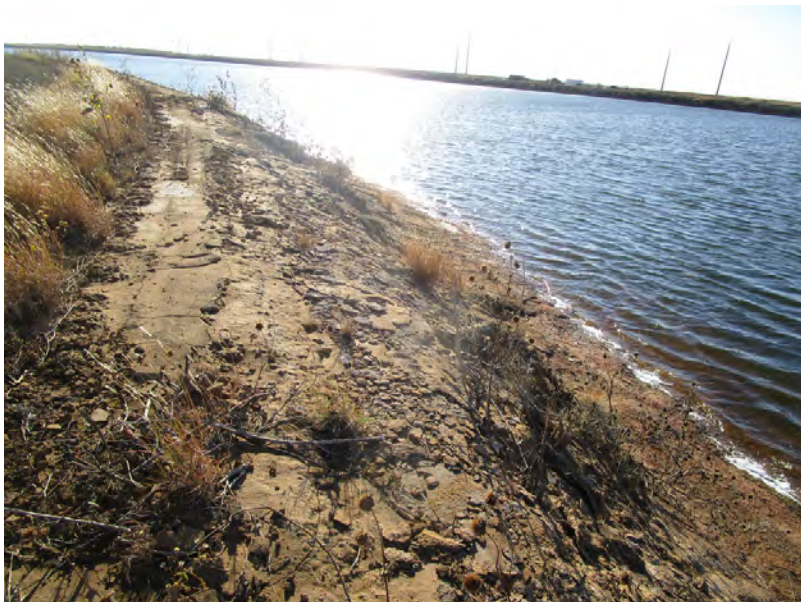
**Photo #4**

The slopes of Pond 21 are in good condition. Pond 21 is an incised 5.1 acre bottom ash pond. The only visible dike portions are 3-5 ft above the normal pool levels. During the inspection there was some erosion damage was noticed on the interior slope of the Makeup Water Pond which is the exterior slope of Pond 21, see Observation 3, Photo #4. The plant will continue to monitor the exterior slope until the repair is performed.

Description: Exterior Slope

Notes: Damage on the Makeup Water Pond Slope. Plan to install rip rap to prevent future Slope failure.

Location: Pond 21 Exterior Slope

- The exterior slope of Pond 21 (the interior slope of the Make-Up Water Pond) is to be visually inspected periodically. Should further erosion occur the plant will take preventative actions by installing rip rap along the eroded area in order to protect slope.
- Piezometer B-1508A shall be monitored monthly for further evaluation due to the increase in water levels since 8/2016.
- Piezometers B-1, B-3, B-4, B-5, and B-6 surrounding Ponds 21, 22, 23 and the WWSP shall continue to be monitored monthly and AEP Civil Engineering services to be immediately notified should the piezometer readings shift above pool levels.

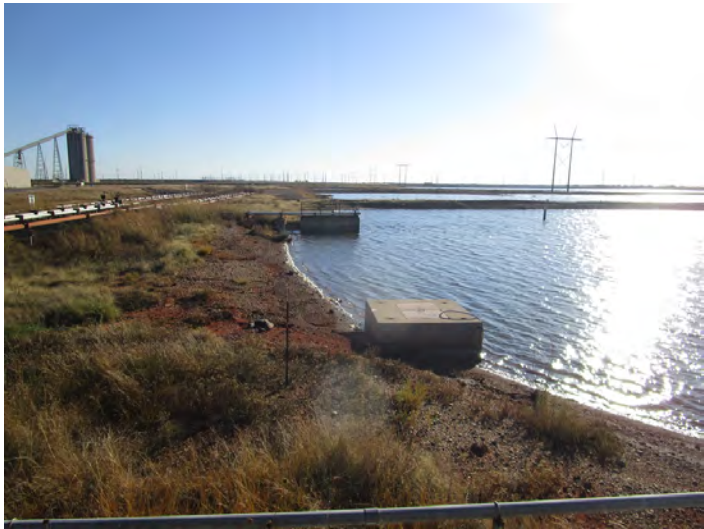
### Photo #1

Description: Interior Slope

Notes: Typical Interior Slope in Good Condition.

Location: North Side of Pond 22

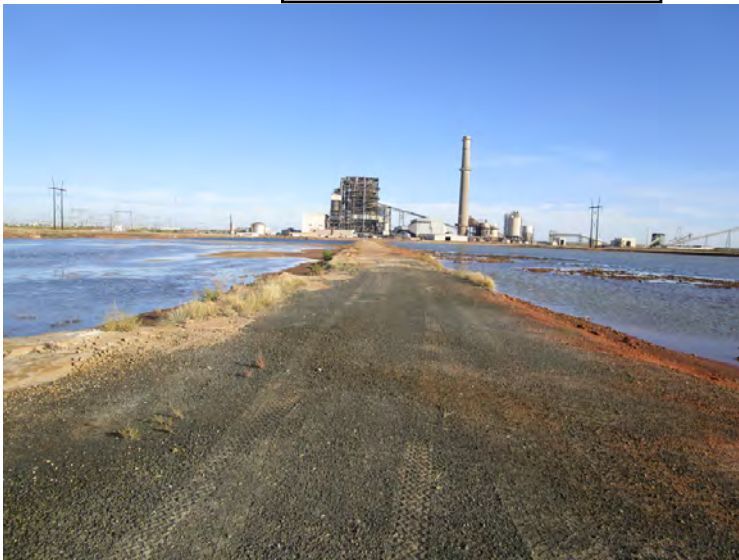
### Photo #2

Description: Crest

Notes: Typical Crest in Good Condition

Location: Dike between Pond 22 and Pond 23.

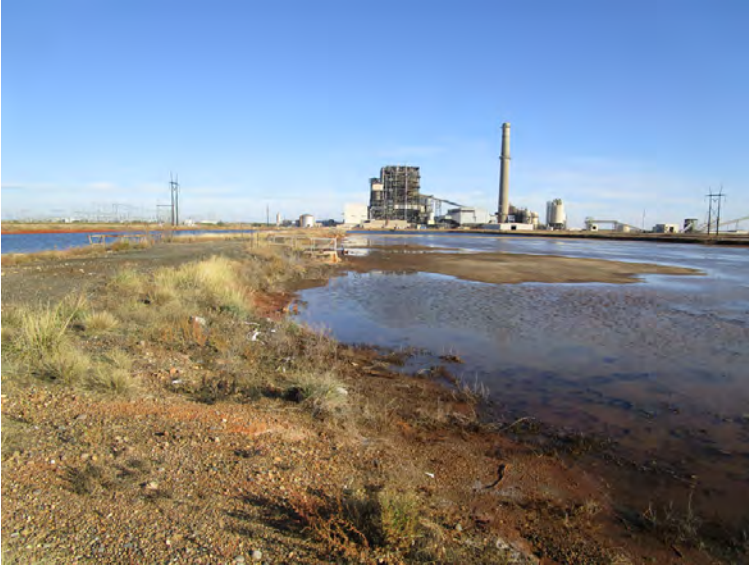
### Photo #3

Description: Interior Slope

Notes: Typical Interior Slope in Good Condition

Location: West Interior Slope

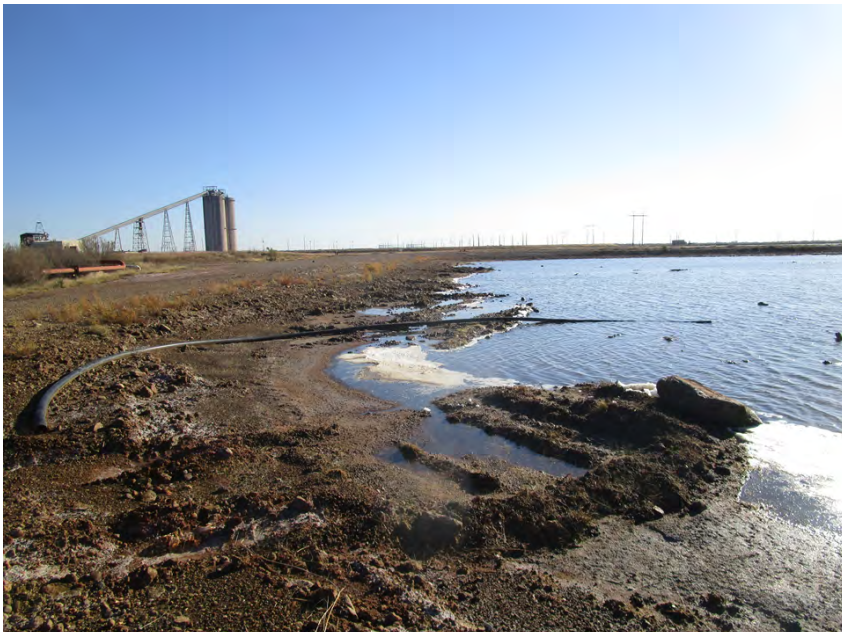
### Photo #4

Description: Other

Notes: Discharge Pipe

Location: South End of Pond

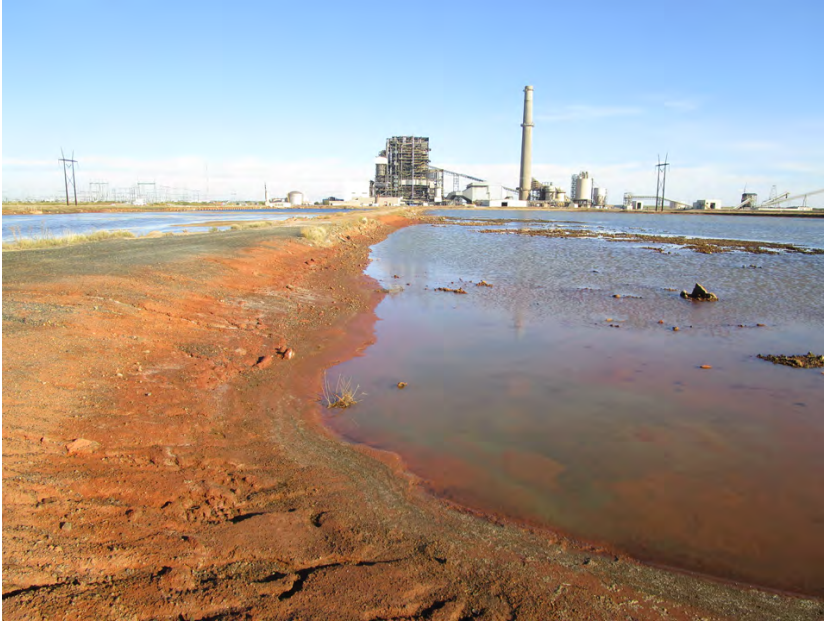
### Photo #3

Description: Interior Slope

Notes: Interior Slope in Good Condition

Location: West Interior Slope. Looking North

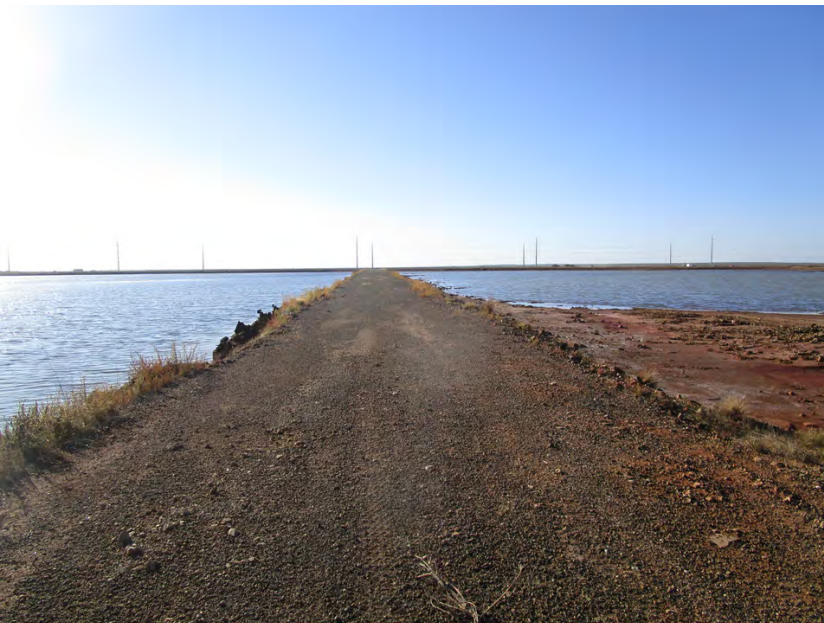
### Photo #4

Description: Crest

Notes: Typical Crest in Good Condition

Location: Dike between Pond 23 and WWSP

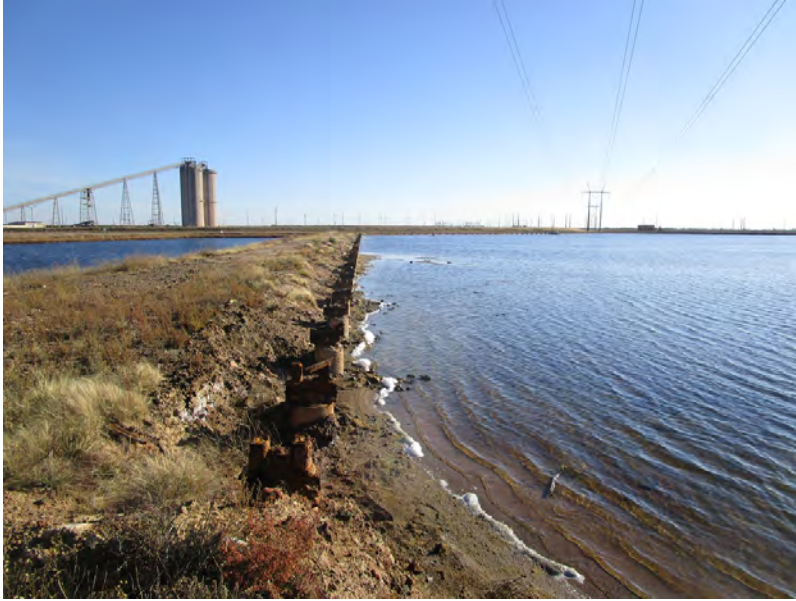
### Photo #3

Description: Interior Slope

Notes: Interior Slope in Good Condition

Location: North Interior Slope. Looking East

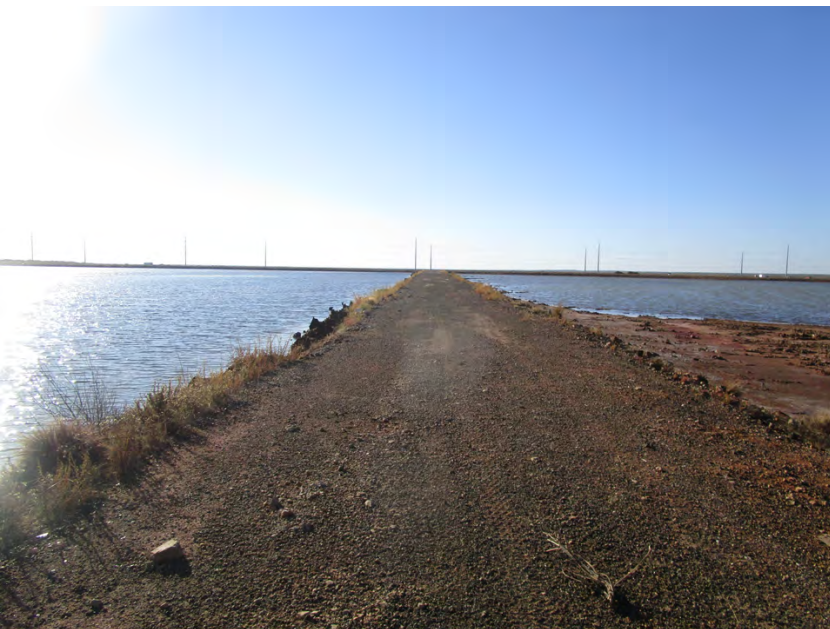
### Photo #4

Description: Crest

Notes: Typical Crest in Good Condition

Location: Dike between WWSP and Pond 7
