2019 ANNUAL DAM AND DIKE INSPECTION REPORT

CCR PONDS COMPLEX

**OKLAUNION POWER STATION
VERNON, TEXAS**

December, 2019

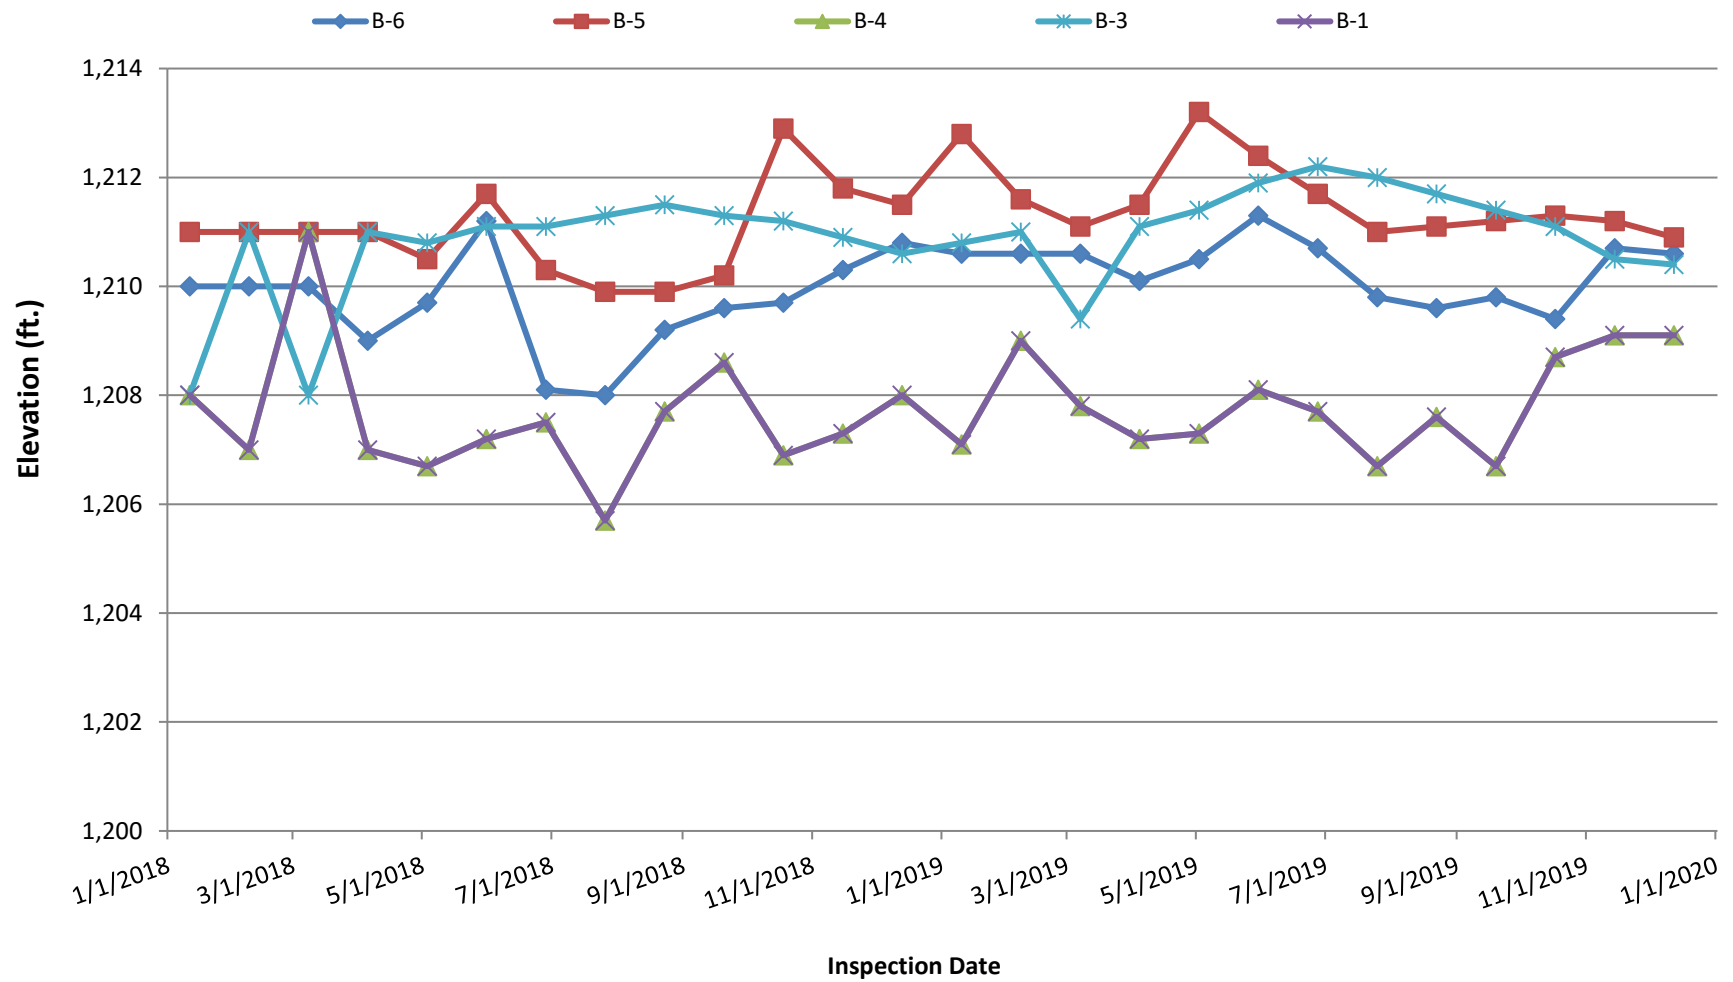
FIGURE 4
Piezometer Readings
Pond 21, 22, 23 & WWSP

Five piezometers (B-1, B-3, B-4, B-5, and B-6) were installed in July 2016 around the Pond 21, 22, 23 and WWSP. Each piezometer was installed at the crest surrounding the ponds. Figure 4 shows the static water levels of those piezometers measured during monthly plant inspections beginning in August, 2016. Pond levels were not measured but are generally around 1213 feet. Over periods of monthly measurement data, the static water levels in the piezometers have indicated some fluctuations. All of the piezometers except B-5 indicated static water levels below the nominal pond pool level (1,213 feet). The elevated static water levels in B-5 are related to elevated pool levels in Ponds 21 and 22 due to operations.

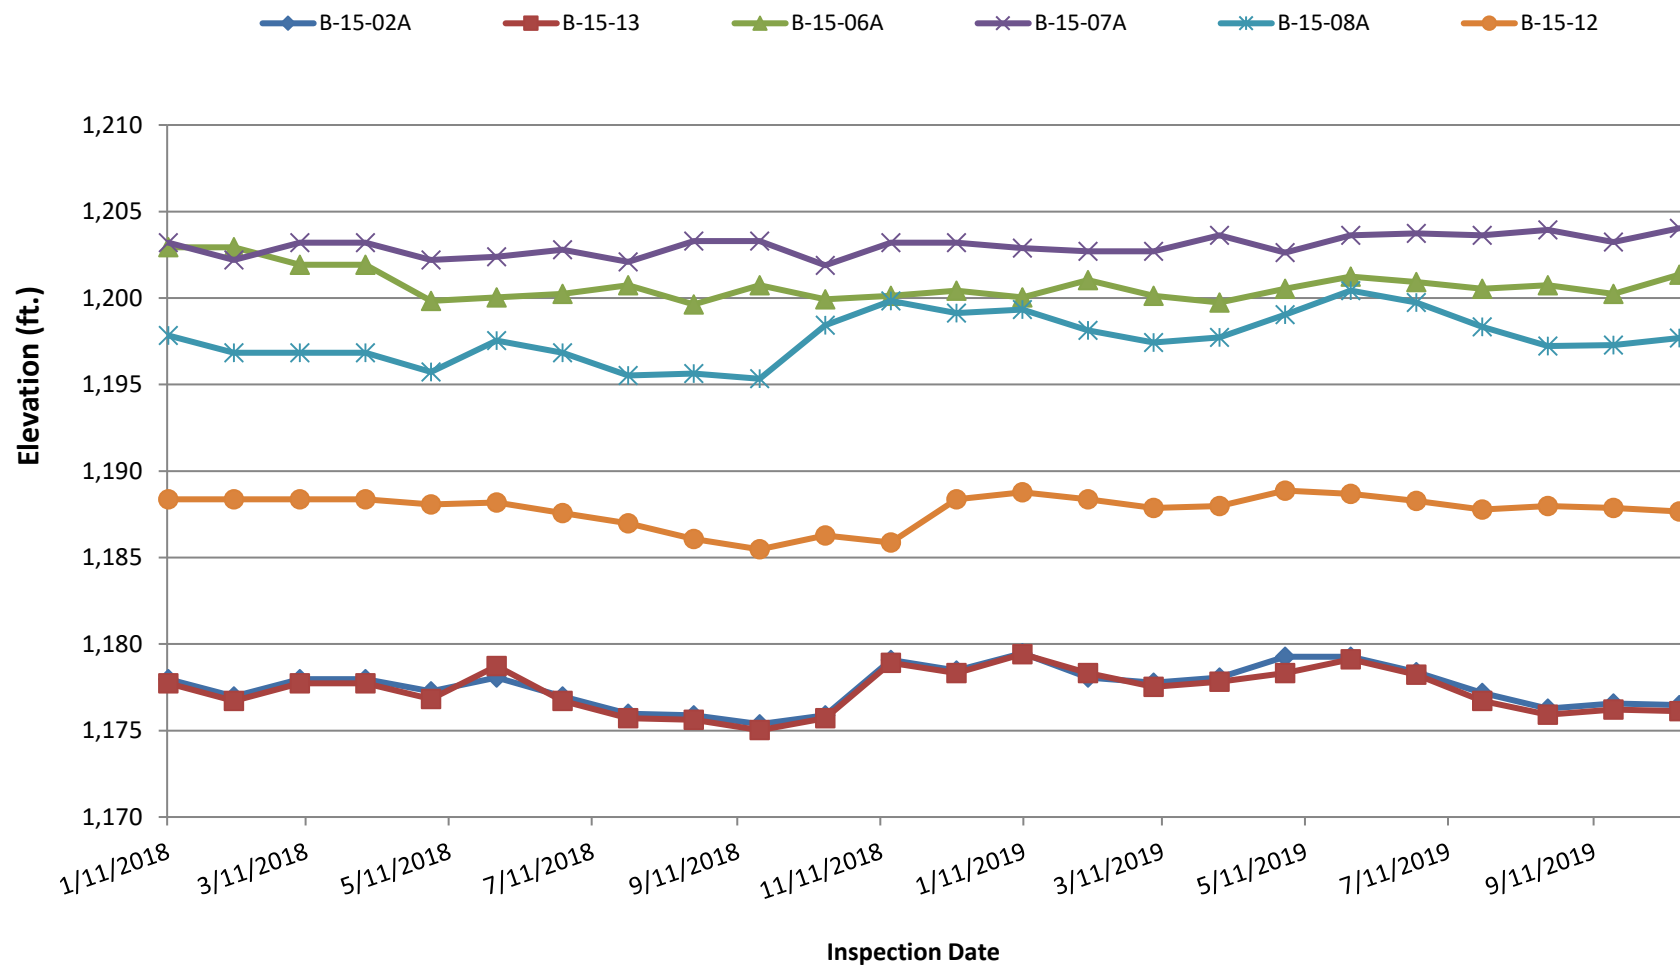
FIGURE 5
Piezometer Readings
Pond 6

Piezometers (B-1502A, B-1506A, B-1507A, B-1508A, B1512, and B1513) were installed in various locations along the crest of Pond 6 as a part of the raising the dikes in 2015. Figure 5 shows the static water levels of those piezometers measured during monthly plant inspections. Pond level was not measured but is estimated to be around elevation 1200 feet at the time of this inspection but it varies up to elevation 1213 during the year. All of the piezometers indicated static water levels below the maximum pond pool level (1213 feet). All piezometers indicated static water levels within expected tolerance for this year's readings.

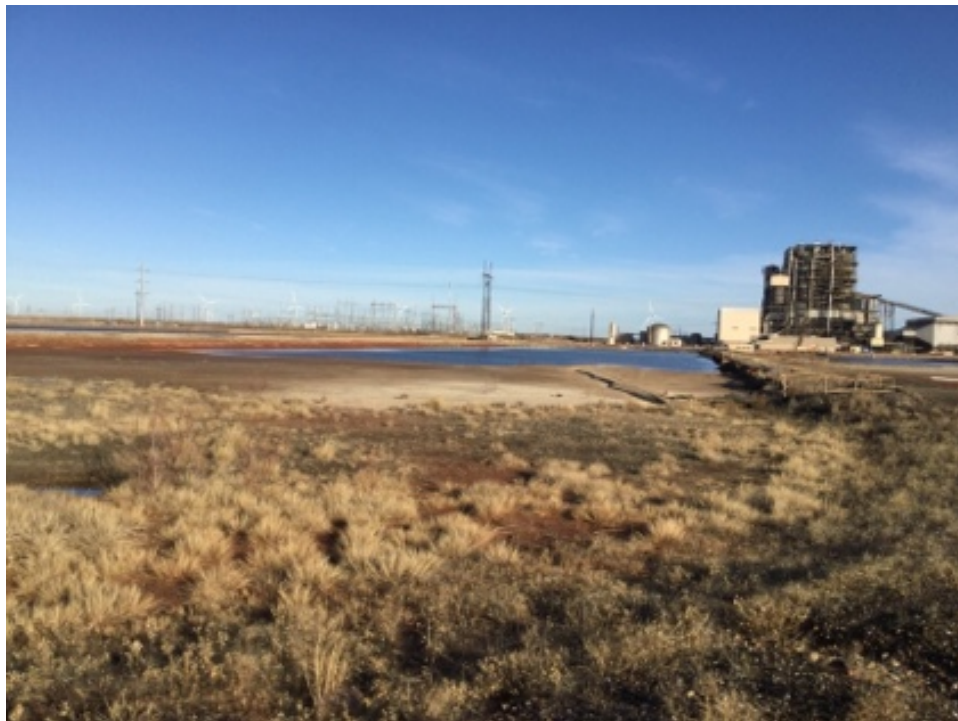
1

General condition of
Pond 21

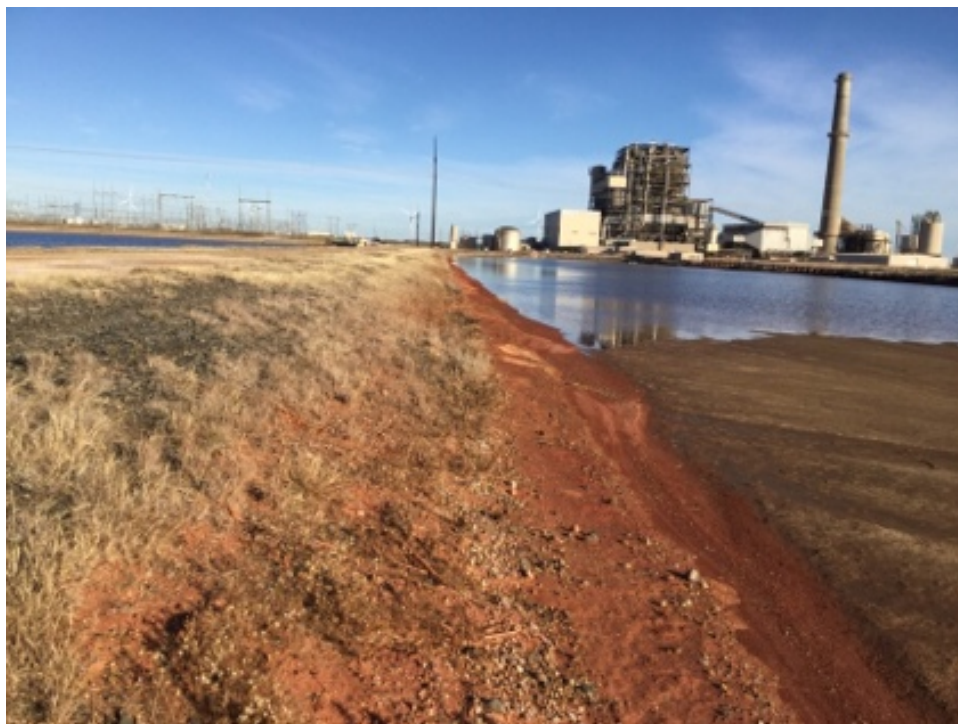
2

General condition of
Pond 21 interior slope

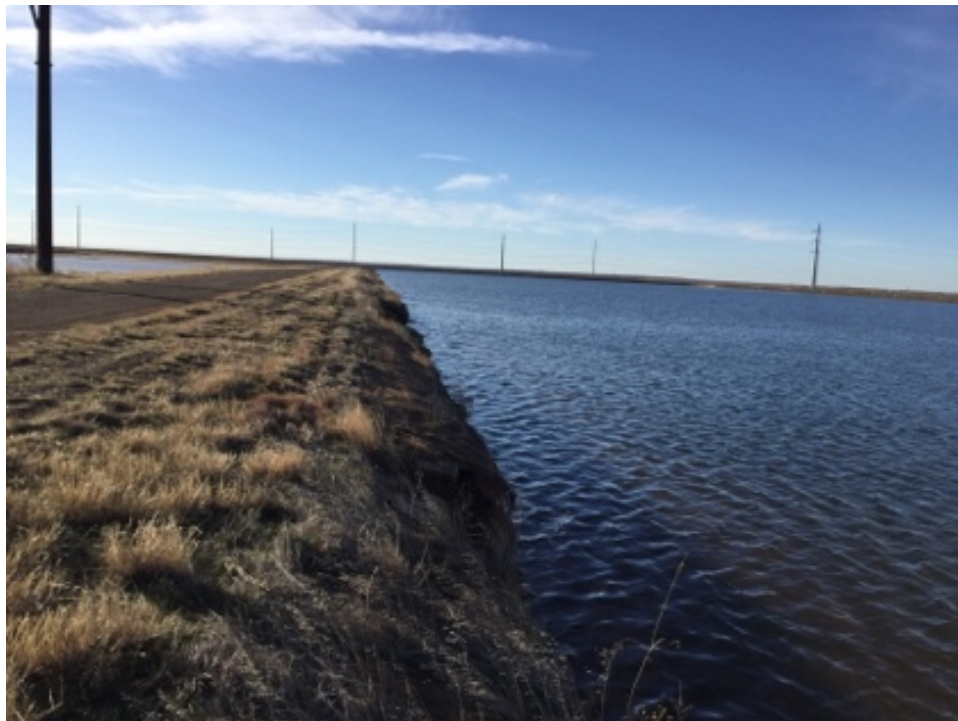
Photo #: 3

The slopes of Pond 21 are in good condition. Pond 21 is a partially incised 5.1 acre bottom ash pond. The only visible dike portions are 3-5 ft above the normal pool levels. The dikes are common to either the Makeup Water Pond or Pond 22. During the inspection there was some erosion damage observed on the interior slope of the Makeup Water Pond which is the exterior slope of Pond 21. The plant will

continue to monitor the exterior slope until the repair is performed.

General condition of
Pond 21 exterior slope
common to Makeup
Water Pond interior
slope

- The exterior slope of Pond 21 (the interior slope of the Make-Up Water Pond) is to be visually inspected periodically. Should further erosion occur the plant will take preventative actions by installing rip rap along the eroded area in order to protect the slope.
- Piezometers B-1, B-3, B-4, B-5, and B-6 surrounding Ponds 21, 22, 23 and the WWSP shall continue to be monitored monthly and AEP Civil Engineering services to be immediately notified

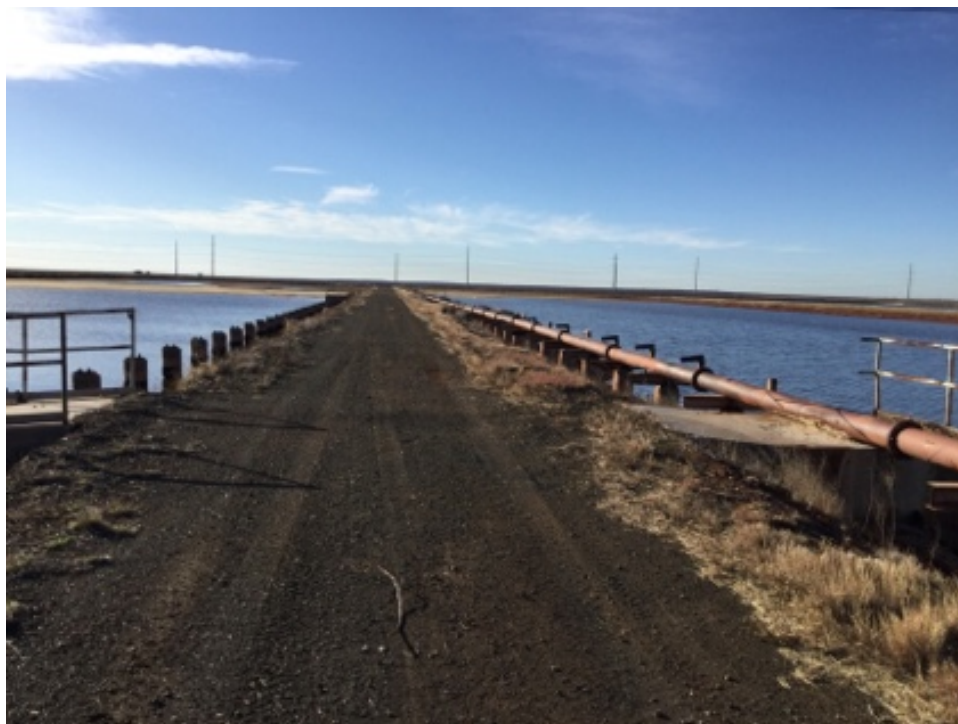
Photo #: 4

General condition of
crest. Common to Pond
21/22

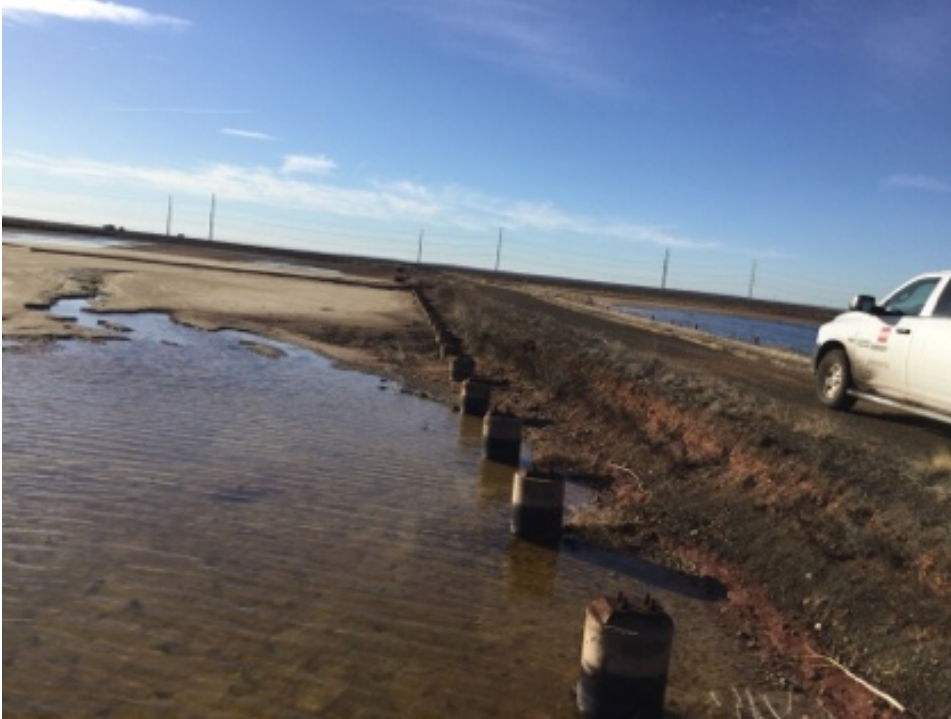
Photo #: 5

General condition of Pond 22 interior slope common to Pond 21 exterior slope

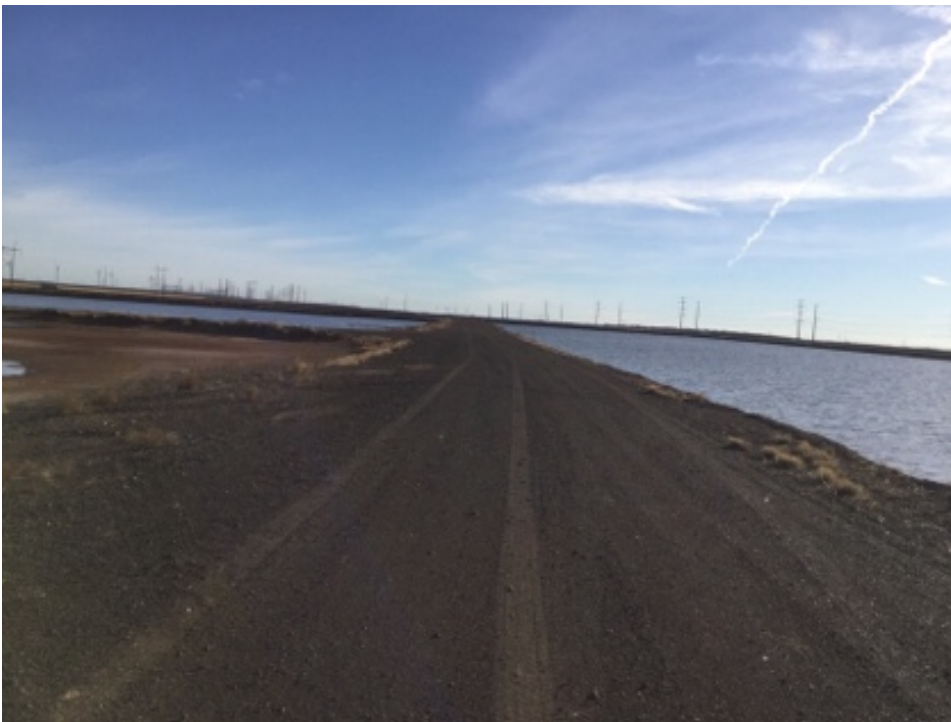
Photo #: 6

General condition of crest common to Pond 22/Makeup Water Pond

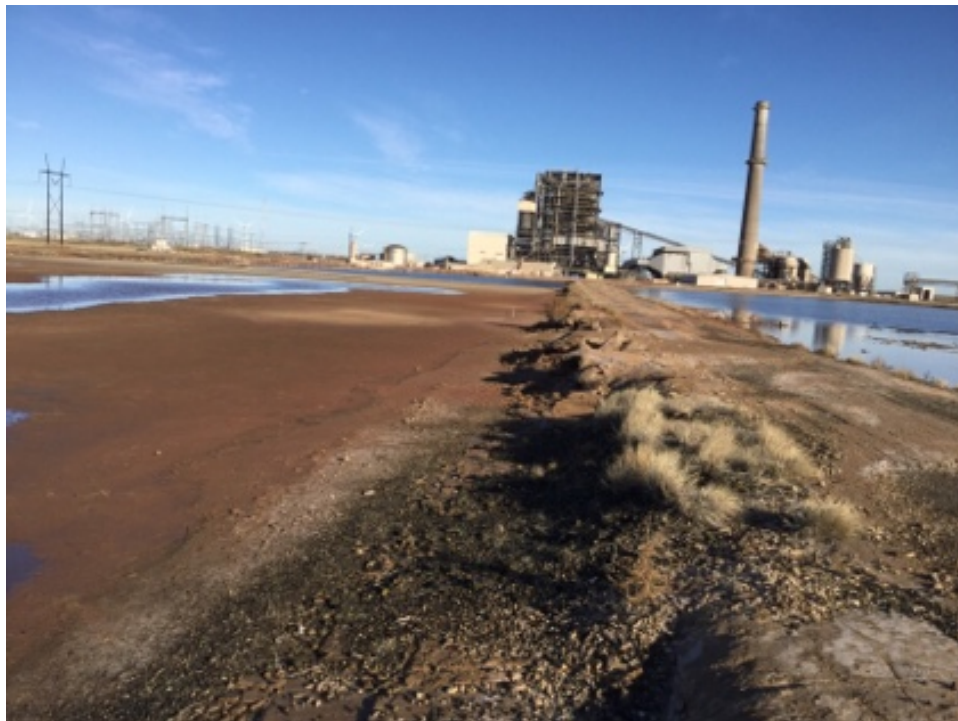
7

General condition of
Pond 22 interior slope
common to Pond 23
exterior slope

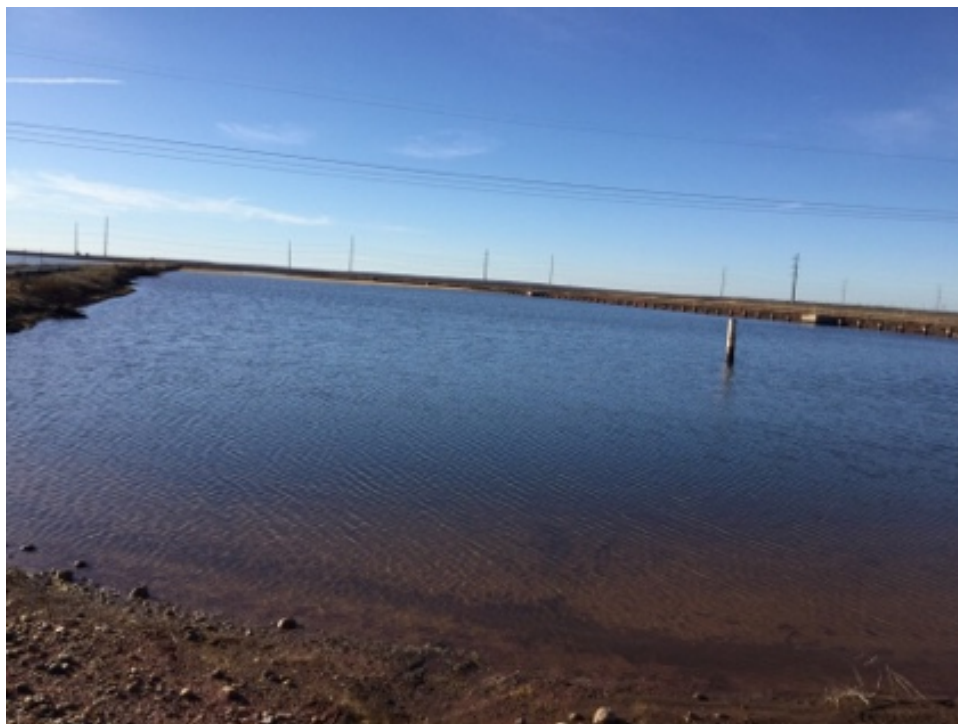
8

General condition of
Pond 22

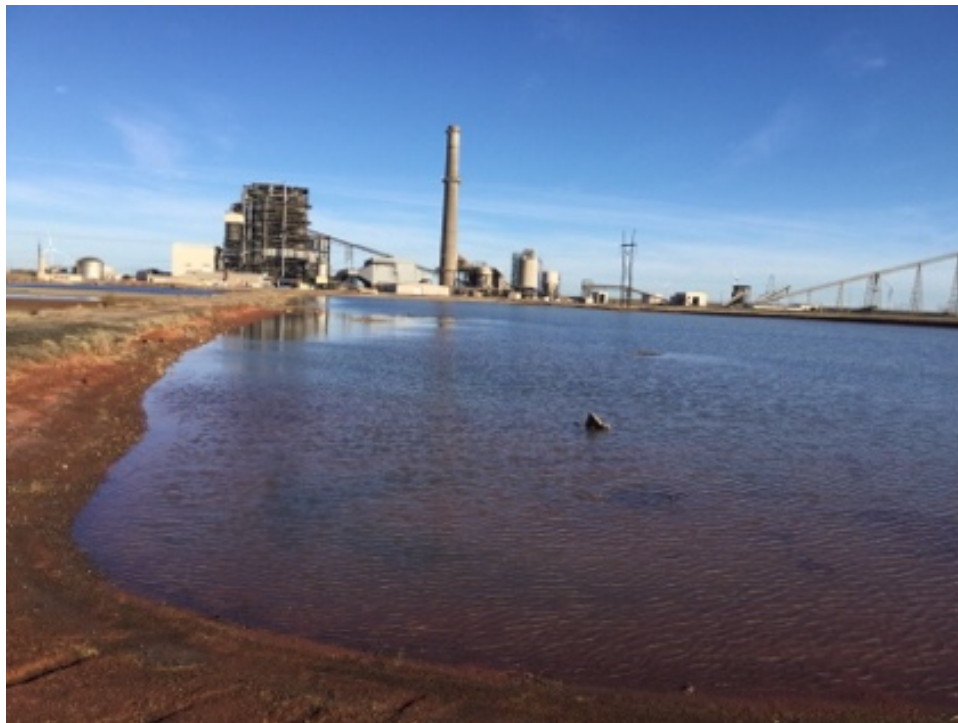
Photo #: 9

General condition of
Pond 23

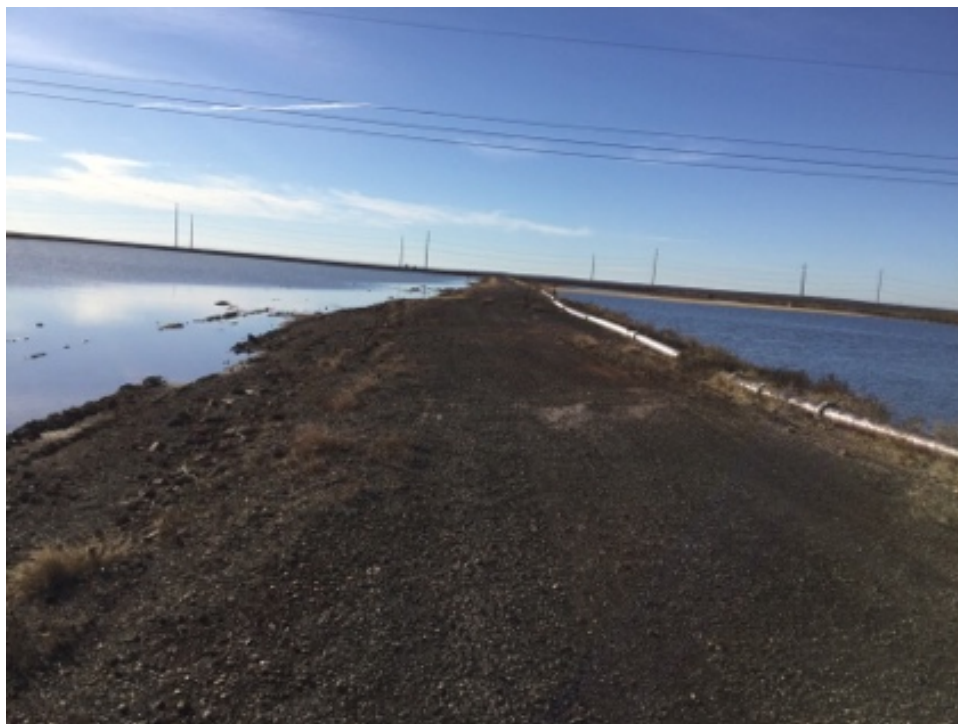
Photo #: 10

General condition of
crest common to Ponds
22/23

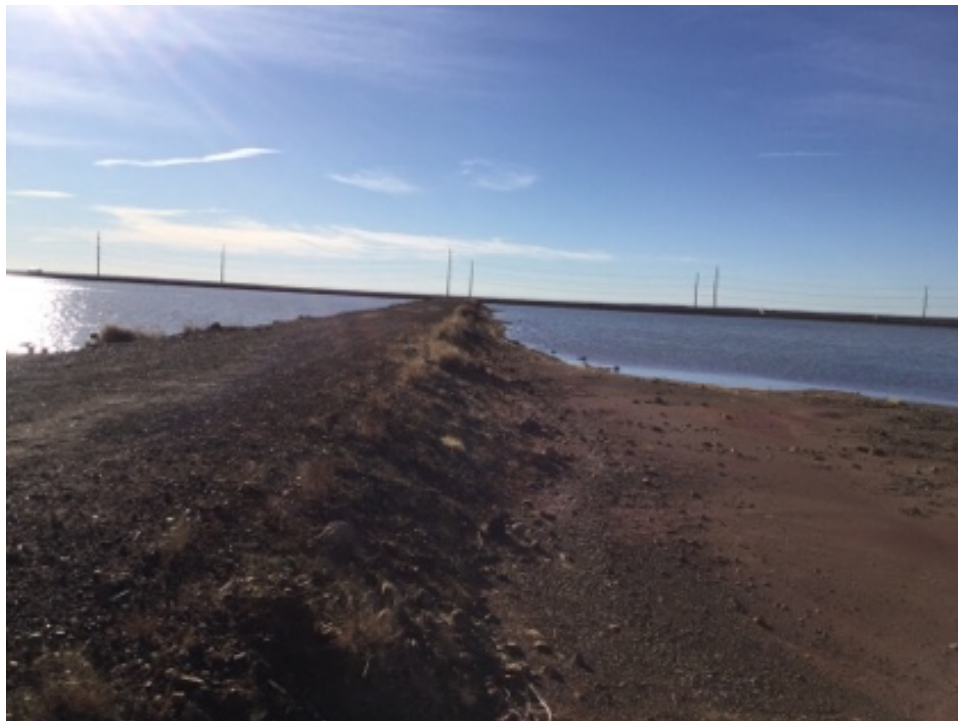
Photo #: 11

General condition of Pond 23 interior slope common to Waste Water Sludge Pond exterior slope.

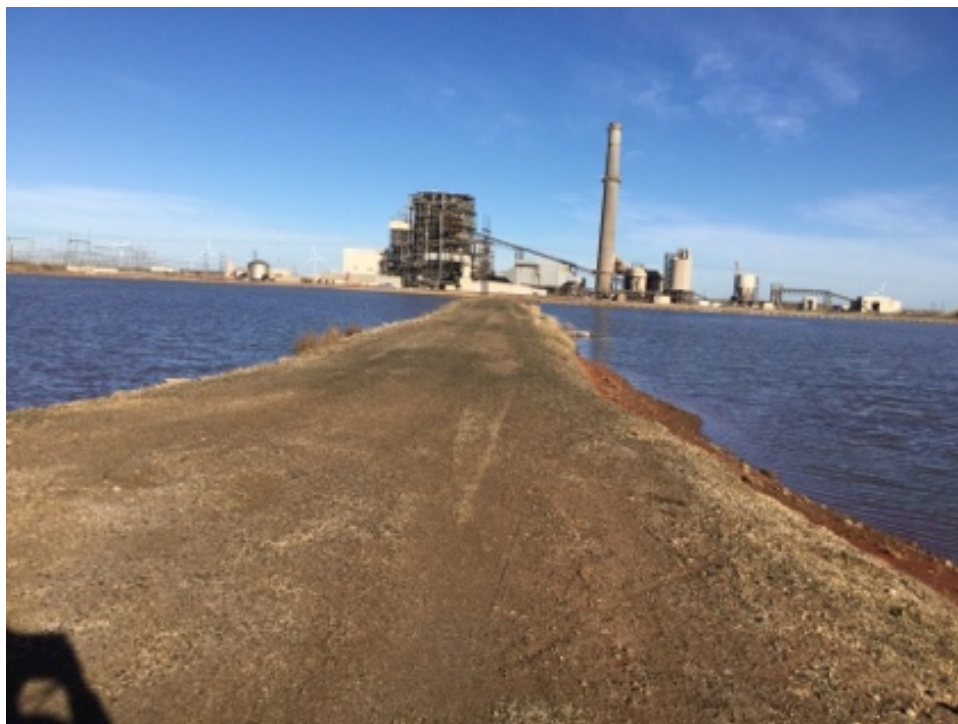
Photo #: 12

General condition of crest common to Ponds 23/Waste Water

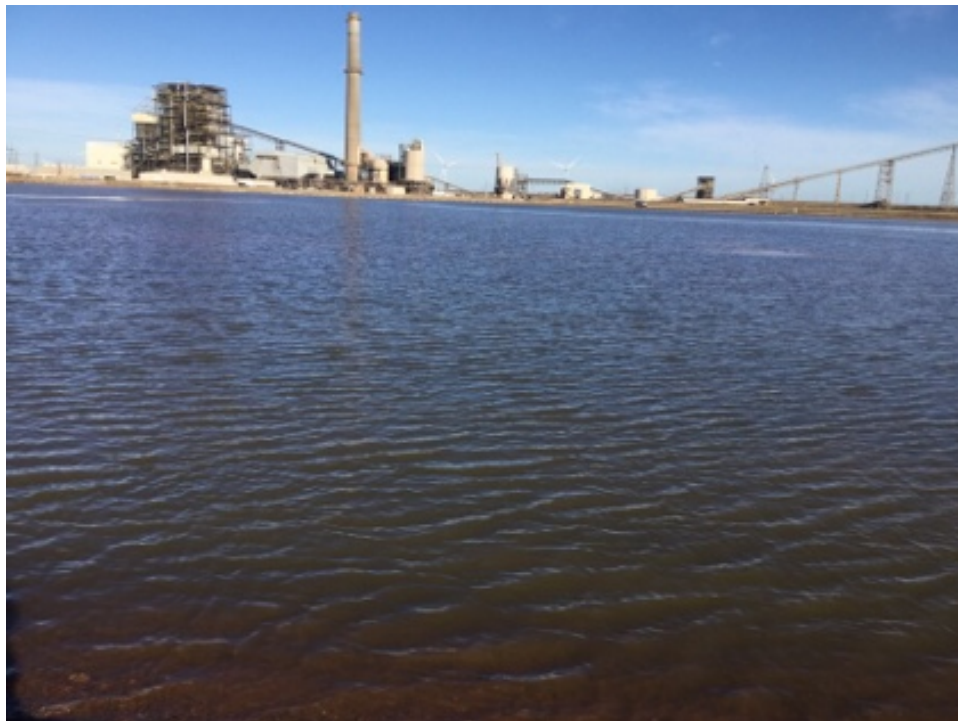
Photo #: 13

General condition of
Waste Water Sludge
Pond

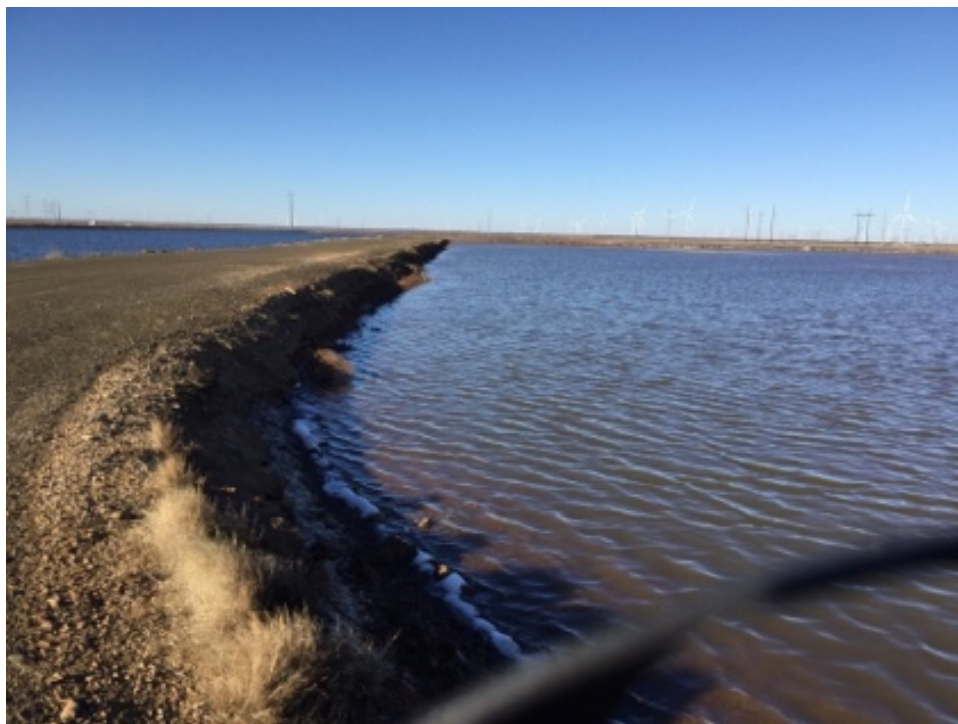
Photo #: 14

General condition of
Waste Water Sludge
Pond interior slope
common to Makeup
Water Pond

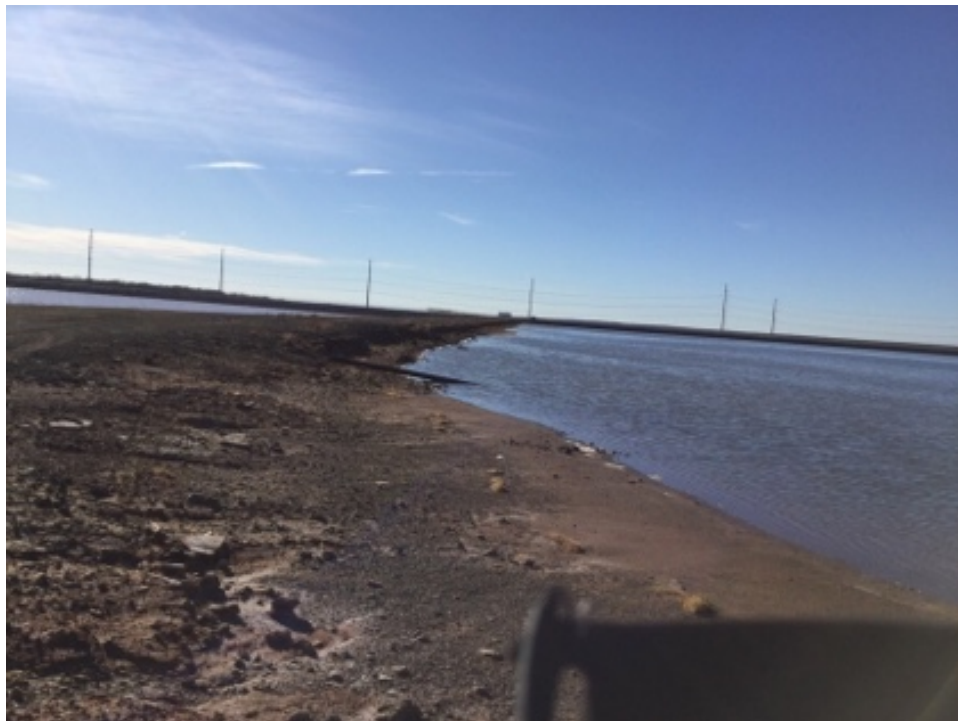
Photo #: 15

General condition of of Waste Water Sludge interior slope, common to Pond 7.

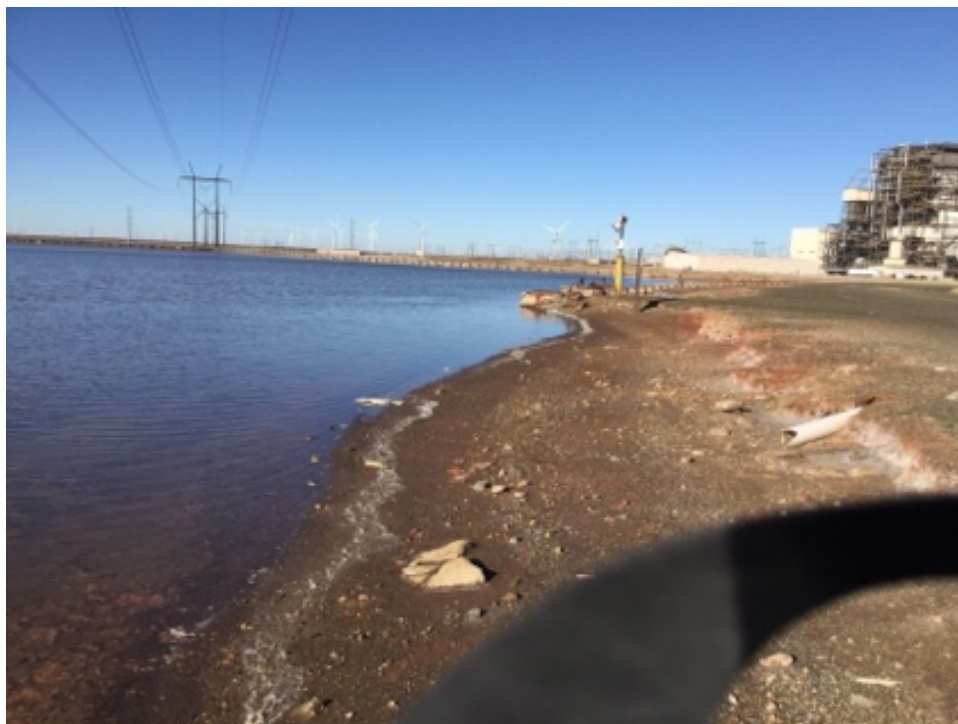
Photo #: 16

General condition of interior slopes of Waste Water Sludge Pond

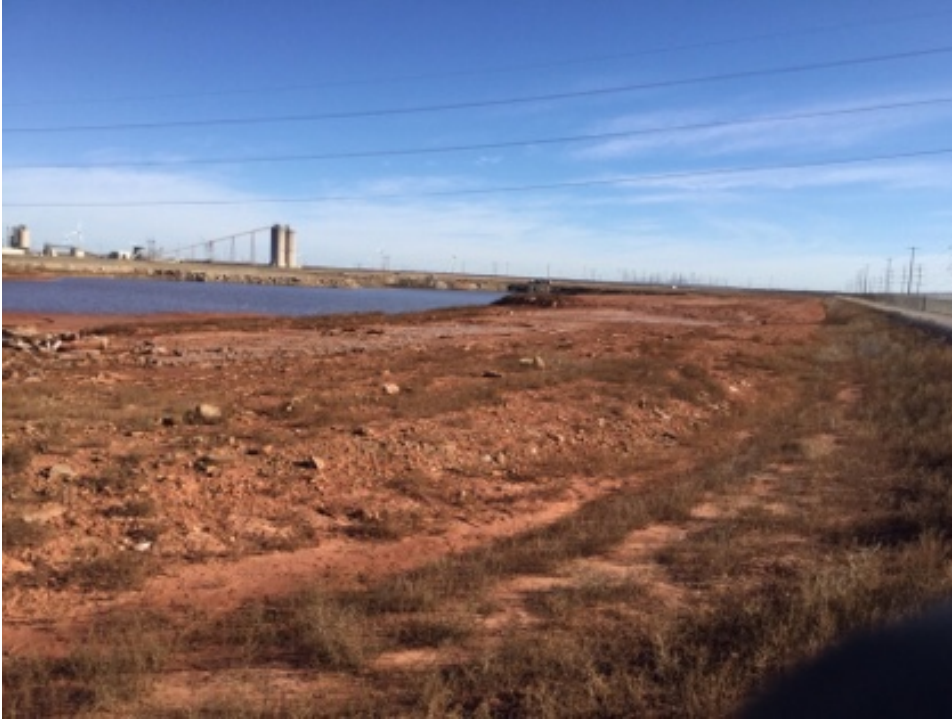
Photo #: 17

General condition of
Pond 6 from SW corner

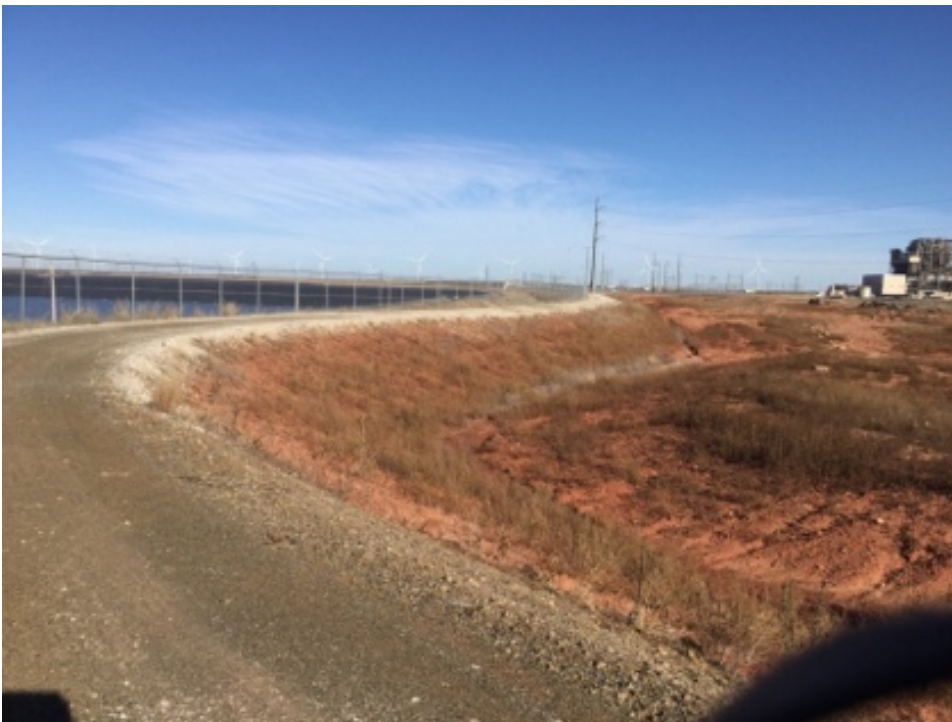
Photo #: 18

General condition of
Pond 6 west interior
slope and crest

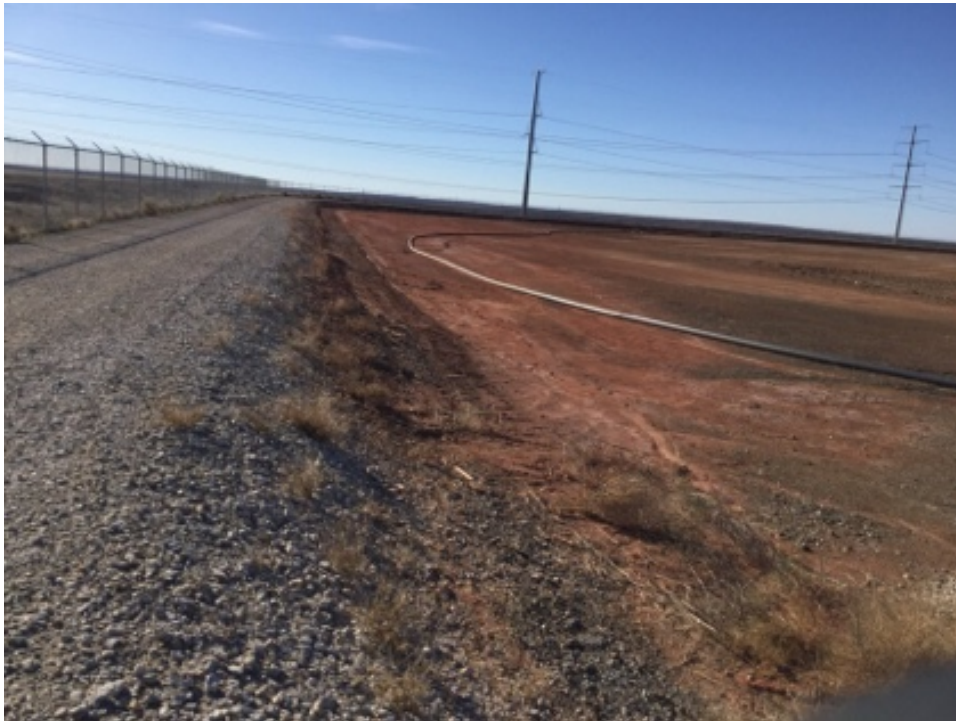
Photo #: 19

Notes: General condition of Pond 6 east interior slope and crest

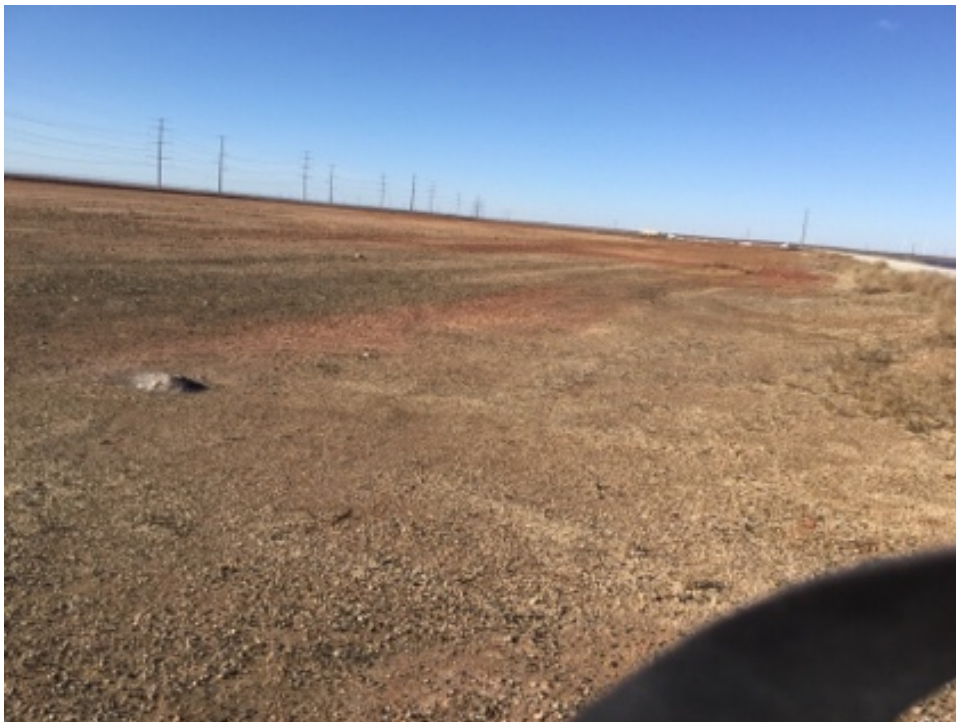
Photo #: 20

Notes: General condition of of Pond 6 from NE corner

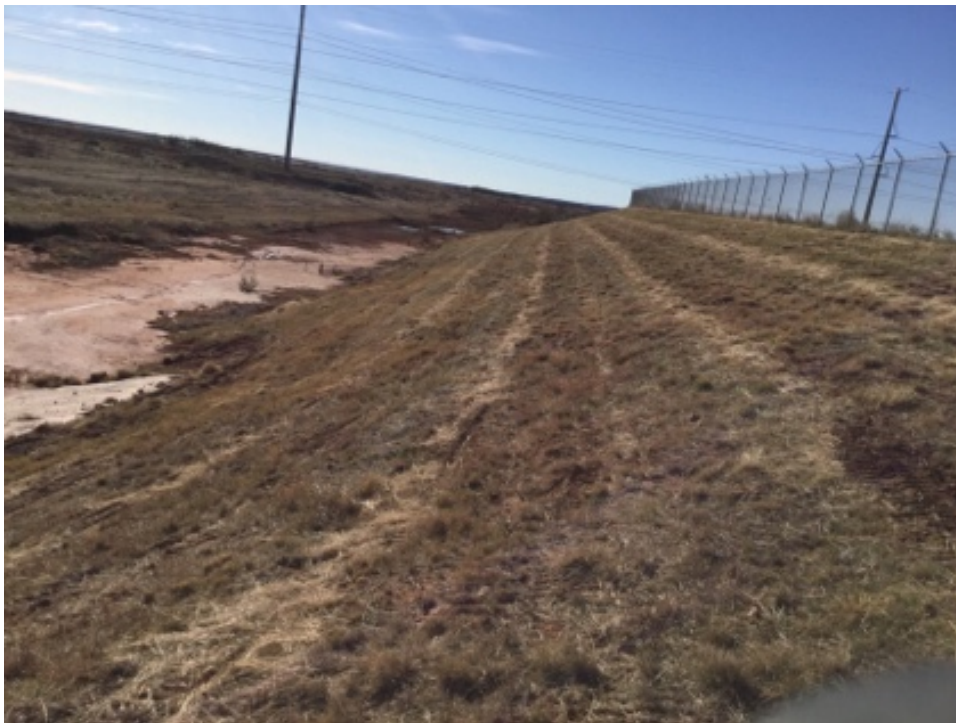
Photo #: 21

General condition of
Pond 6 east exterior
slope

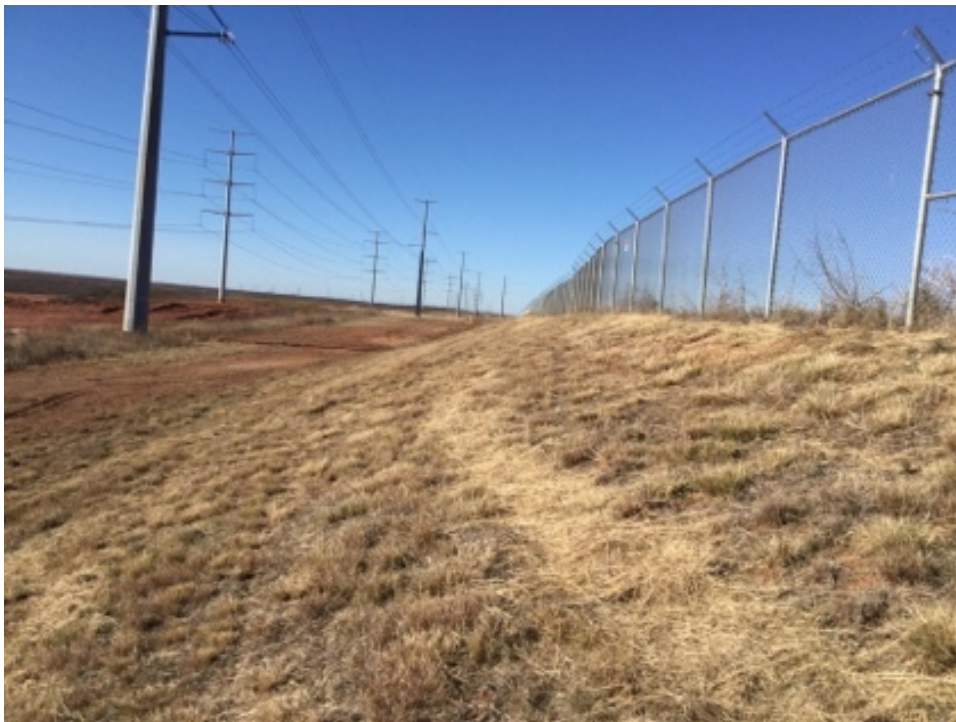
Photo #: 22

General condition of
Pond 6 south exterior
slope

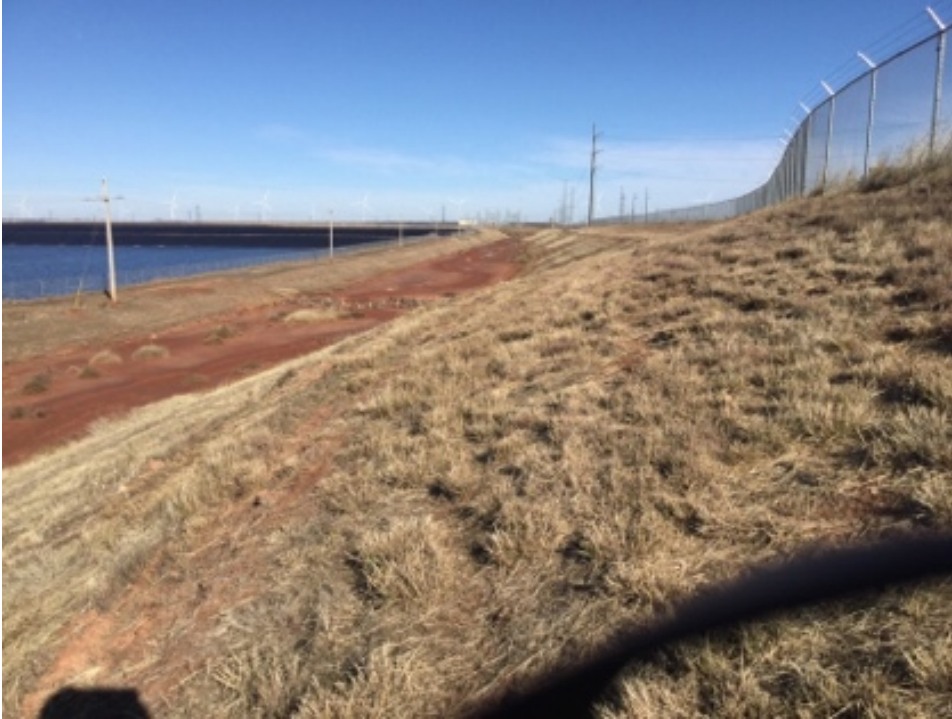
Photo #: 23

General condition of
Pond 6 west exterior
slope

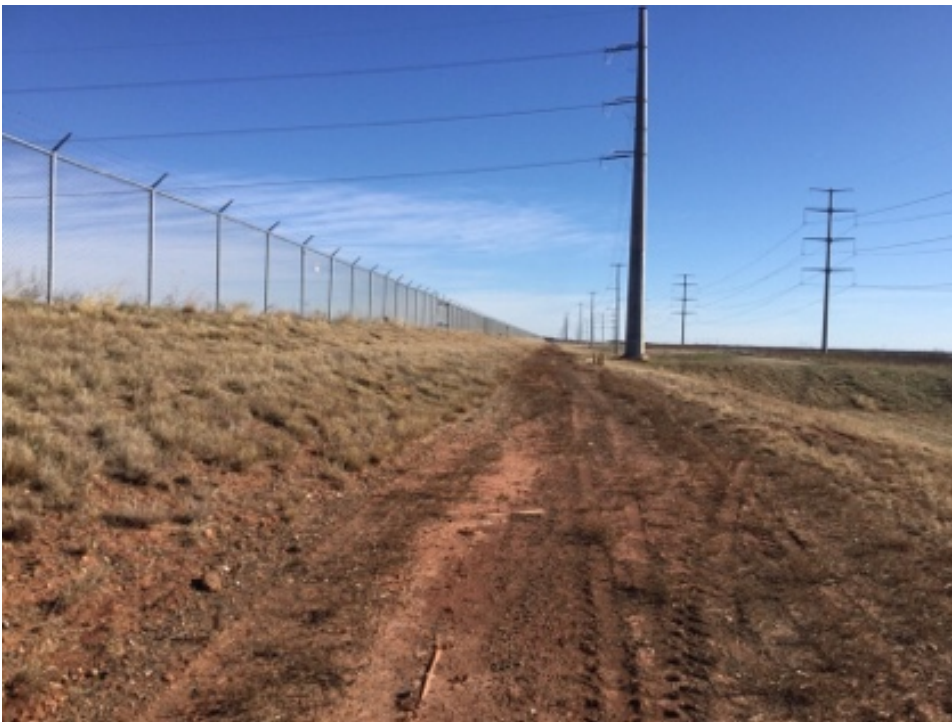
Photo #: 24

General condition of
Pond 6 south exterior
slope
