# **2020 ANNUAL DAM AND DIKE INSPECTION REPORT**

**CCR PONDS COMPLEX**

**Oklaunion Industrial Park LLC  
VERNON, TEXAS**

**December, 2020**

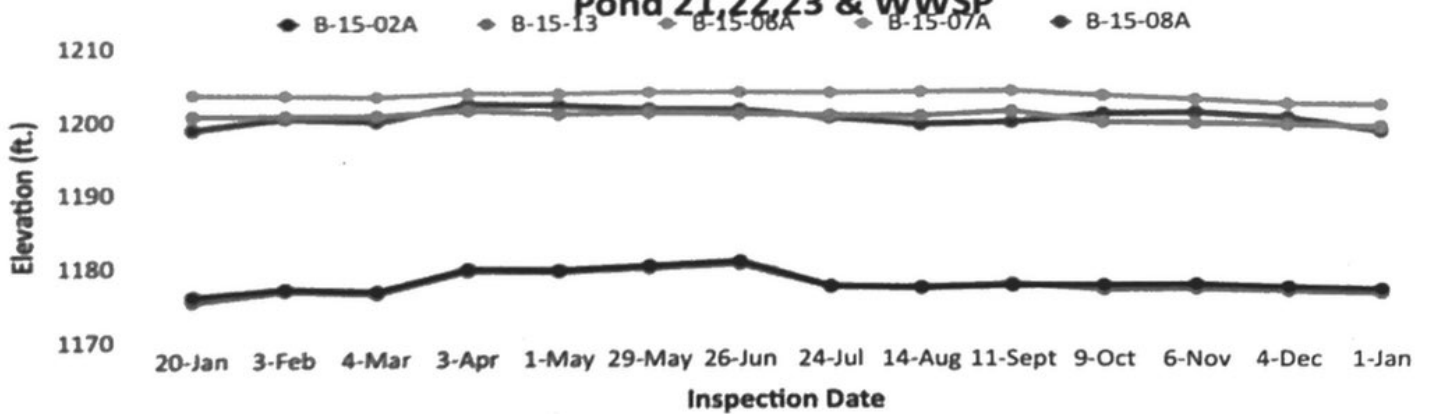
## FIGURE 4

Five piezometers (B-1, B-3, B-4, B-5, and B-6) were installed in July 2016 around the Pond 21, 22, 23 and WWSP. Each piezometer was installed at the crest surrounding the ponds. Figure 4 shows the static water levels of those piezometers measured during monthly plant inspections beginning in August, 2016. Pond levels were not measured but are generally around 1213 feet. Over periods of monthly measurement data, the static water levels in the piezometers have indicated some fluctuations. All of the piezometers except B-5 indicated static water levels below the nominal pond pool level (1,213 feet). The elevated static water levels in B-5 are related to elevated pool levels in Ponds 21 and 22 due to operations.

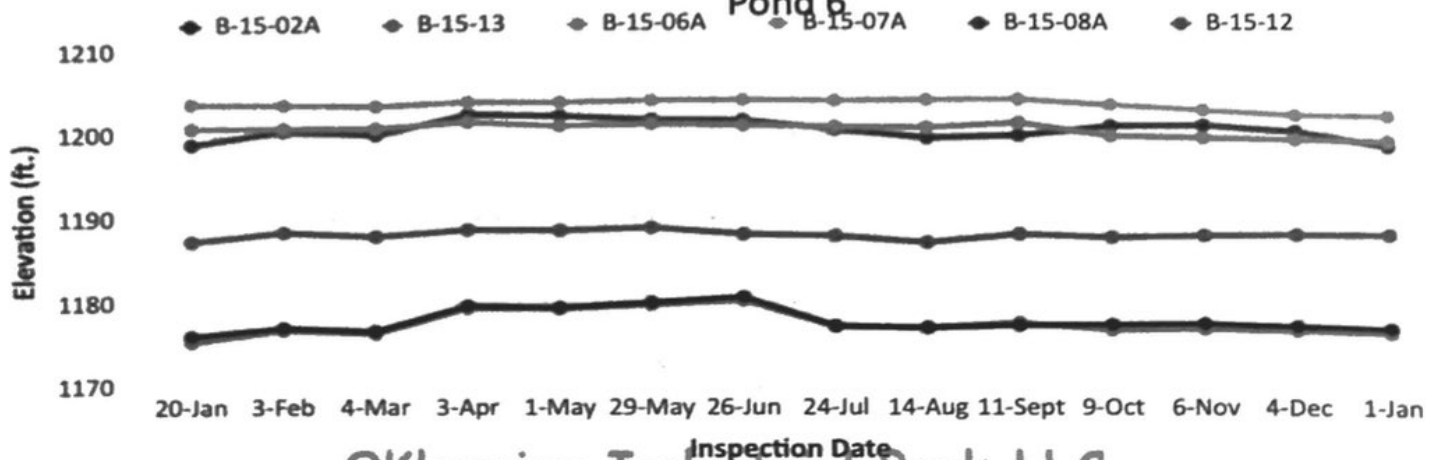
## FIGURE 5

Piezometers (B-1502A, B-1506A, B-1507A, B-1508A, B1512, and B1513) were installed in various locations along the crest of Pond 6 as a part of the raising the dikes in 2015. Figure 5 shows the static water levels of those piezometers measured during monthly plant inspections. Pond level was not measured but is estimated to be around elevation 1200 feet at the time of this inspection but it varies up to elevation 1213 during the year. All of the piezometers indicated static water levels below the maximum pond pool level (1213 feet). All piezometers indicated static water levels within expected tolerance for this year's readings.

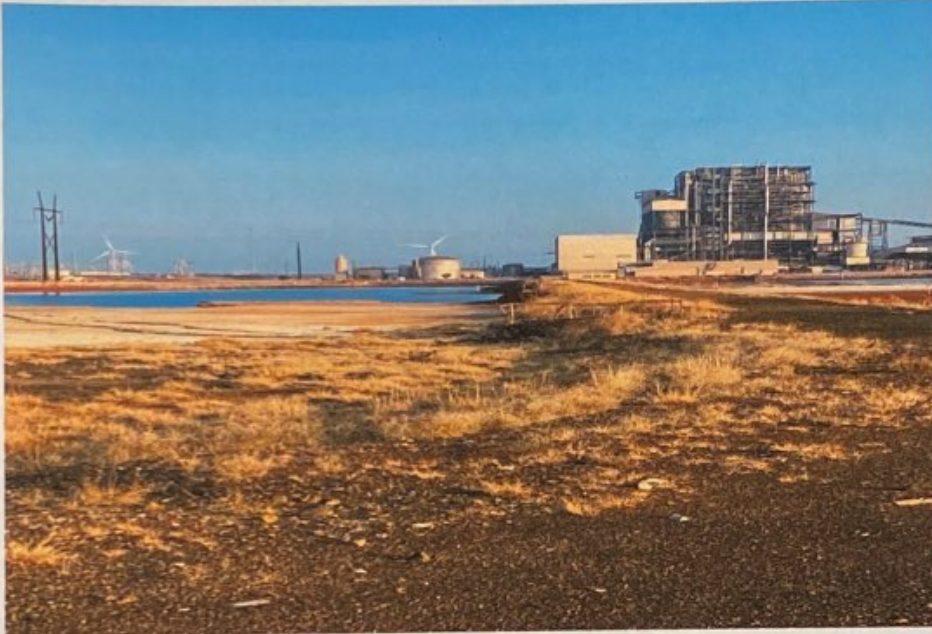
Photo #: 1

General condition of  
Pond 21

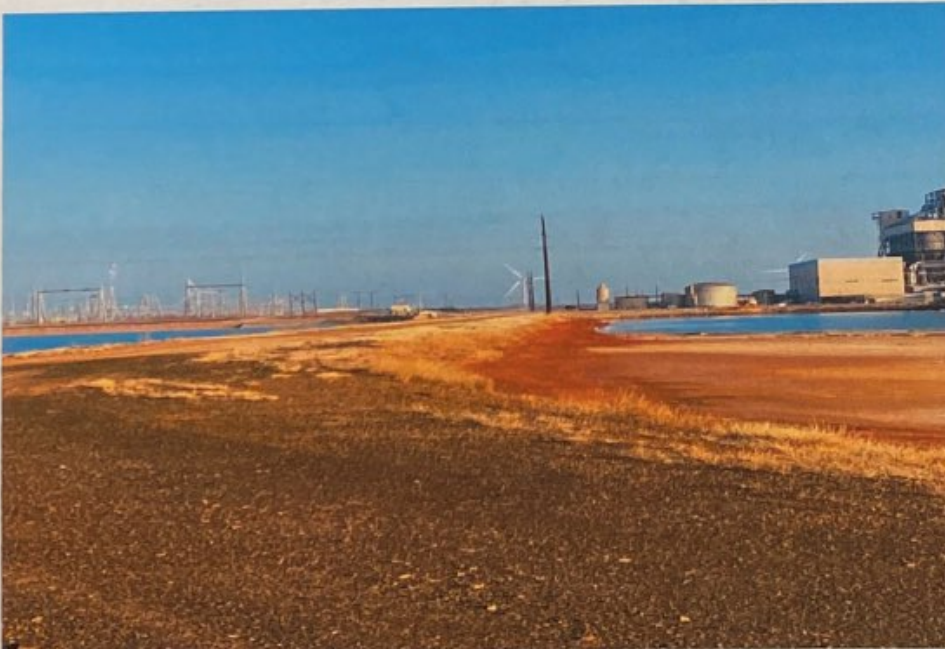
Photo #: 1

General condition of  
Pond 21 interior slope

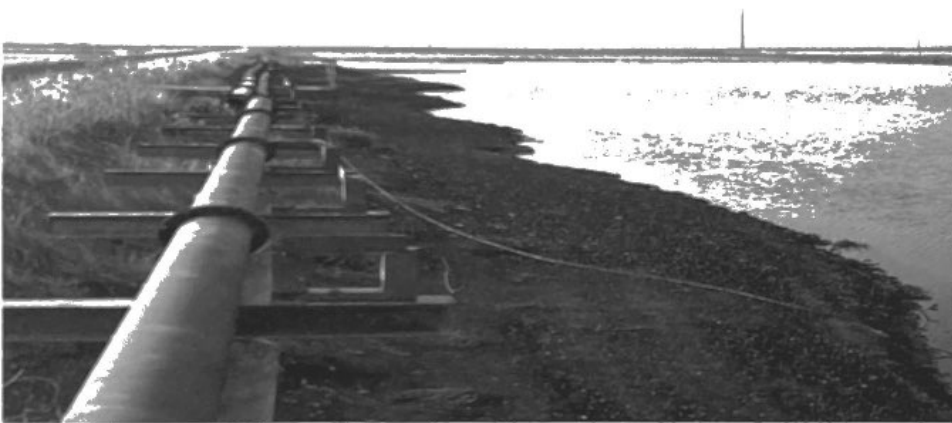
2

General condition of  
Pond 21 exterior slope  
common to Makeup  
Water Pond interior  
slope

- The exterior slope of Pond 21 (the interior slope of the Make-Up Water Pond) is to be visually inspected periodically. Should further erosion occur the plant will take preventative actions by installing rip rap along the eroded area in order to protect the slope.
- Piezometers B-1, B-3, B-4, B-5, and B-6 surrounding Ponds 21, 22, 23 and the WWSP shall continue to be monitored monthly and Oklaunion Industrial Park Engineering services to be immediately notified

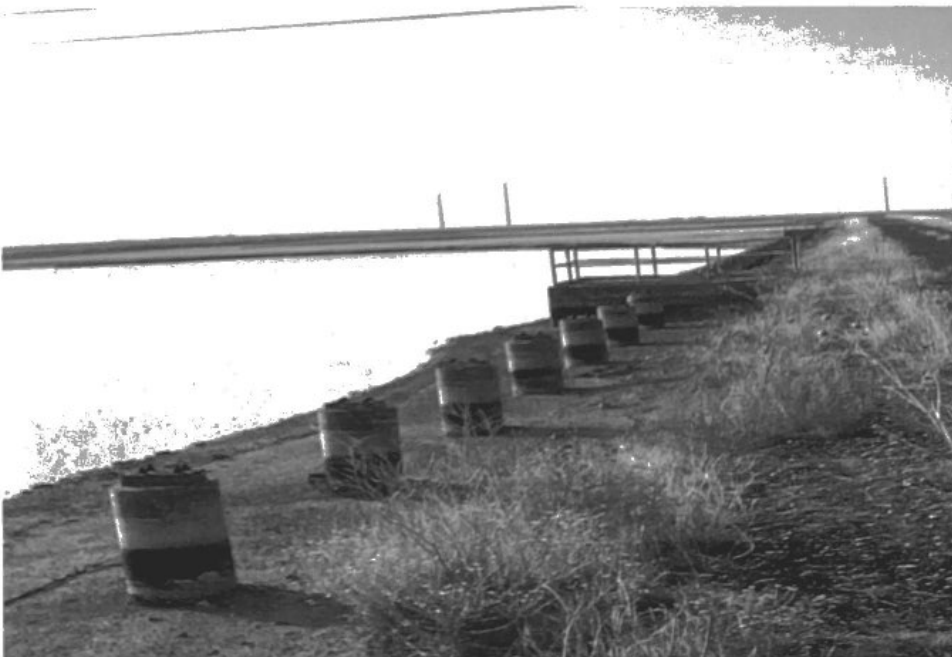
3

General condition of  
crest. Common to Pond  
21/22

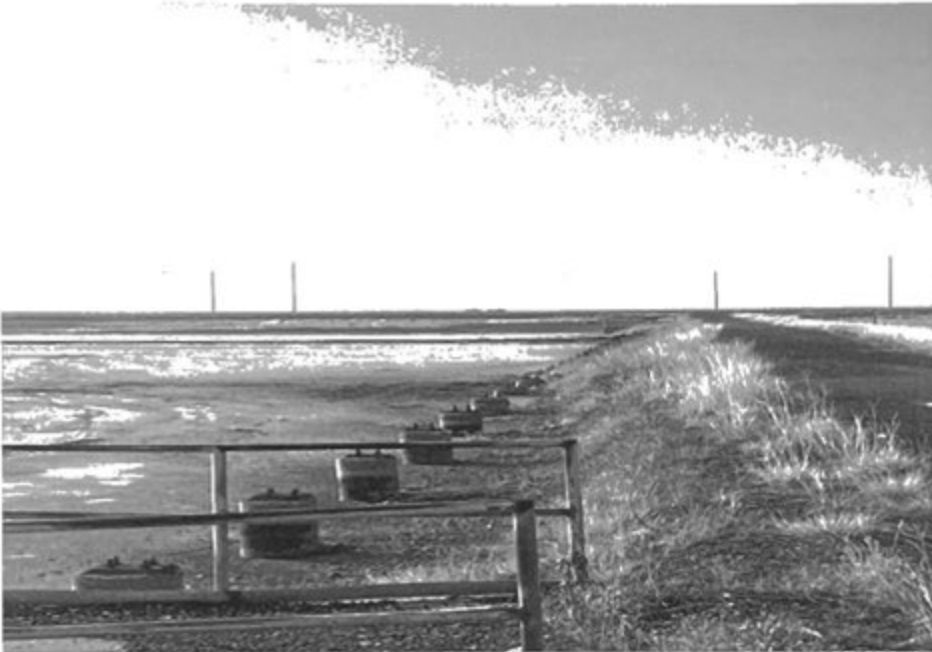
Photo #: 4

General condition of  
Pond 22 interior slope  
common to Pond 21  
exterior slope

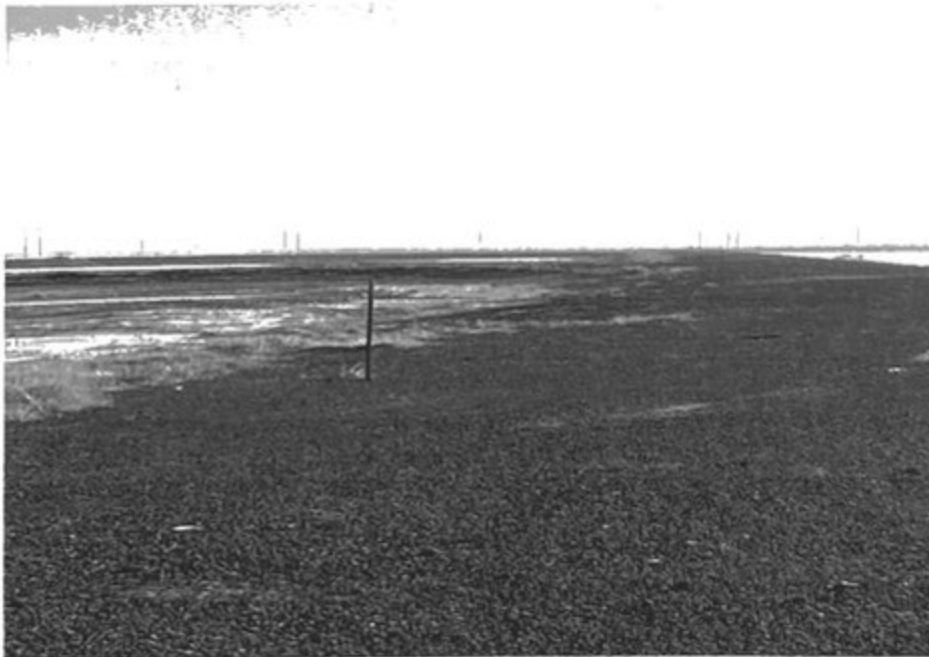
Photo #: 0

General condition of  
crest common to Pond  
22/Makeup Water Pond

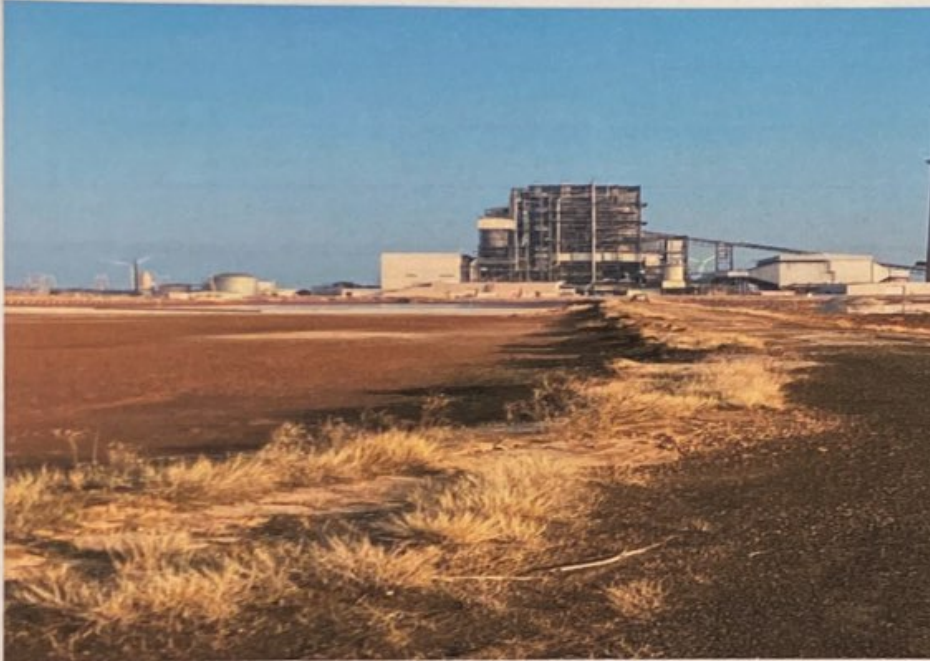
6

General condition of  
Pond 22 interior slope  
common to Pond 23  
exterior slope

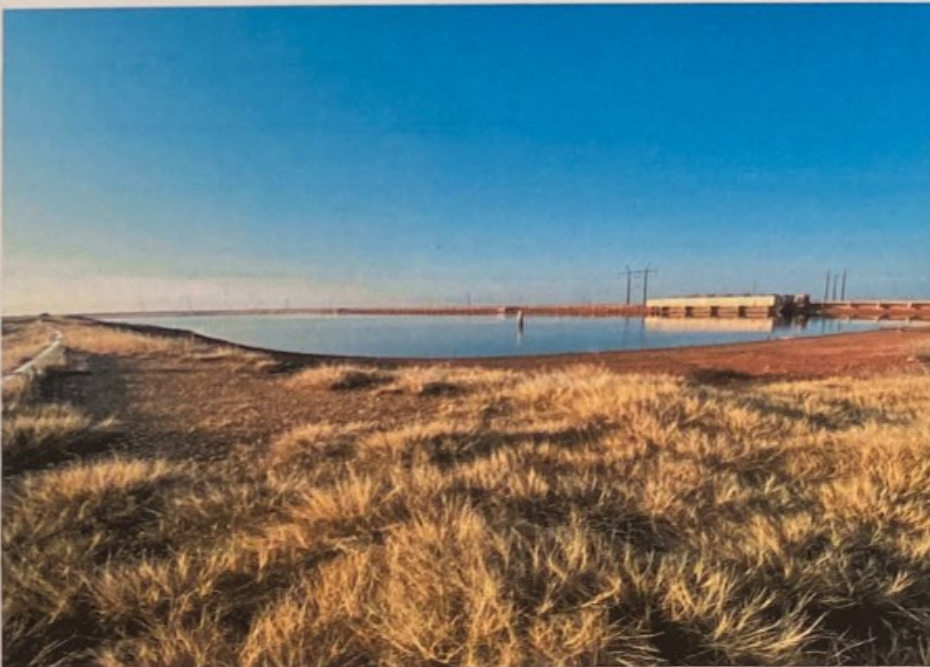
/2

General condition of  
Pond 22

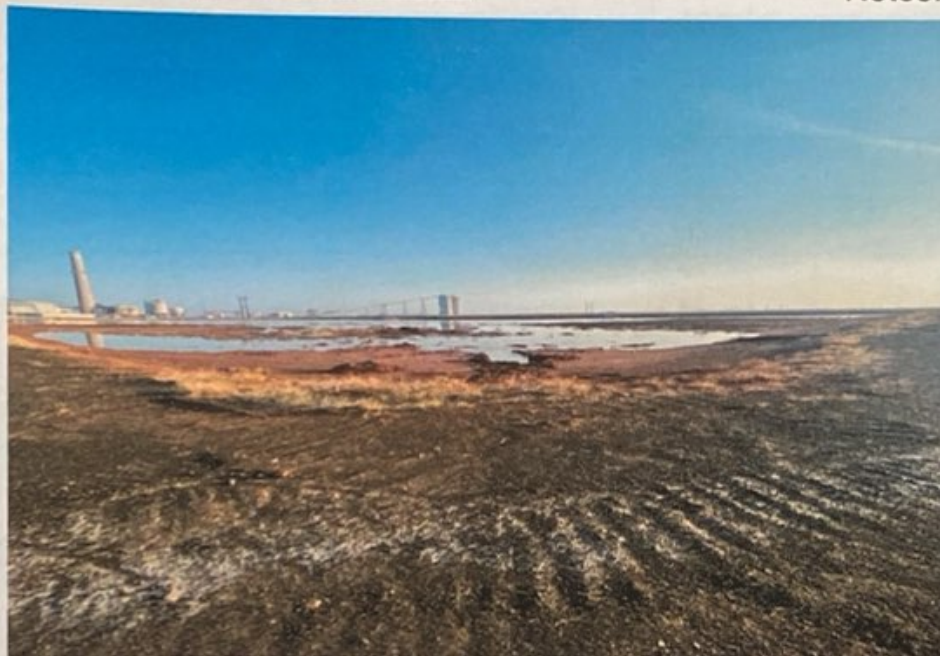
9

General condition of  
Pond 23

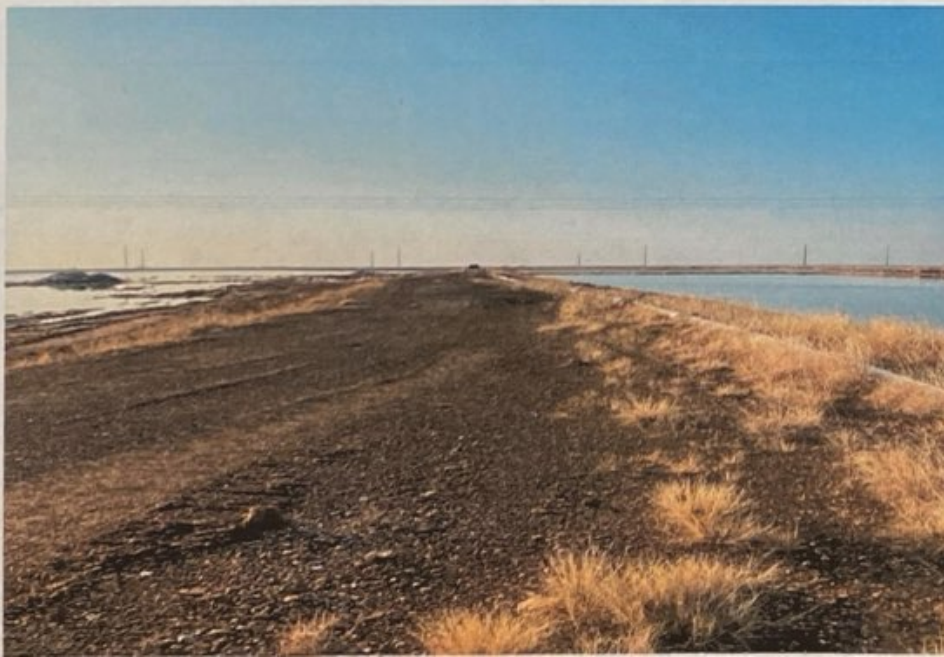
11

General condition of  
crest common to Ponds  
22/23

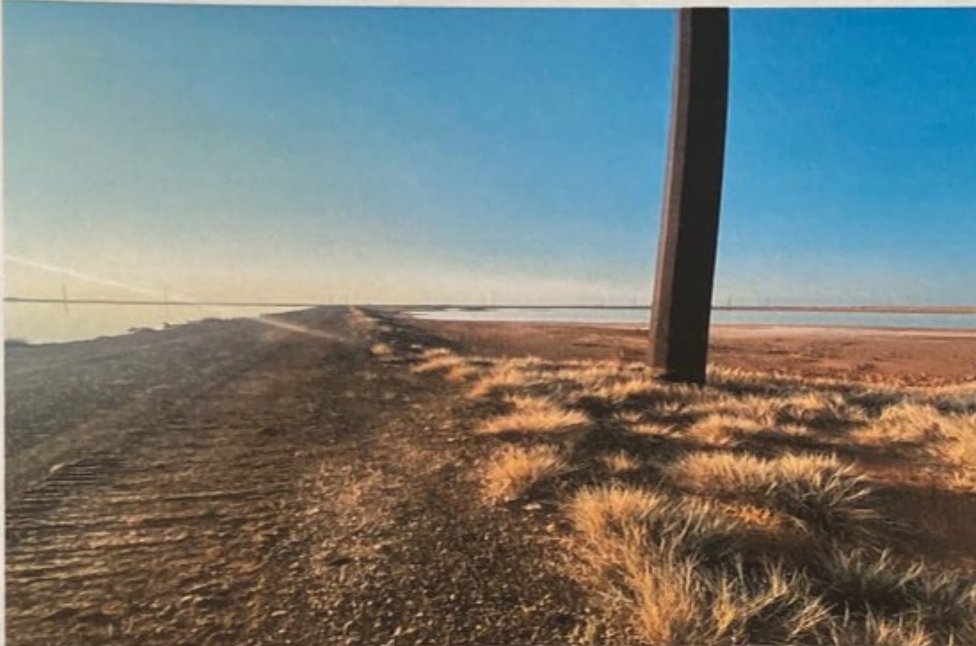
Photo #: 11

General condition of Pond 23 interior slope common to Waste Water Sludge Pond exterior slope.

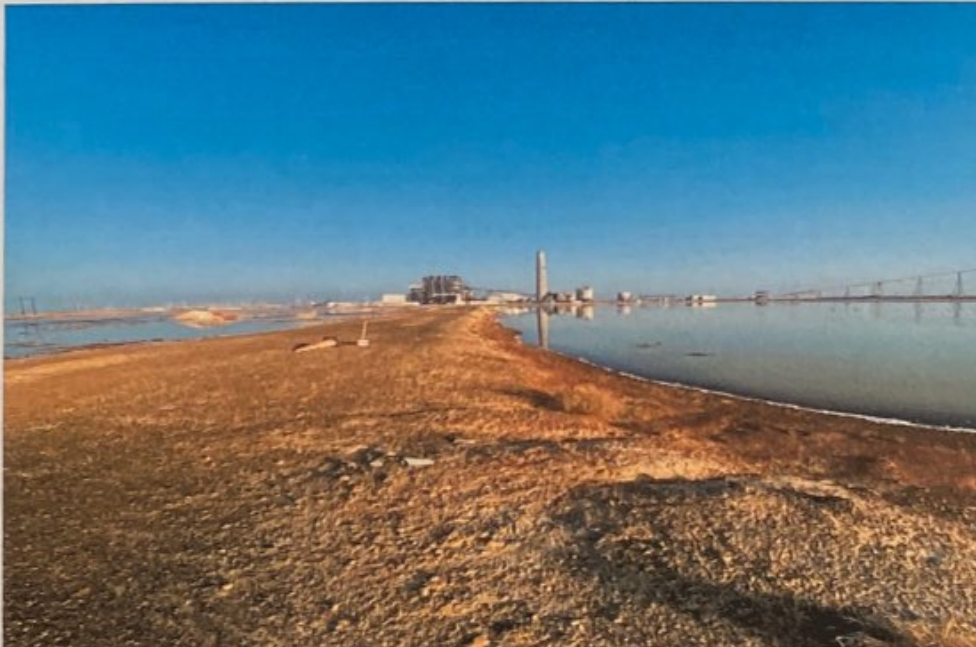
Photo #: 1.

General condition of crest common to Ponds 23/Waste Water

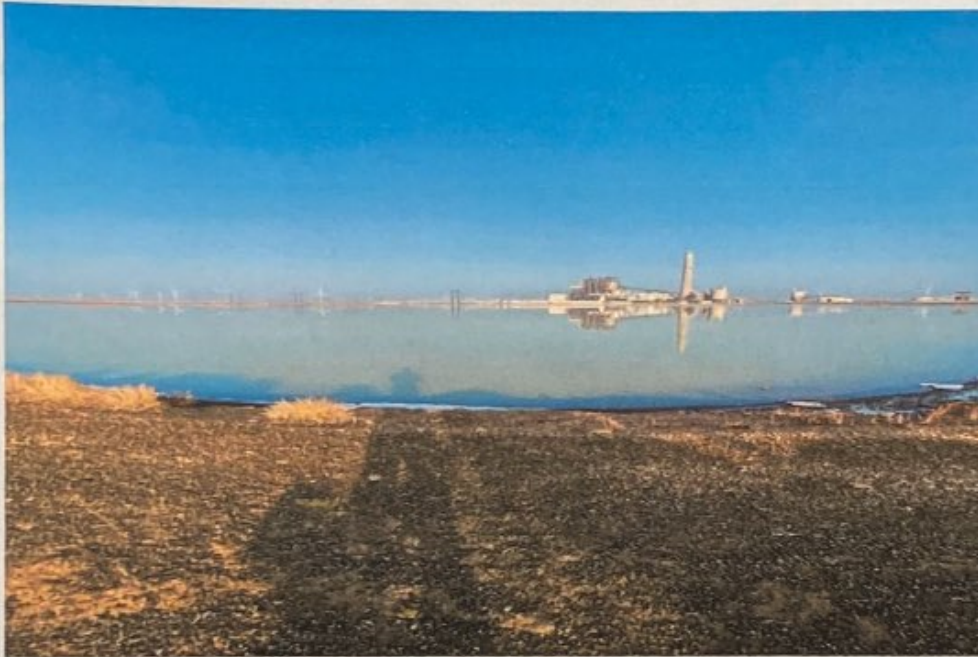
Photo #: 16

Notes: General condition of  
Waste Water Sludge  
Pond

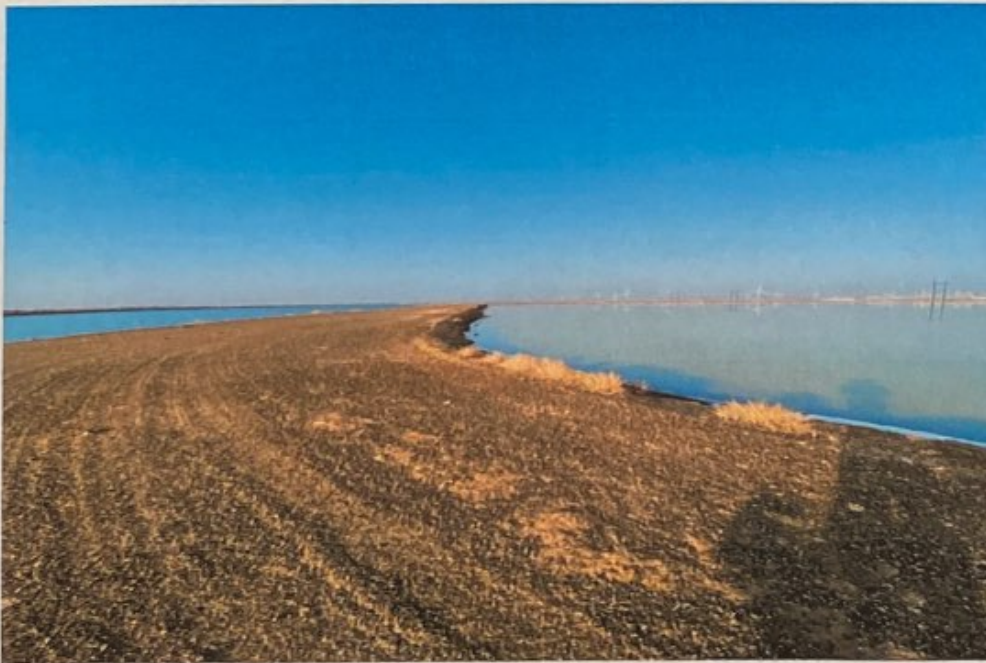
Photo #: 15

Notes: General condition of  
Waste Water Sludge  
Pond interior slope  
common to Makeup  
Water Pond

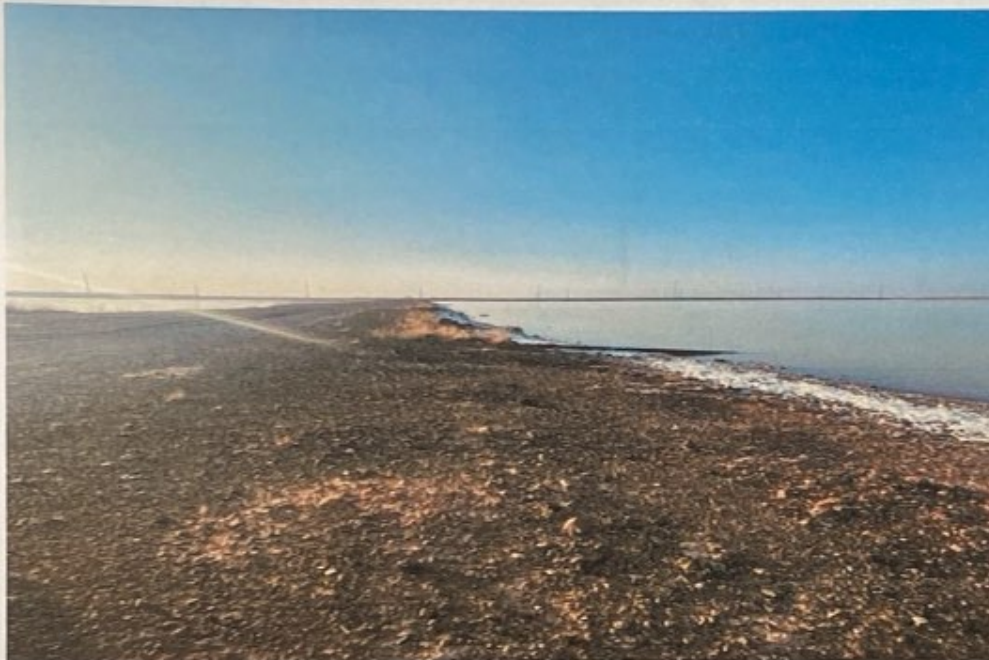
Photo #: 14

General condition of of Waste Water Sludge interior slope, common to Pond 7.

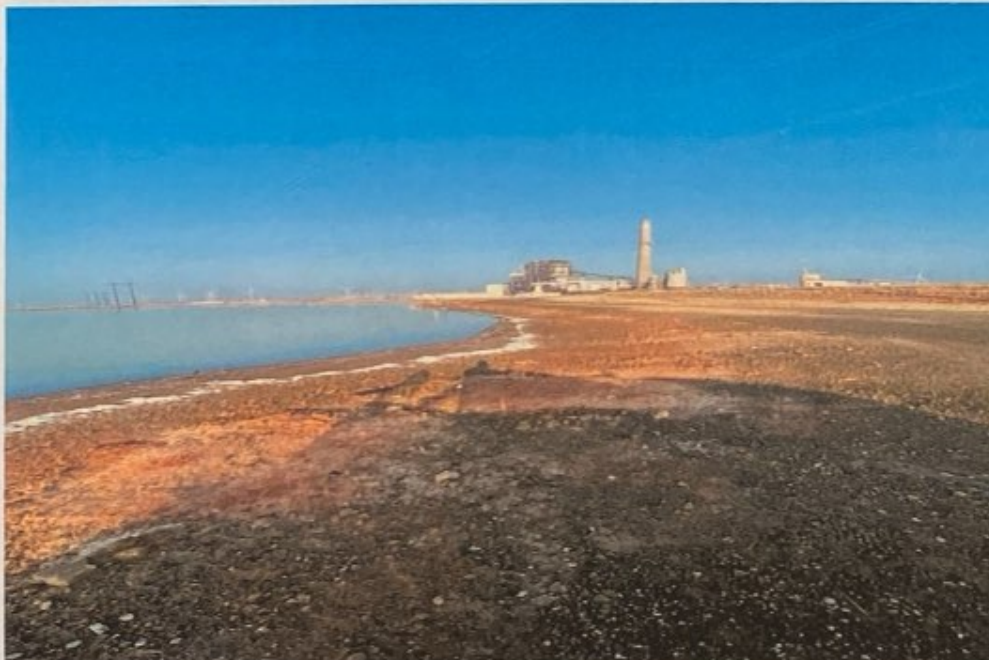
Photo #: 13

General condition of interior slopes of Waste Water Sludge Pond

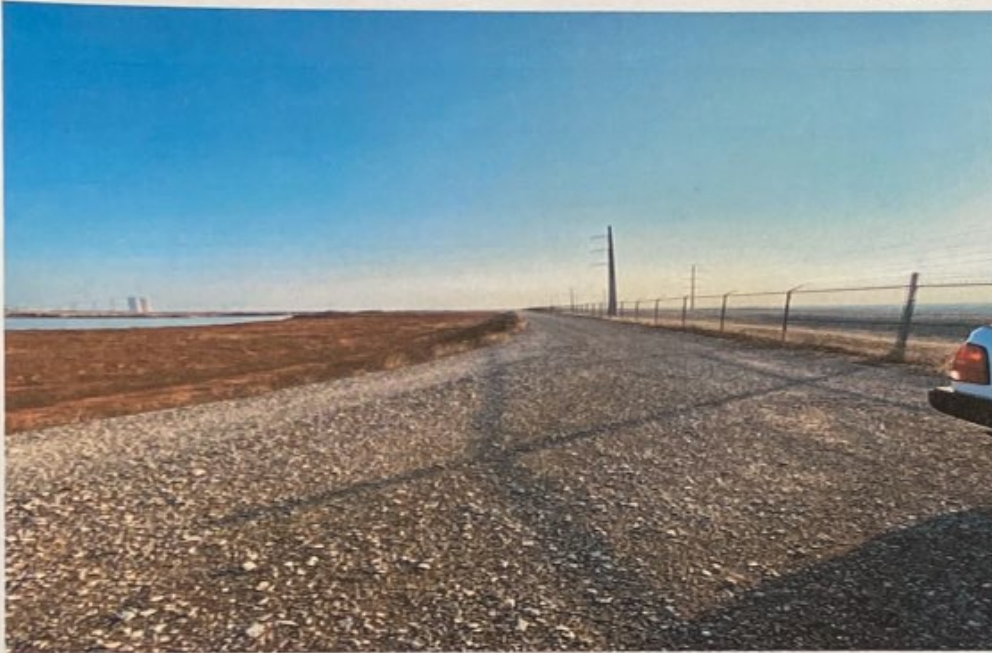
Photo #: 01

General condition of  
Pond 6 from SW corner

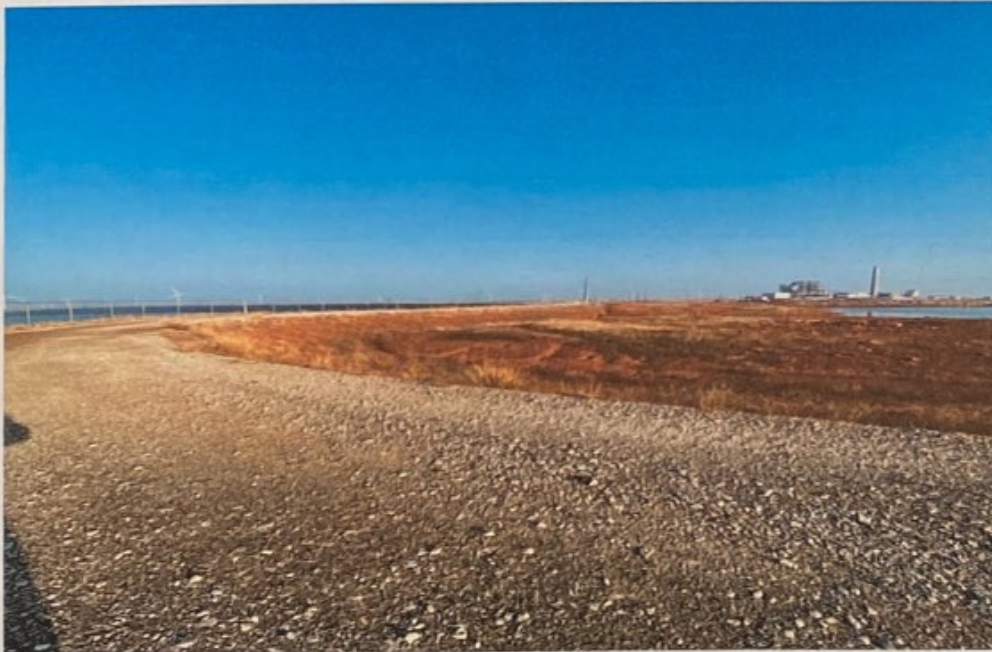
Photo #: 02

General condition of  
Pond 6 west interior  
slope and crest

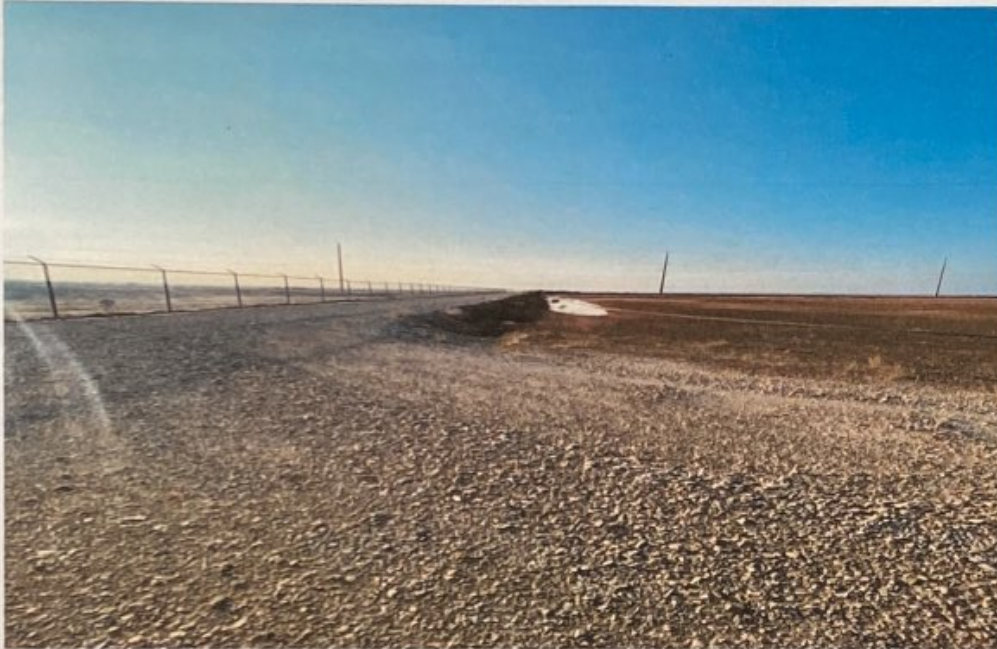
Photo #: 0.

Notes: General condition of Pond 6 east interior slope and crest

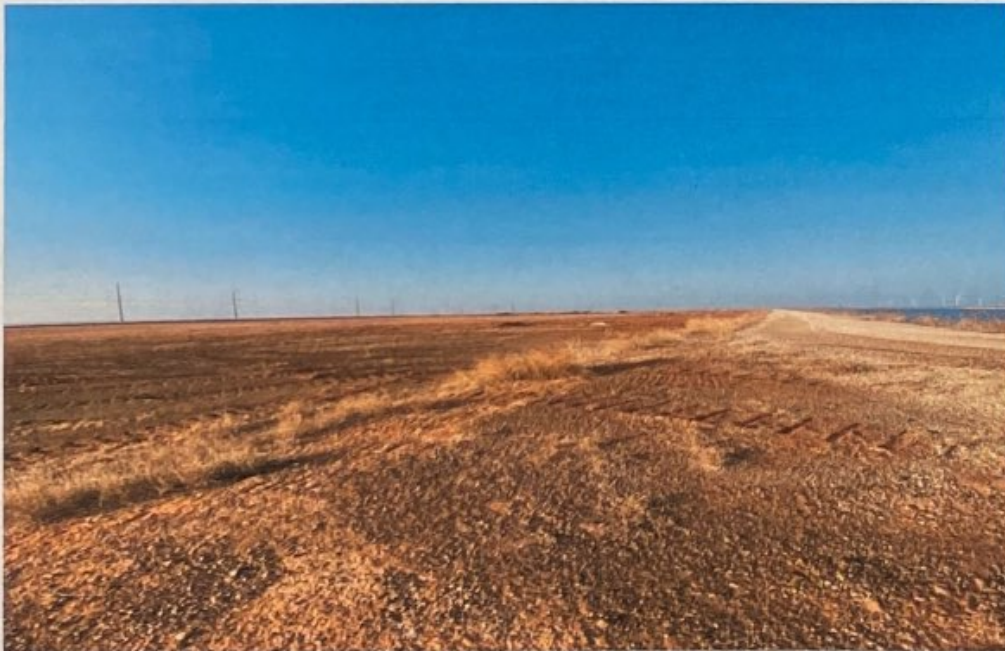
Photo #: 17

Notes: General condition of of Pond 6 from NE corner

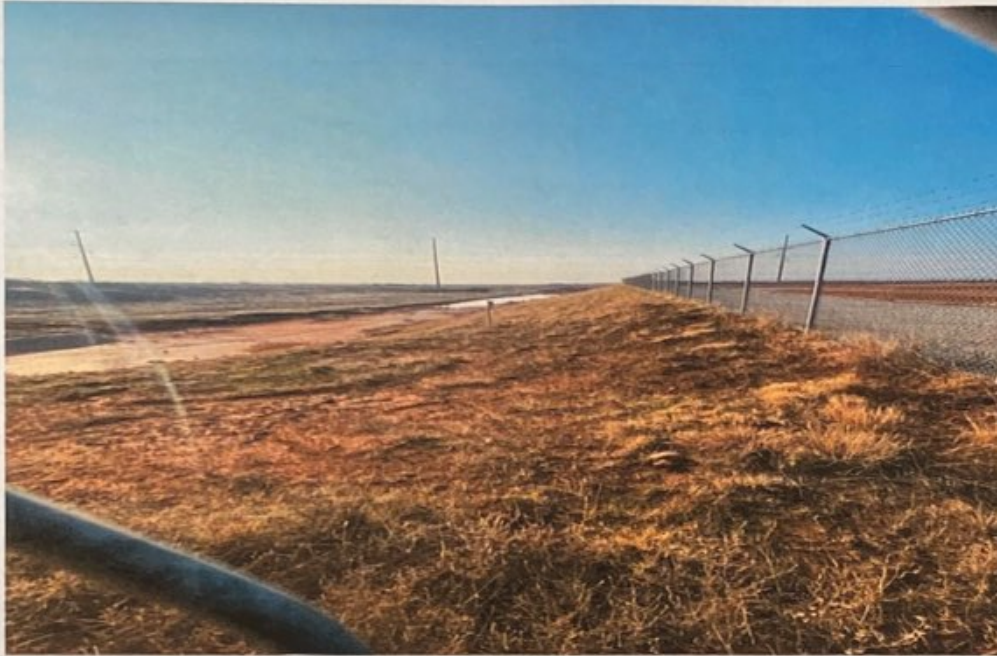
Photo #: 21

- Drainage along the toe of Pond 6 east exterior dike is considered fair and requires visual inspections of the area to continue with the weekly/monthly inspections.
- Vegetation management for the facility is considered good. Grassed areas should continue to be mowed regularly. Any areas that are not accessible to mowing equipment should be controlled by the use of weed trimmers, power brush cutters, or other suitable vegetation control method.
- Plant inspection and monitoring procedures, maintenance activities, and reporting with respect to the dikes should be implemented in coordination with Oklaunion Industrial Park Engineering.

Notes: General condition of Pond 6 east exterior slope

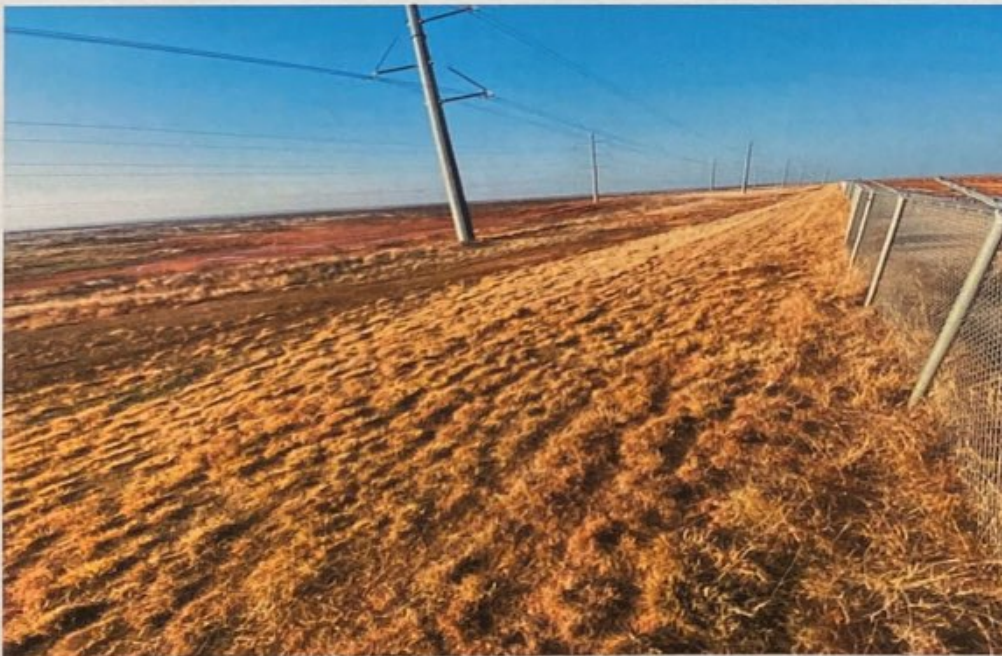
Photo #: 22

Notes: General condition of Pond 6 south exterior slope

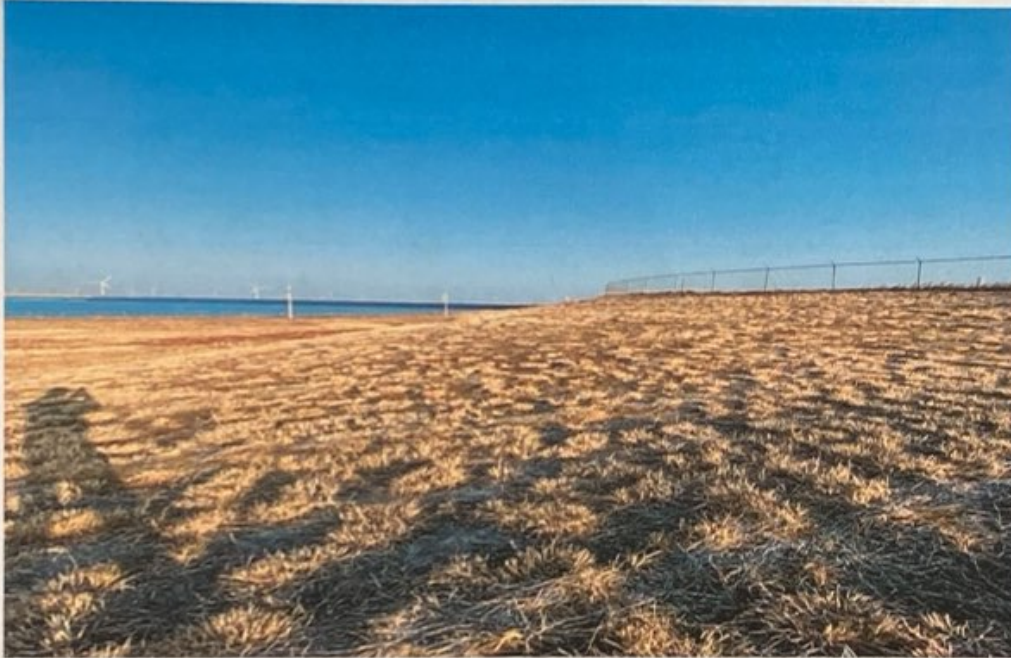
Photo #: 23

General condition of  
Pond 6 west exterior  
slope

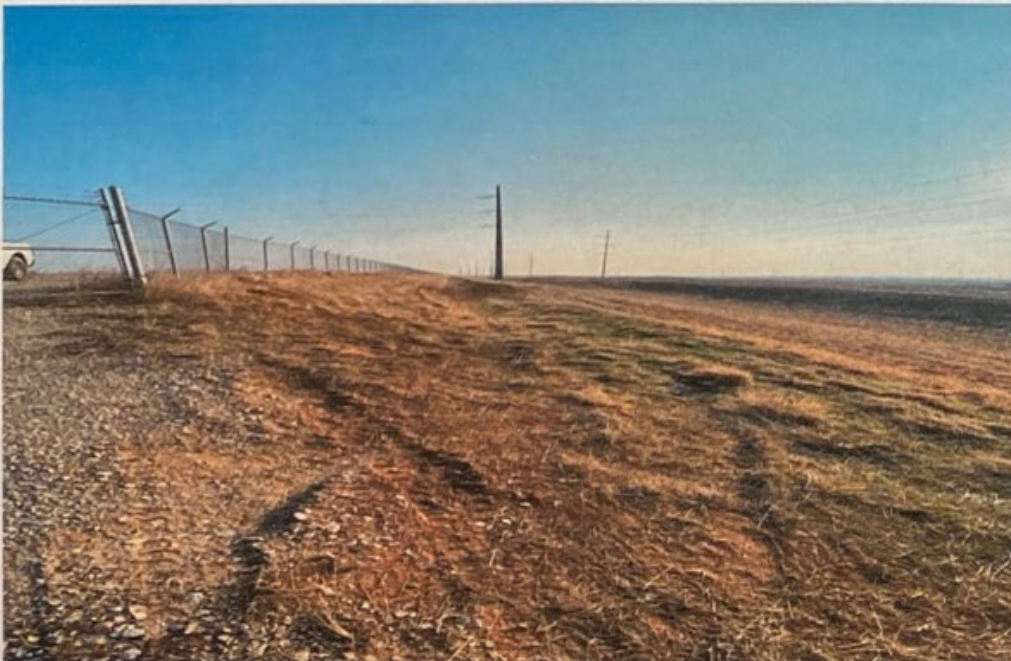
Photo #: 24

General condition of  
Pond 6 south exterior  
slope
