# **2021 ANNUAL DAM AND DIKE INSPECTION REPORT**

**CCR PONDS COMPLEX**

**Oklaunion Industrial Park LLC  
VERNON, TEXAS**

INSPECTION DATE December 10, 2021

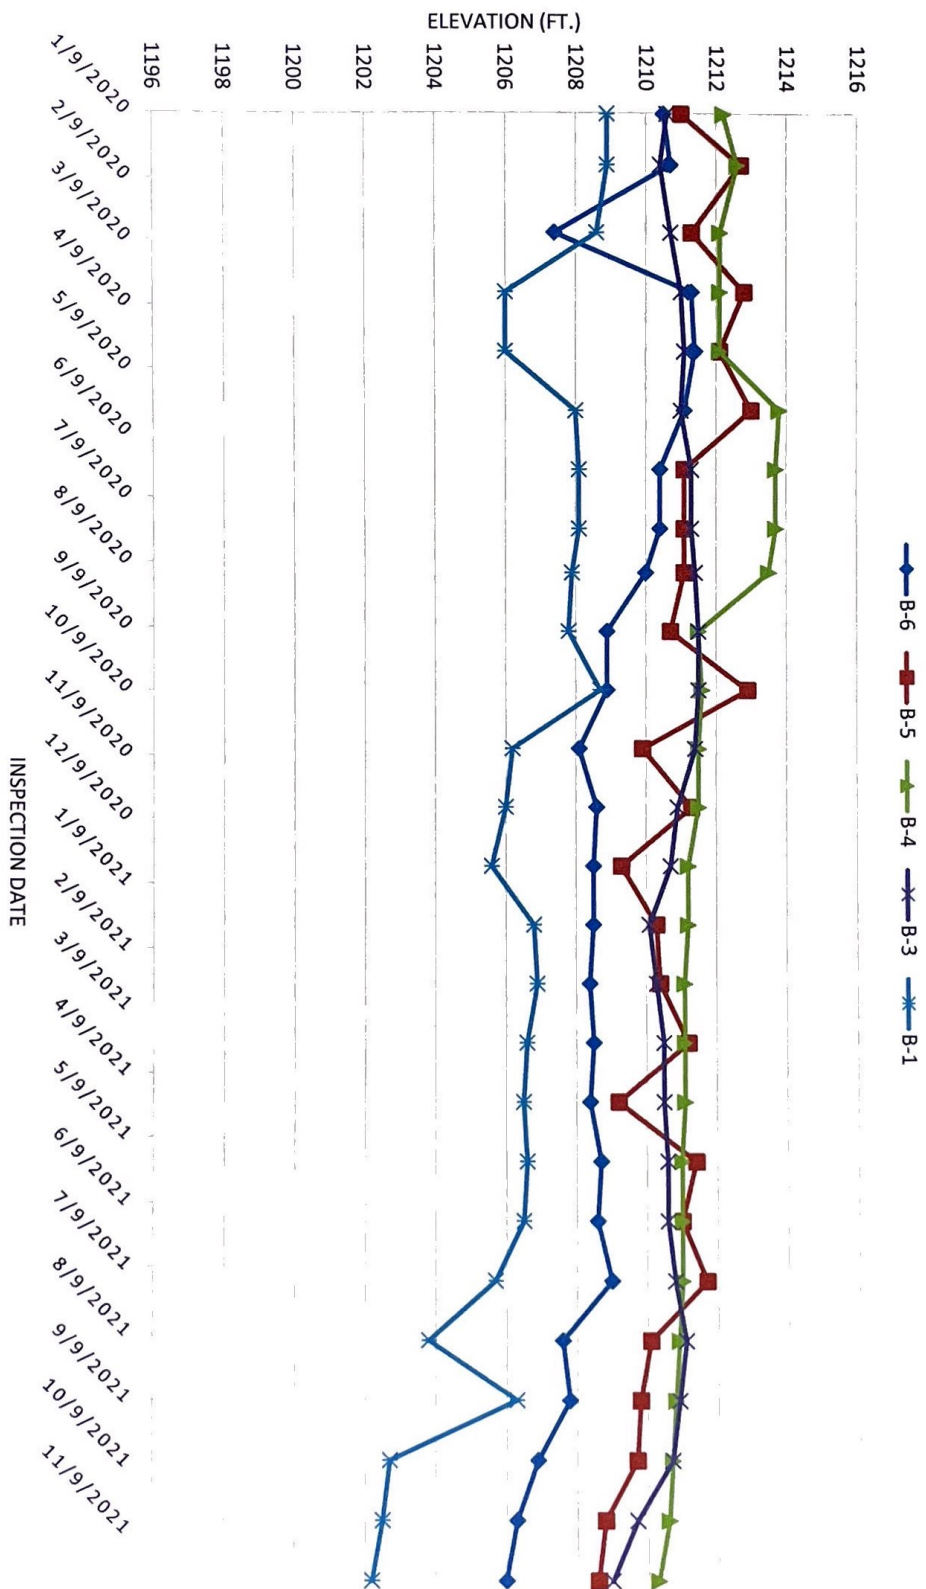
**FIGURE 4**  
**PIEZOMETER READINGS**  
**POND 21, 22, 23 & WWS P**

Five piezometers (B-1, B-3, B-4, and B-6) were installed in July 2016 around the Pond 21, 22, 23 and WWSP. Each piezometer was installed at the crest surrounding the ponds. Figure 4 shows the static water levels of those piezometers measured during monthly inspections beginning in August, 2016. Pond levels were not measured but are generally around 1213 feet. Over periods of monthly measurement data, the static water levels in the piezometers have indicated some fluctuations. All of the piezometers except B-5 indicate static water levels below the nominal pond pool level (1,213 feet). The elevated static water levels in B-5 are related to elevated pool levels in Ponds 21 and 22 due to operations.

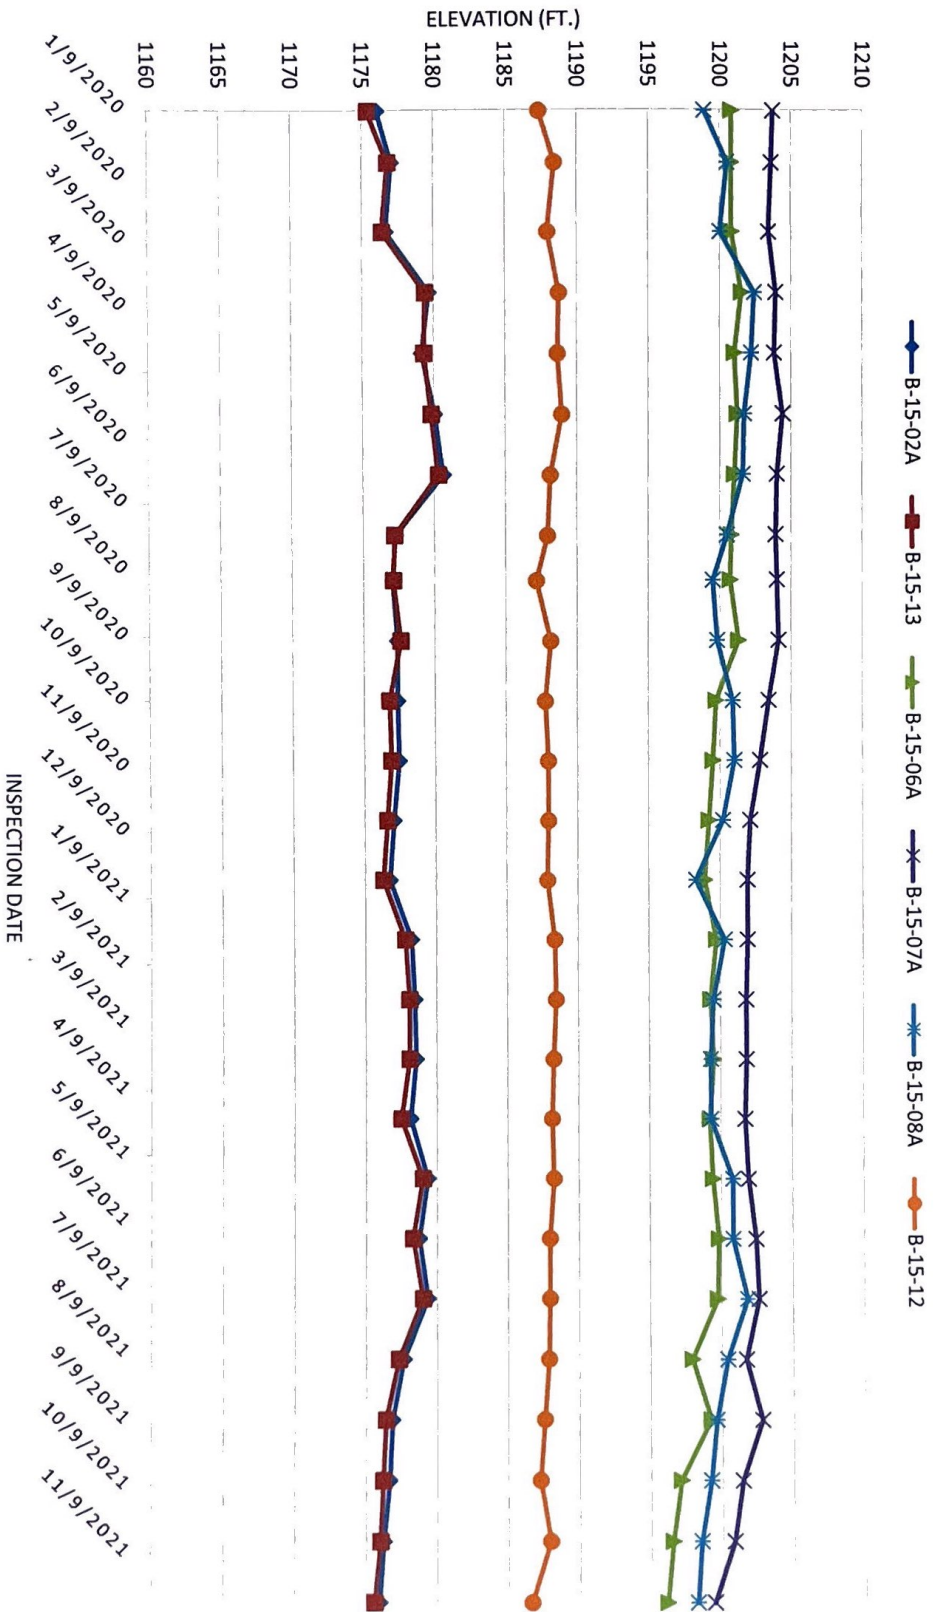
**FIGURE 5**  
**PIEZOMETER READINGS**  
**POND 6**

Piezometers (B-1502A, B-1506A, B-1507A, B-1508A, 81512, and 81513) were installed in various locations along the crest of Pond 6 as a part of the raising of the dikes in 2015. Figure 5 shows the static water levels of those piezometers measured during monthly plant inspections. Pond level was not measured but is estimated to be around elevation 1200 feet at the time of this inspection but it varies up to elevation 1213 during the year. All of the piezometers indicated static water levels below the maximum pond pool level (1213 feet). All piezometers indicated static water levels within expected tolerance for this year's readings.

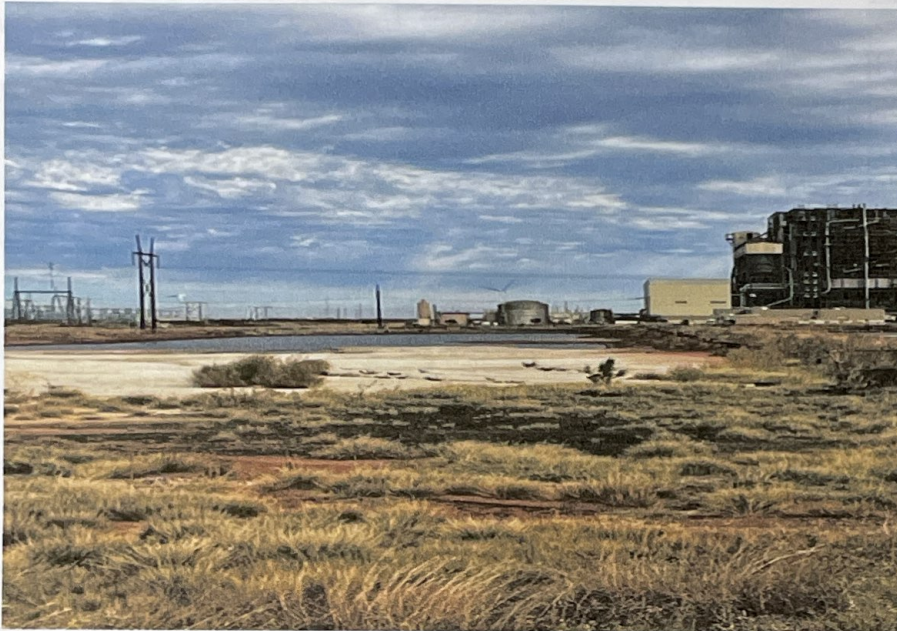
**Photo #:** 1

**Notes:** General condition of  
Pond 21

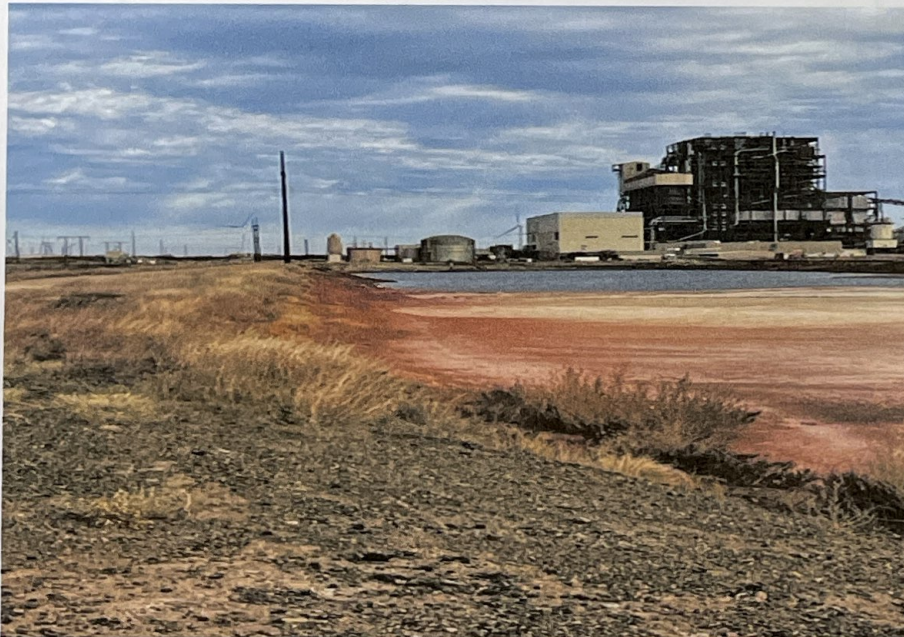
**Photo #:** 2

**Notes:** General condition of  
Pond 21 interior slope

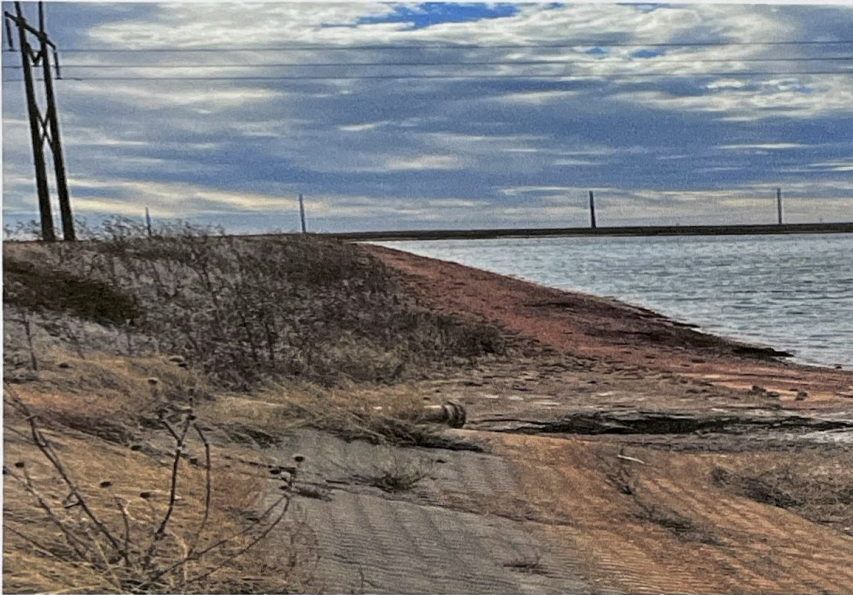
**Photo #:** 3

**Notes:** General condition of  
Pond 21 exterior slope  
common to Makeup  
Water Pond interior  
slope

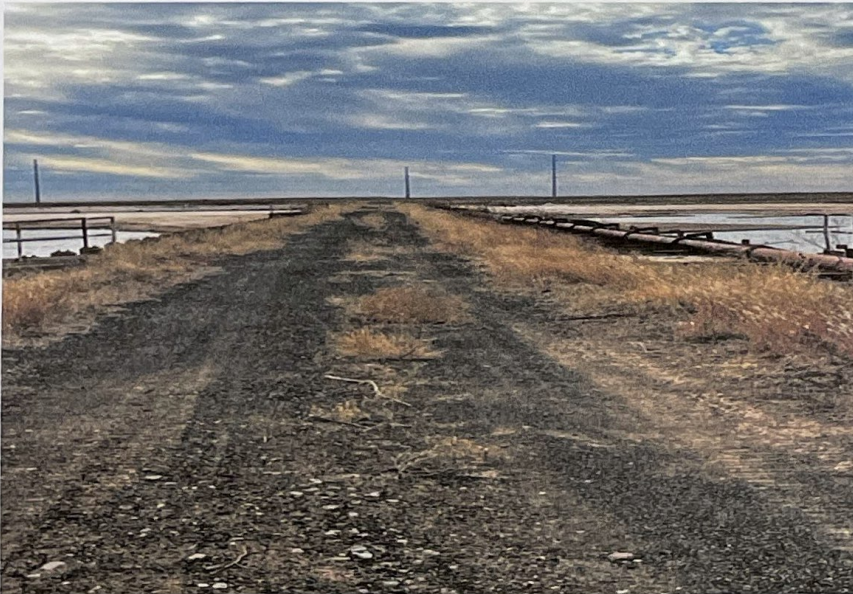
**Photo #:** 4

**Notes:** General condition of  
crest common to Pond  
21/22 Makeup Water Pond

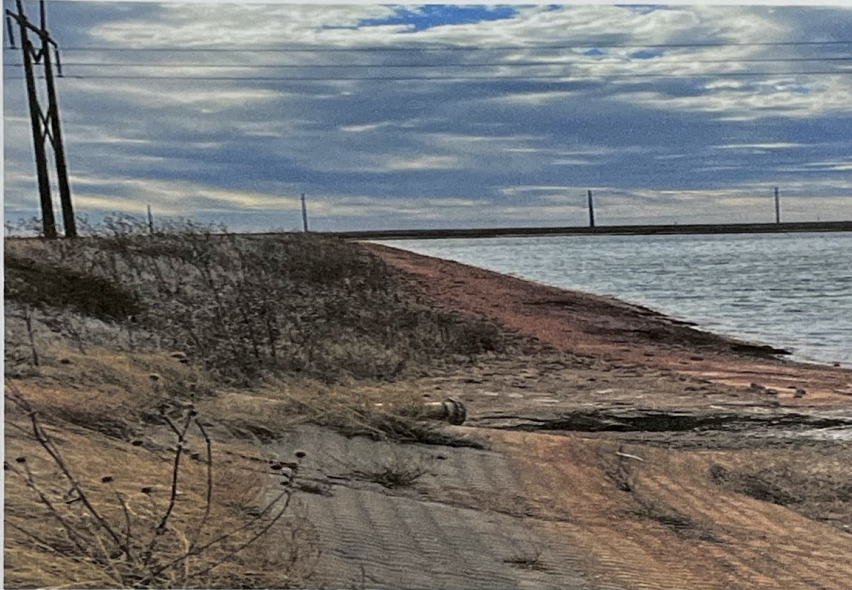
**Photo #:** 3

**Notes:** General condition of Pond 21 exterior slope common to Makeup Water Pond interior slope

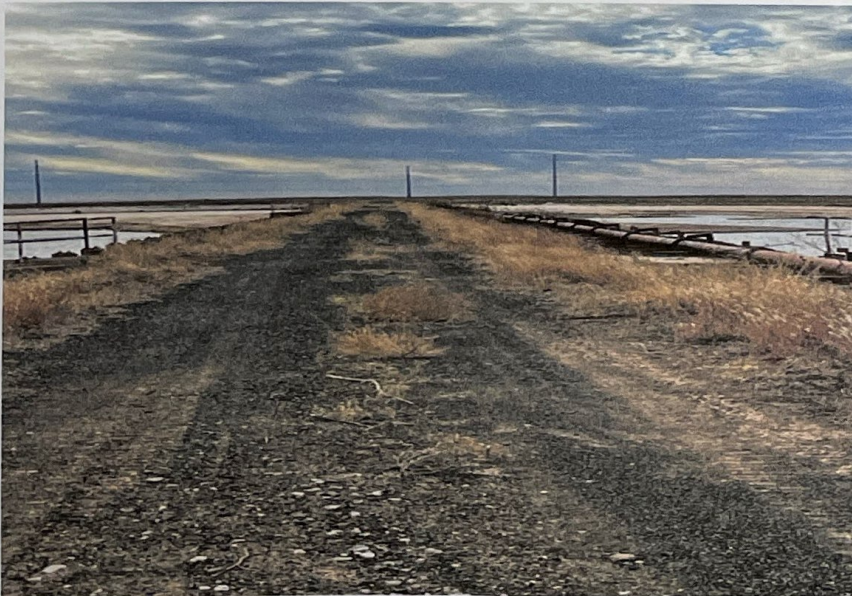
**Photo #:** 4

**Notes:** General condition of crest common to Pond 21/22 Makeup Water Pond

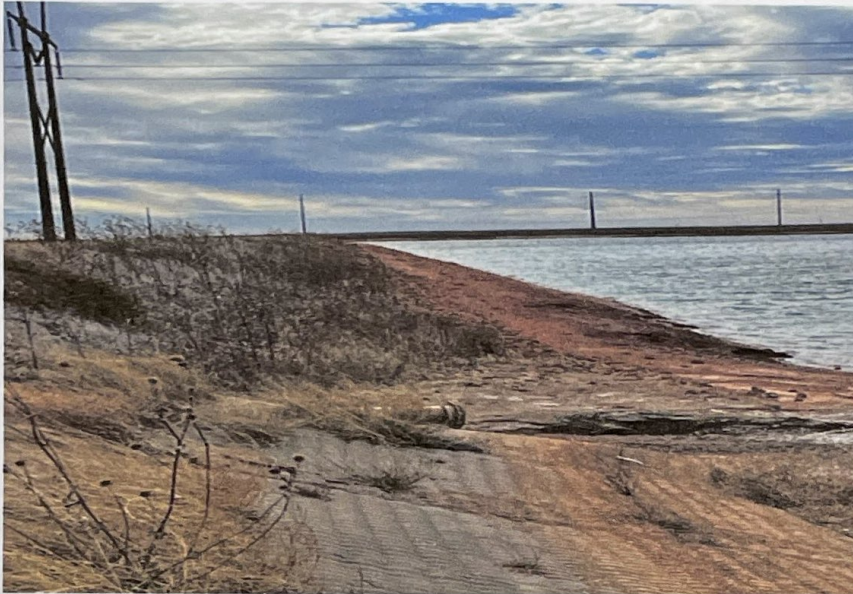
**Photo #:** 3

**Notes:** General condition of  
Pond 21 exterior slope  
common to Makeup  
Water Pond interior  
slope

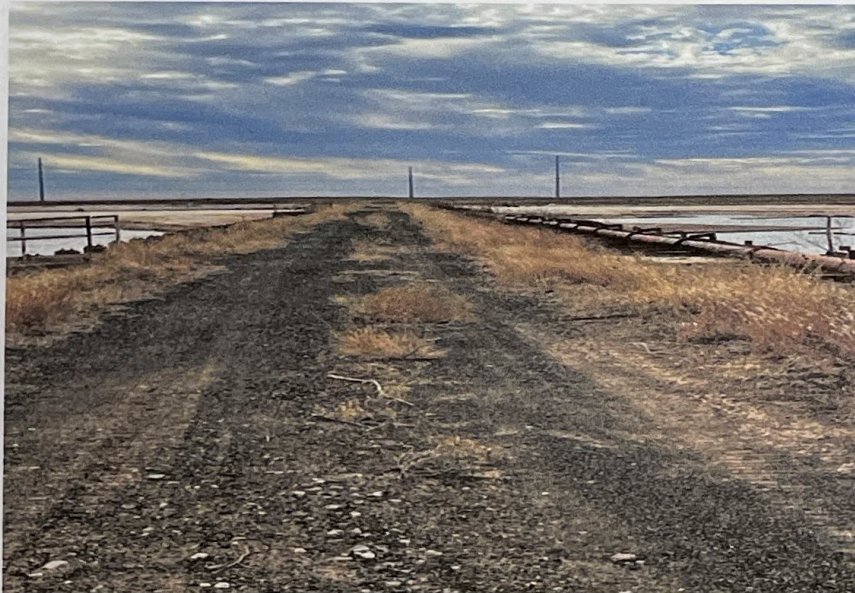
**Photo #:** 4

**Notes:** General condition of  
crest common to Pond  
21/22 Makeup Water Pond

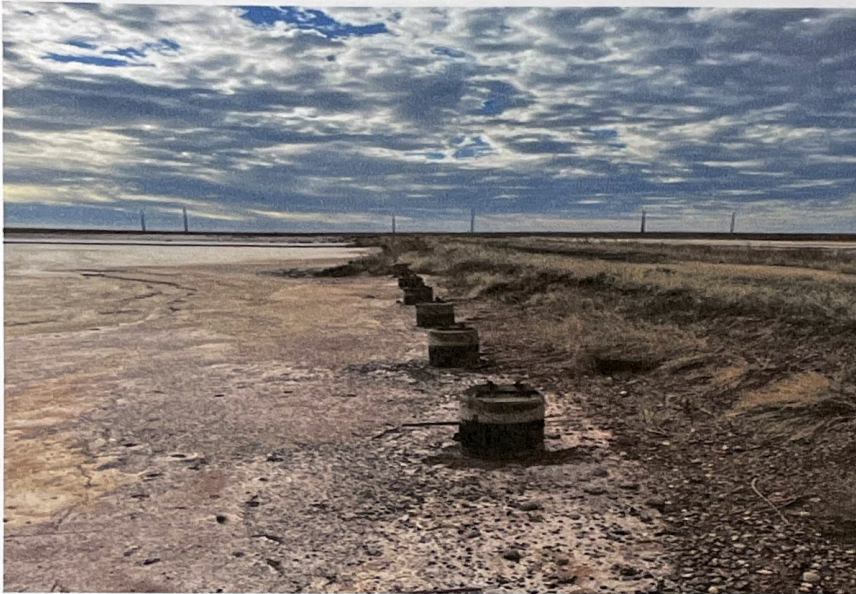
**Photo #:** 5

**Notes:** General condition of  
Pond 22 interior slope  
common to Pond 21  
exterior slope

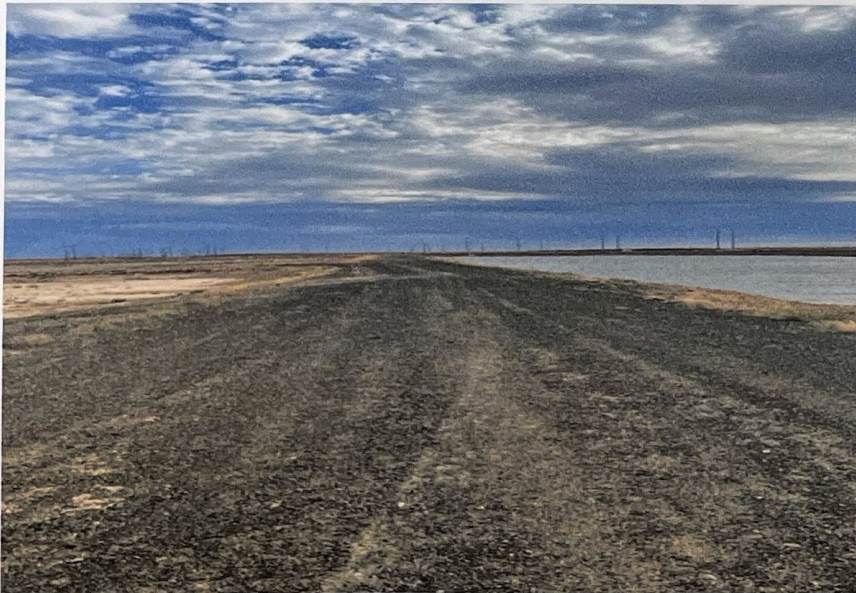
**Photo #:** 6

**Notes:** General condition of  
crest common to Pond  
22/Makeup Water Pond

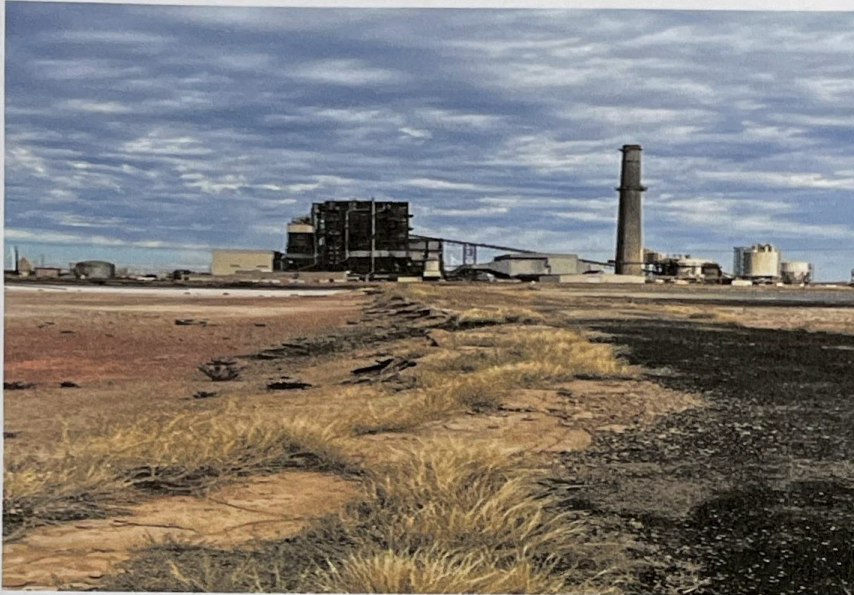
**Photo #:** 7

**Notes:** General condition of  
Pond 22 interior slope  
common to Pond 23  
exterior slope

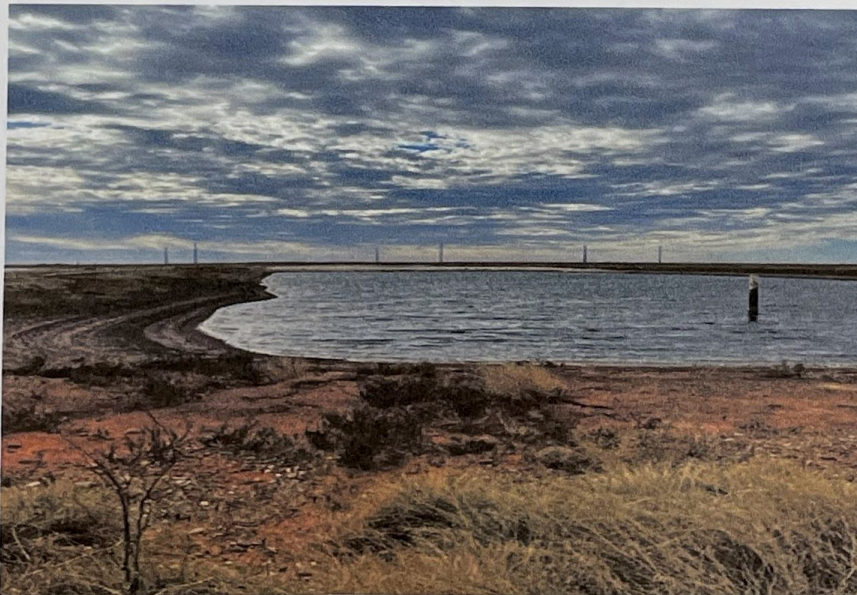
**Photo #:** 8

**Notes:** General condition of  
Pond 22

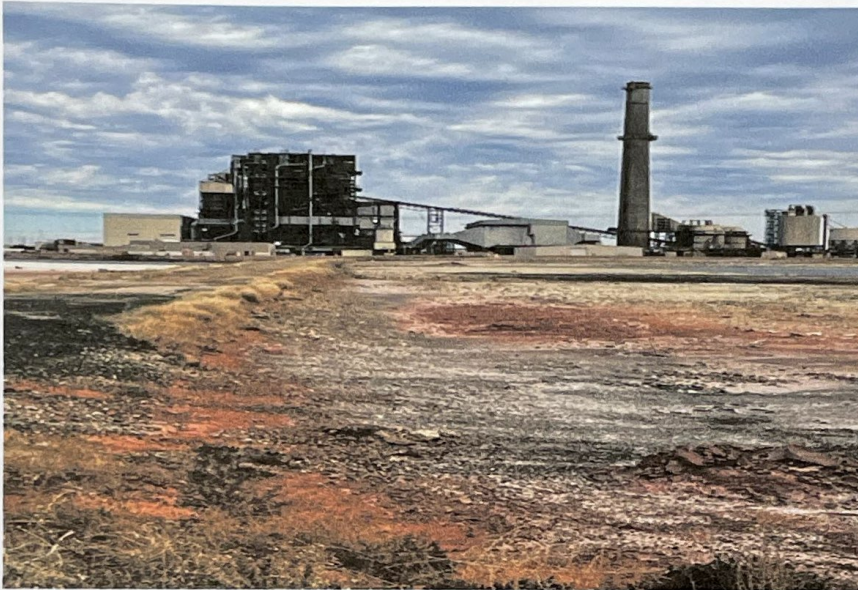
**Photo #:** 9

**Notes:** General condition of  
Pond 23

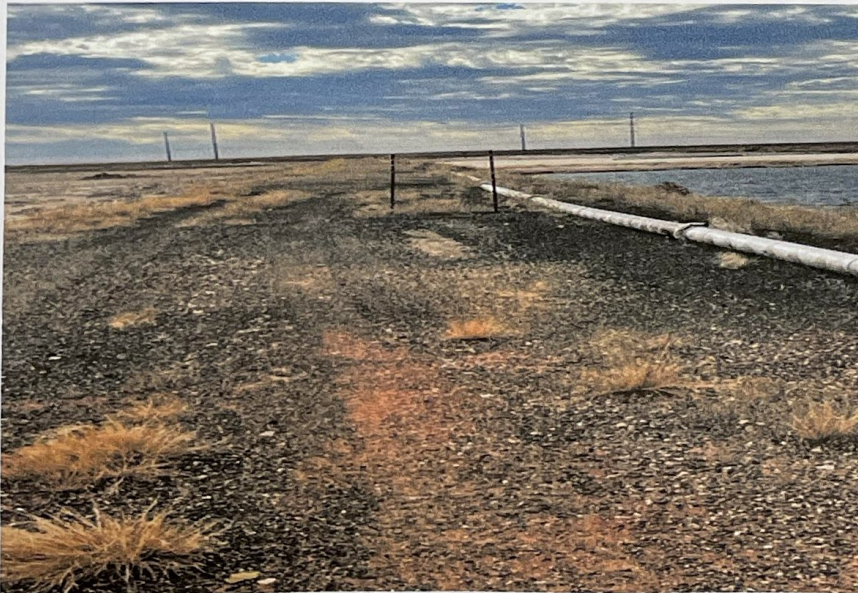
**Photo #:** 10

**Notes:** General condition of  
crest common to Ponds  
22/23

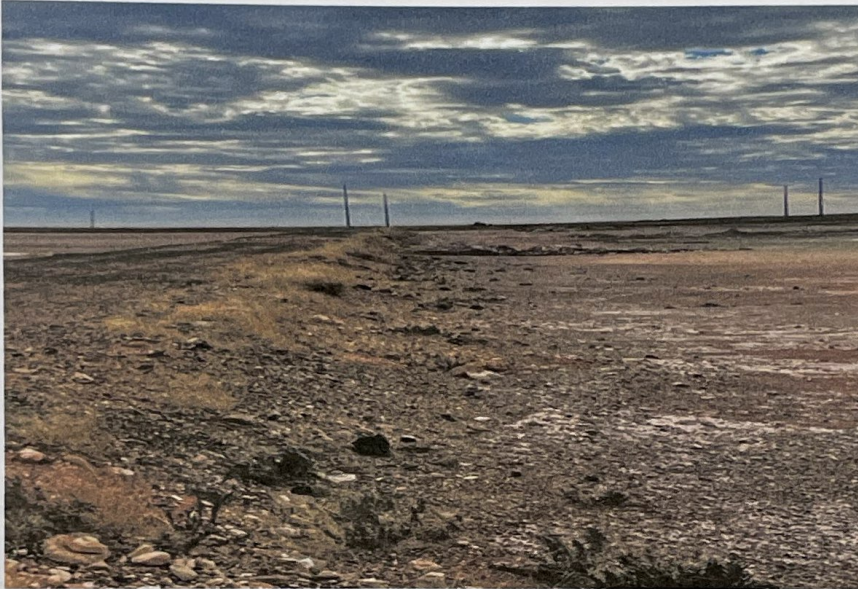
**Photo #:** 11

**Notes:** General condition of Pond 23 interior slope common to Waste Water Sludge Pond exterior slope

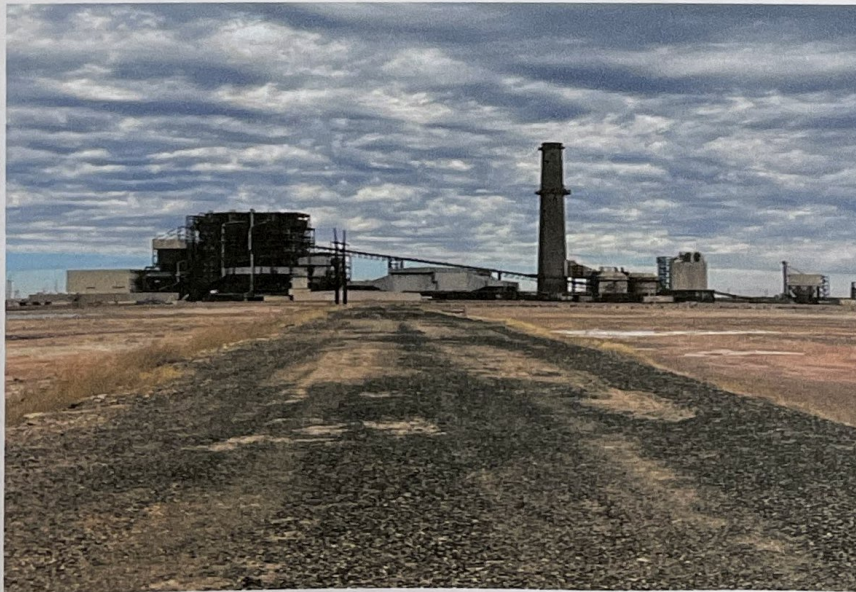
**Photo #:** 12

**Notes:** General condition of crest common to Ponds 23/Waste Water Sludge Pond

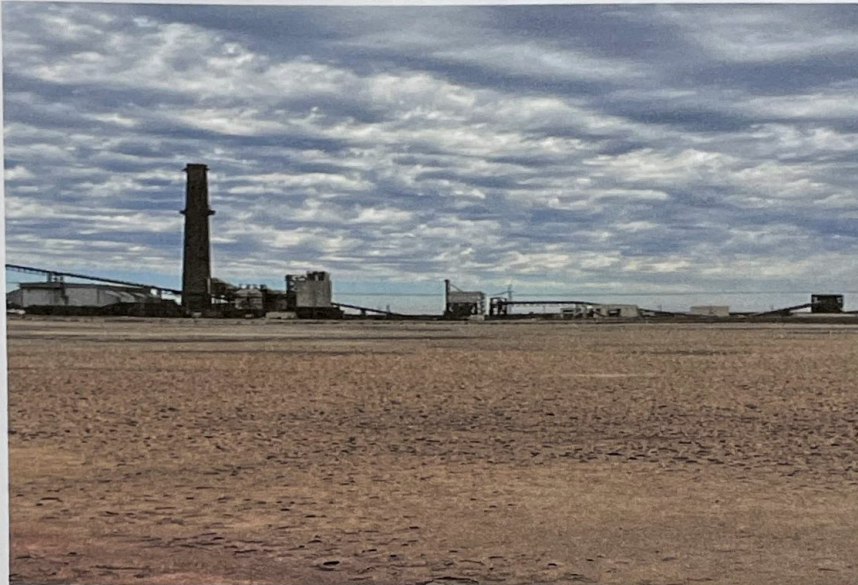
**Photo #:** 13

**Notes:** General condition of  
Waste Water Sludge  
Pond

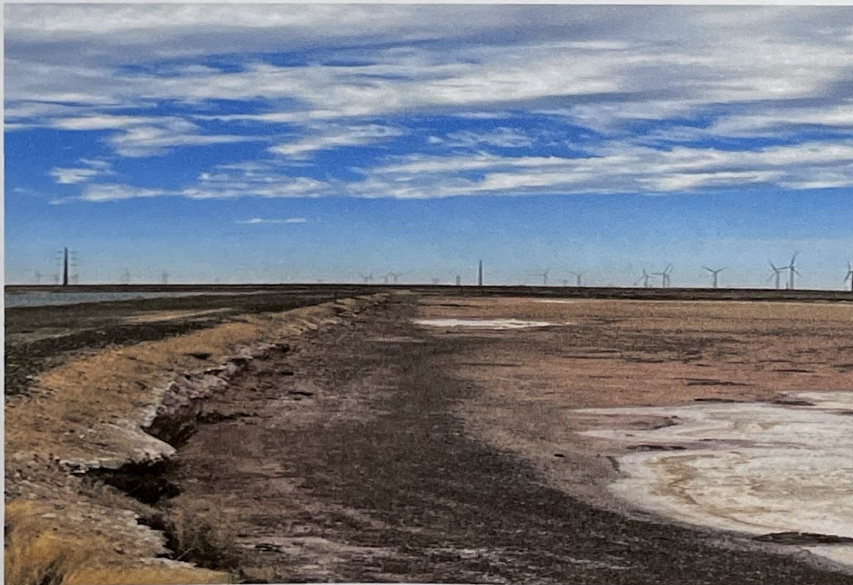
**Photo #:** 14

**Notes:** General condition of  
Waste Water Sludge  
Pond interior slope  
common to Makeup  
Water Pond

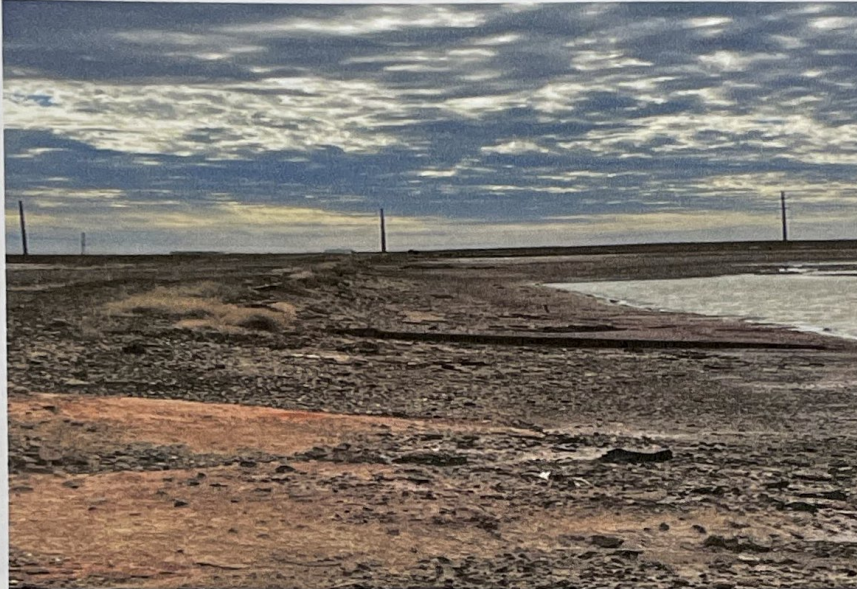
**Photo #:** 15

**Notes:** General condition of  
Waste Water Sludge  
Pond interior slope  
common to Pond 7

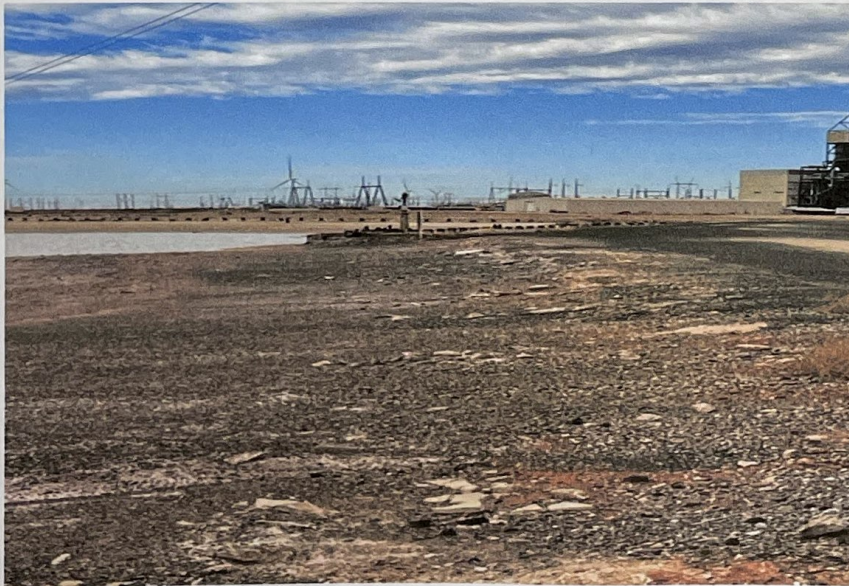
**Photo #:** 16

**Notes:** General condition of  
interior slopes of Waste  
Water Sludge Pond

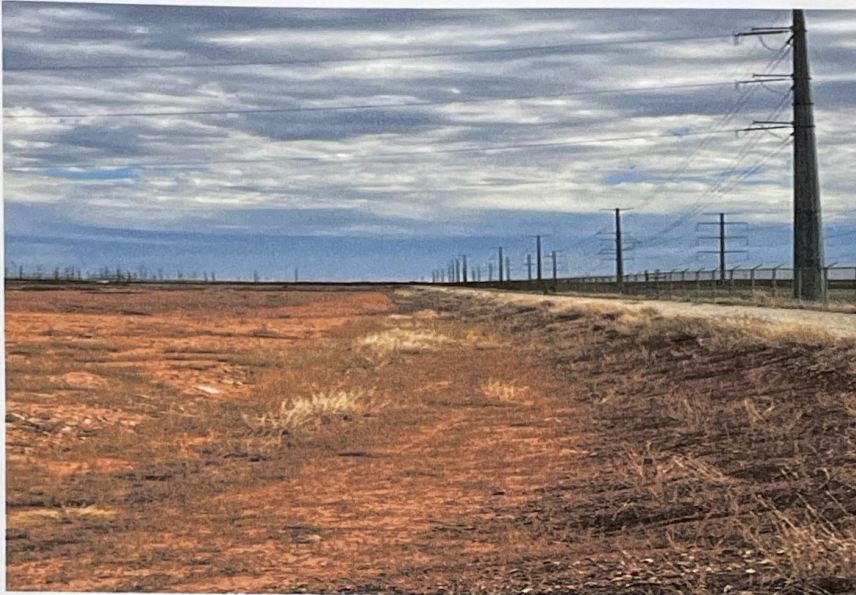
**Photo #:** 17

**Notes:** General condition of  
Pond 6 from SW corner

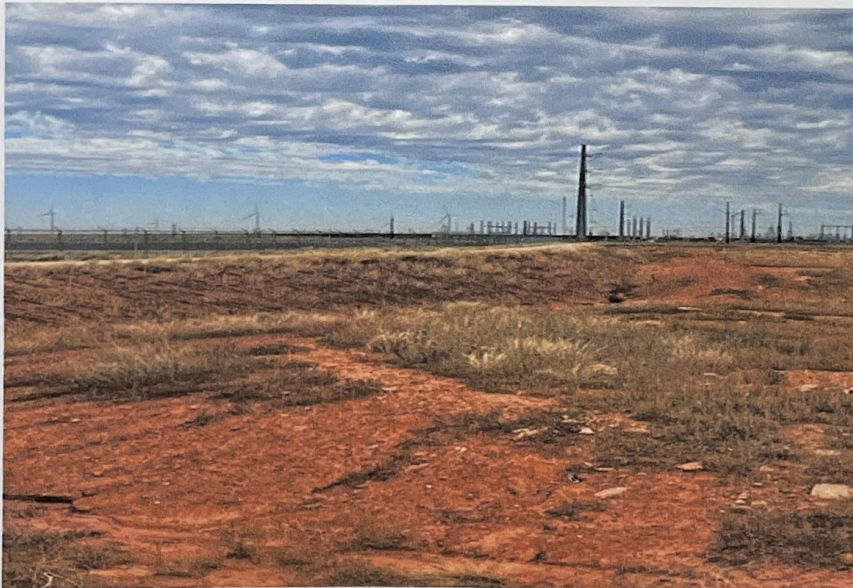
**Photo #:** 18

**Notes:** General condition of  
Pond 6 west interior  
slope and crest

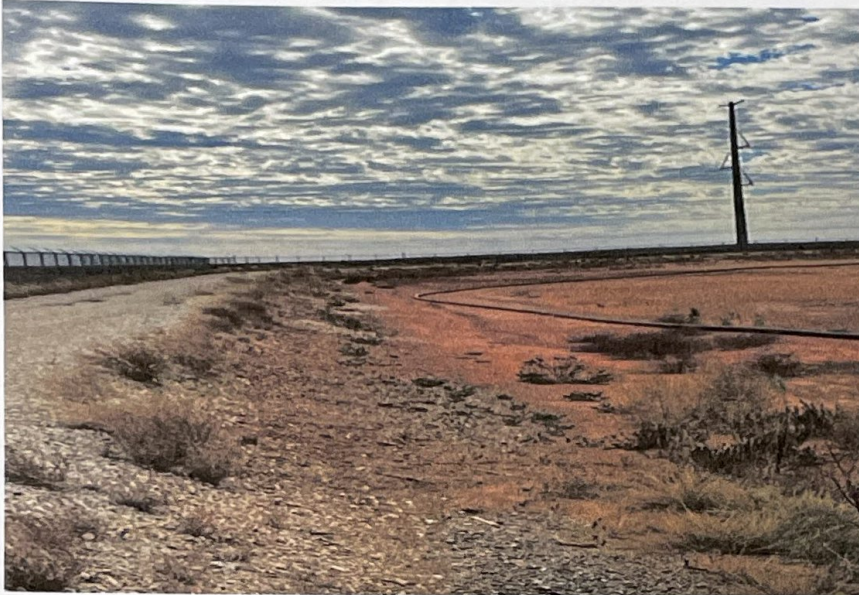
**Photo #:** 19

**Notes:** General condition of  
Pond 6 east interior  
slope and crest

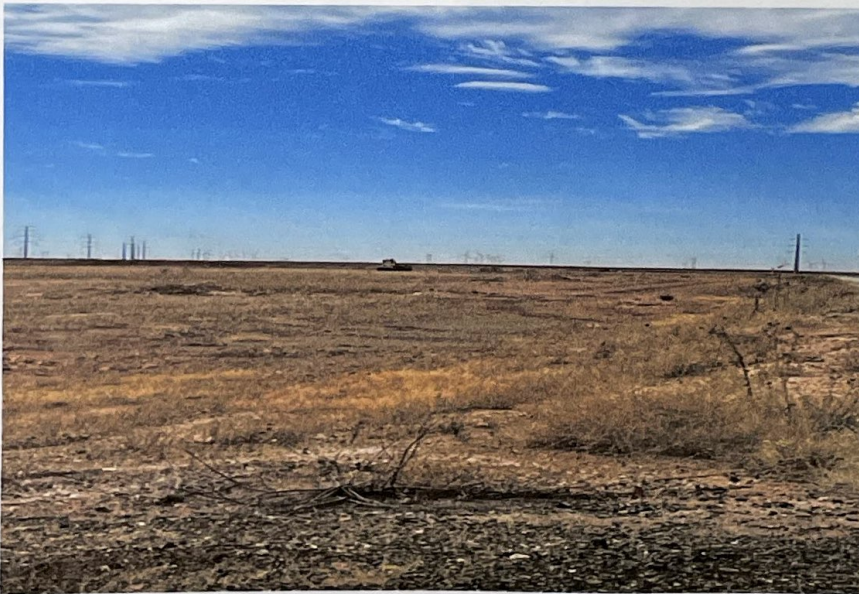
**Photo #:** 20

**Notes:** General condition of  
Pond 6 from NE corner

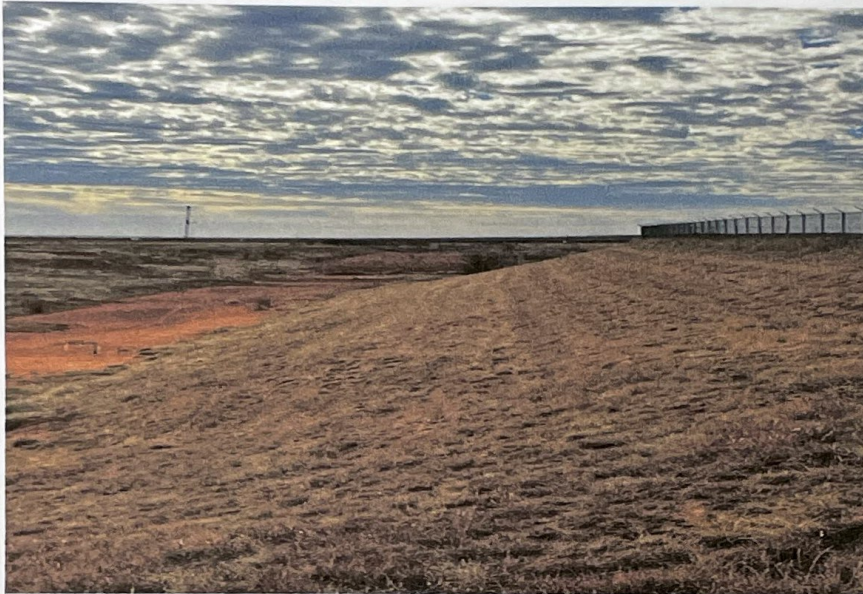
**Photo #:** 21

**Notes:** General condition of  
Pond 6 east interior  
slope

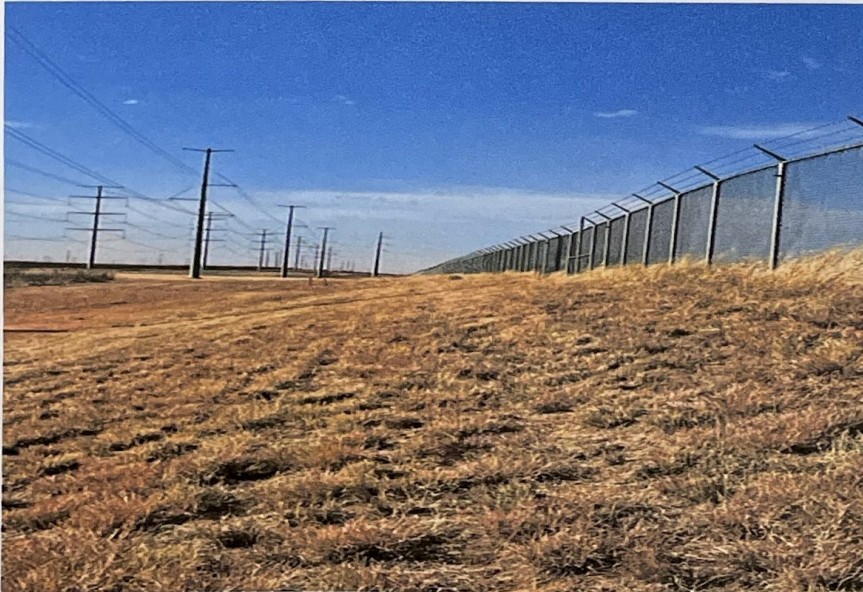
**Photo #:** 22

**Notes:** General condition of  
Pond 6 south exterior  
slope

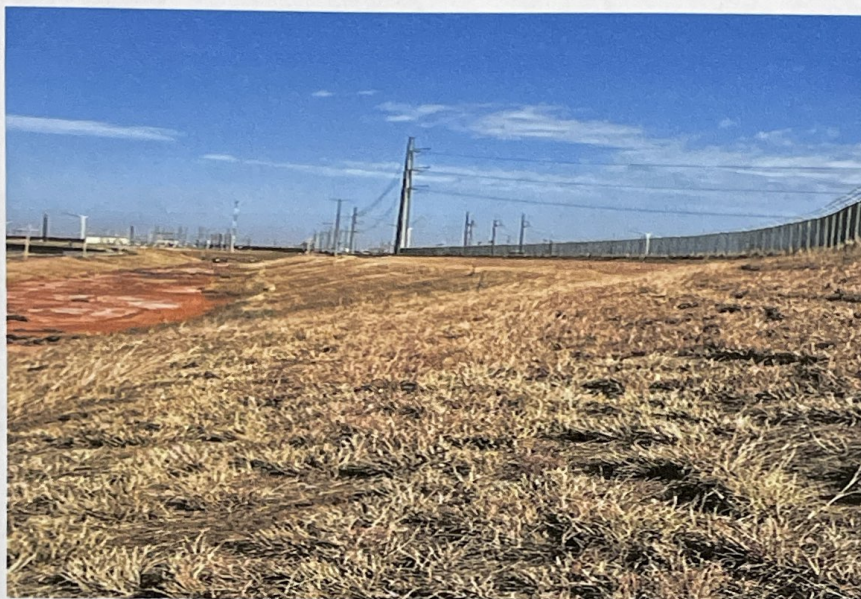
**Photo #:** 23

**Notes:** General condition of  
Pond 6 west exterior  
slope

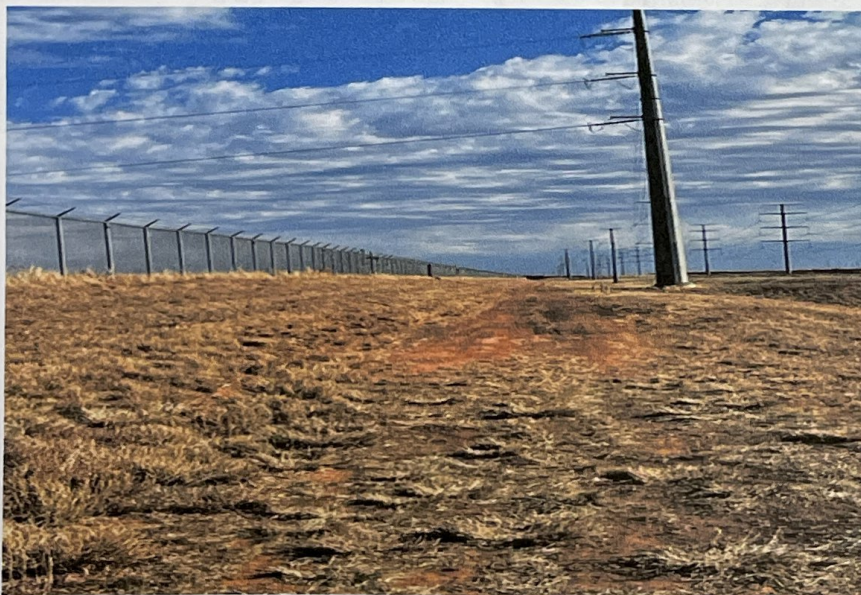
**Photo #:** 24

**Notes:** General condition of  
Pond 6 south exterior  
slope
