OKLAUNION INDUSTRIAL PARK, LLC

2023 ANNUAL DAM AND DIKE INSPECTION REPORT

CCR PONDS COMPLEX
PROJECT NO. 135110

REVISION 0
FEBRUARY 2024

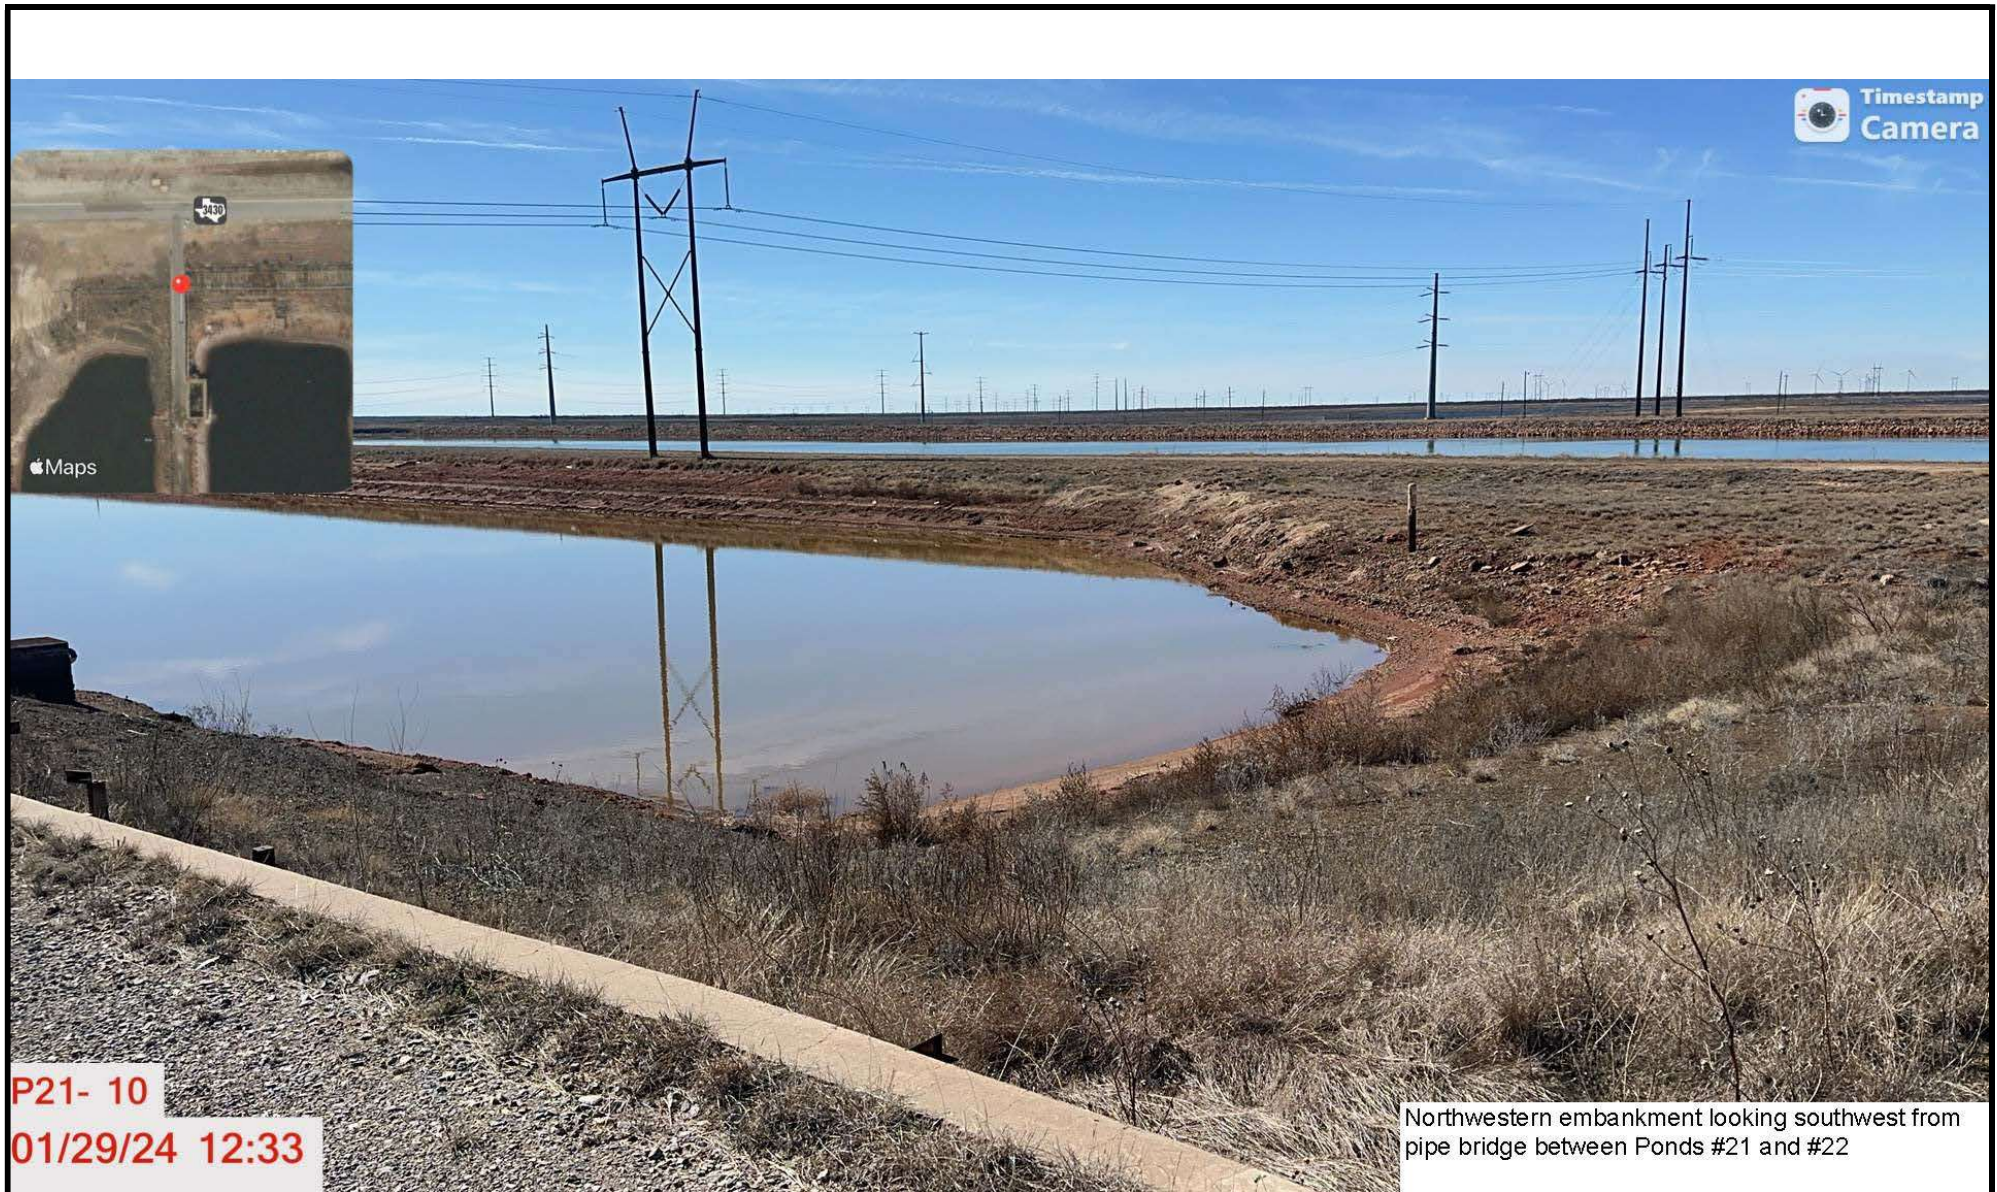
P21- 10
01/29/24 12:33

Northwestern embankment looking southwest from
pipe bridge between Ponds #21 and #22

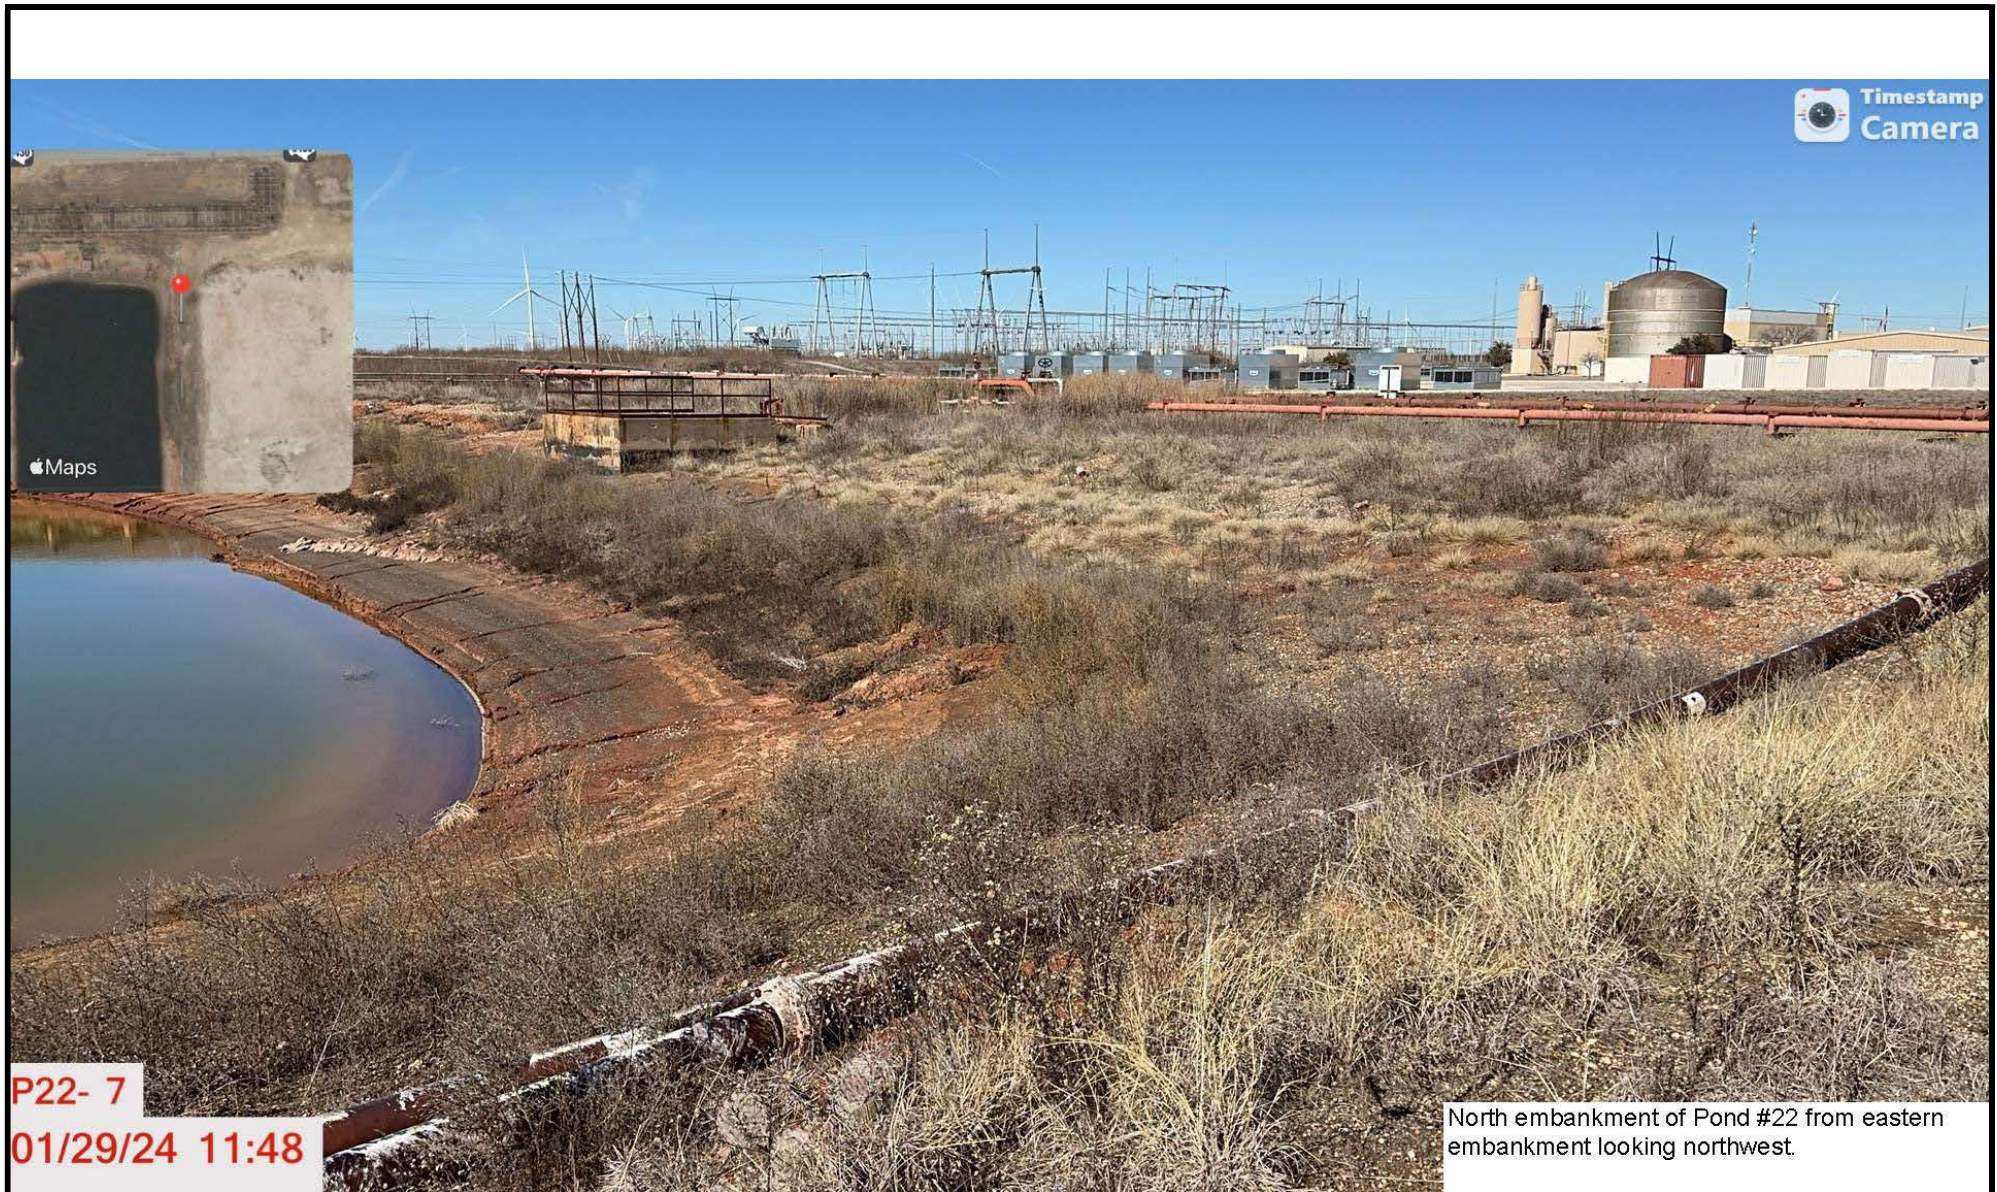
P22- 7
01/29/24 11:48

North embankment of Pond #22 from eastern embankment looking northwest.

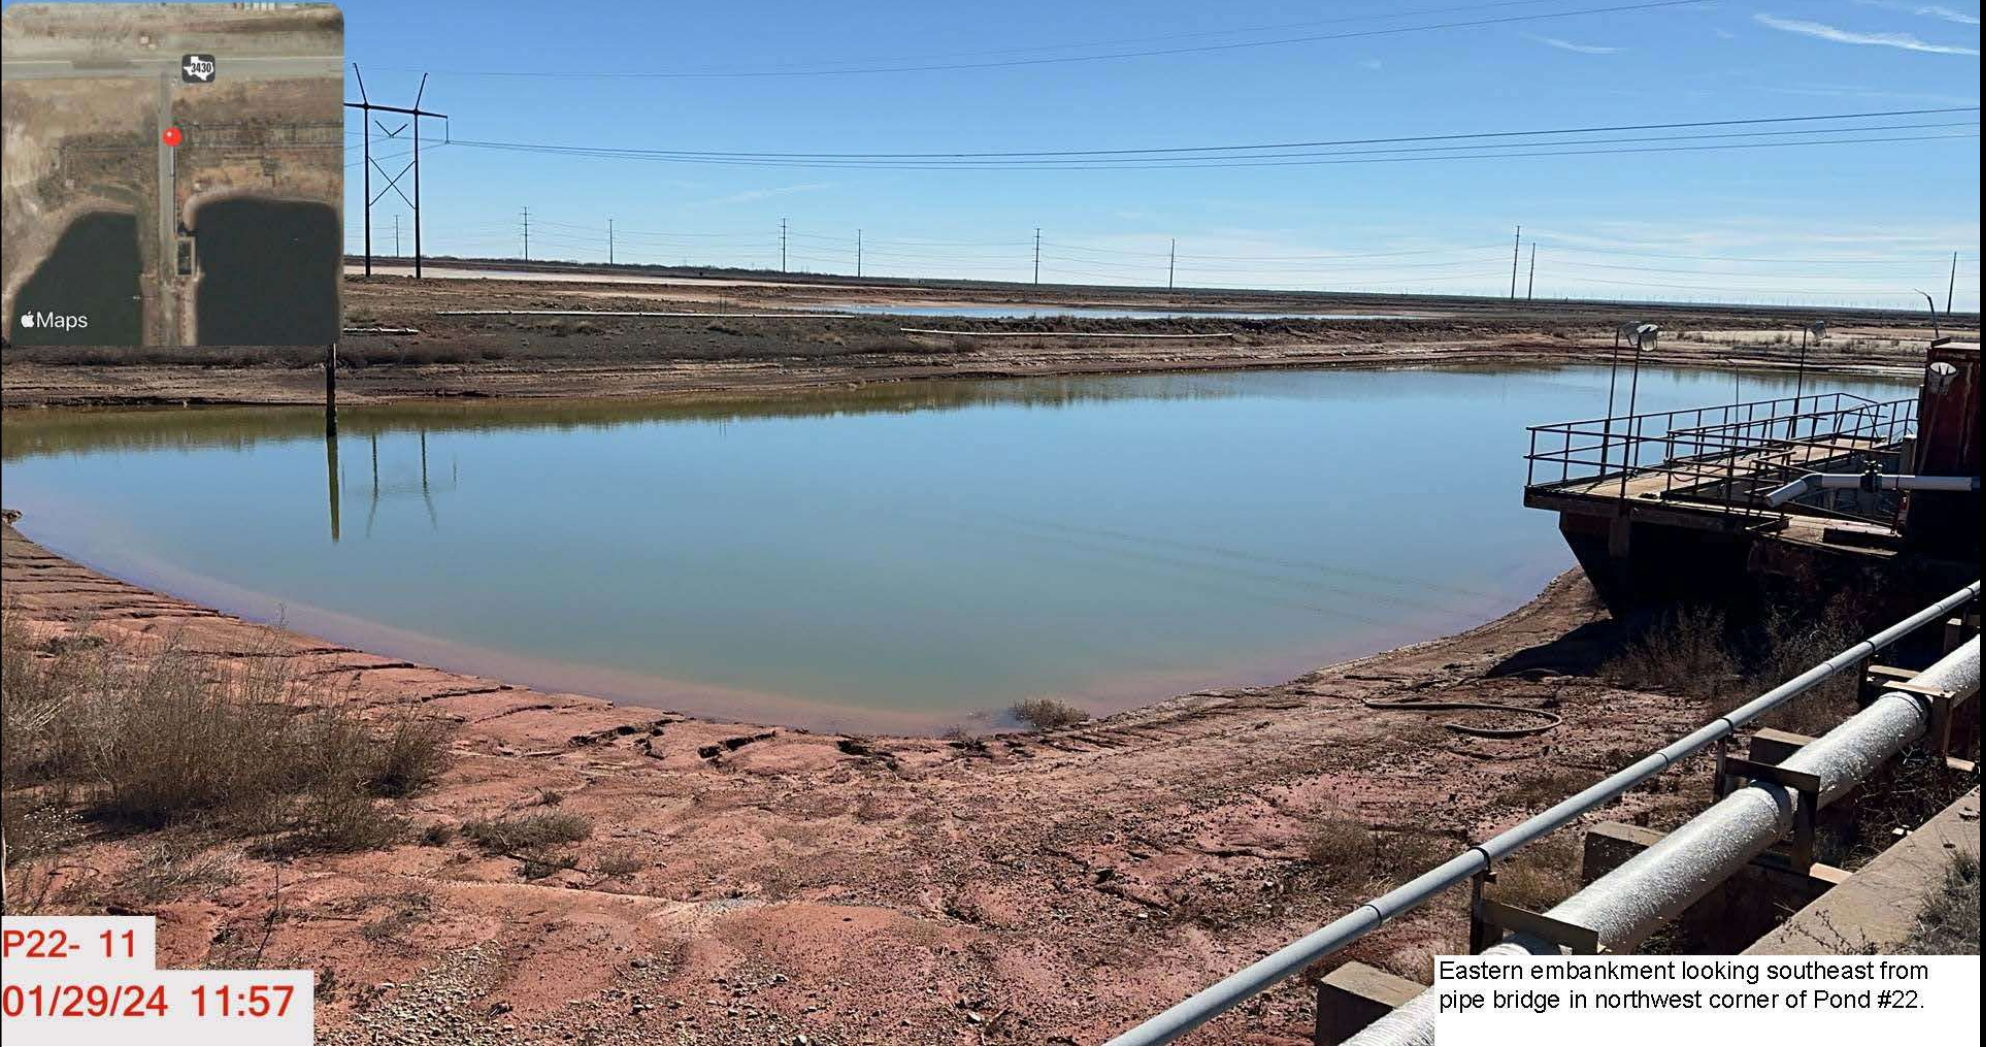
P22- 11
01/29/24 11:57

Eastern embankment looking southeast from
pipe bridge in northwest corner of Pond #22.

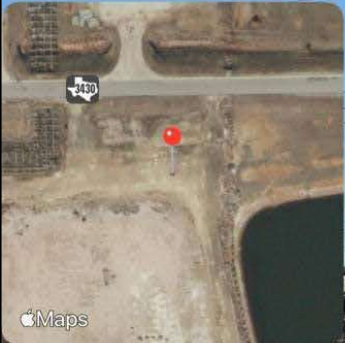
P23- 8
01/29/24 11:25

Eastern embankment looking south from NE corner of pond 23.

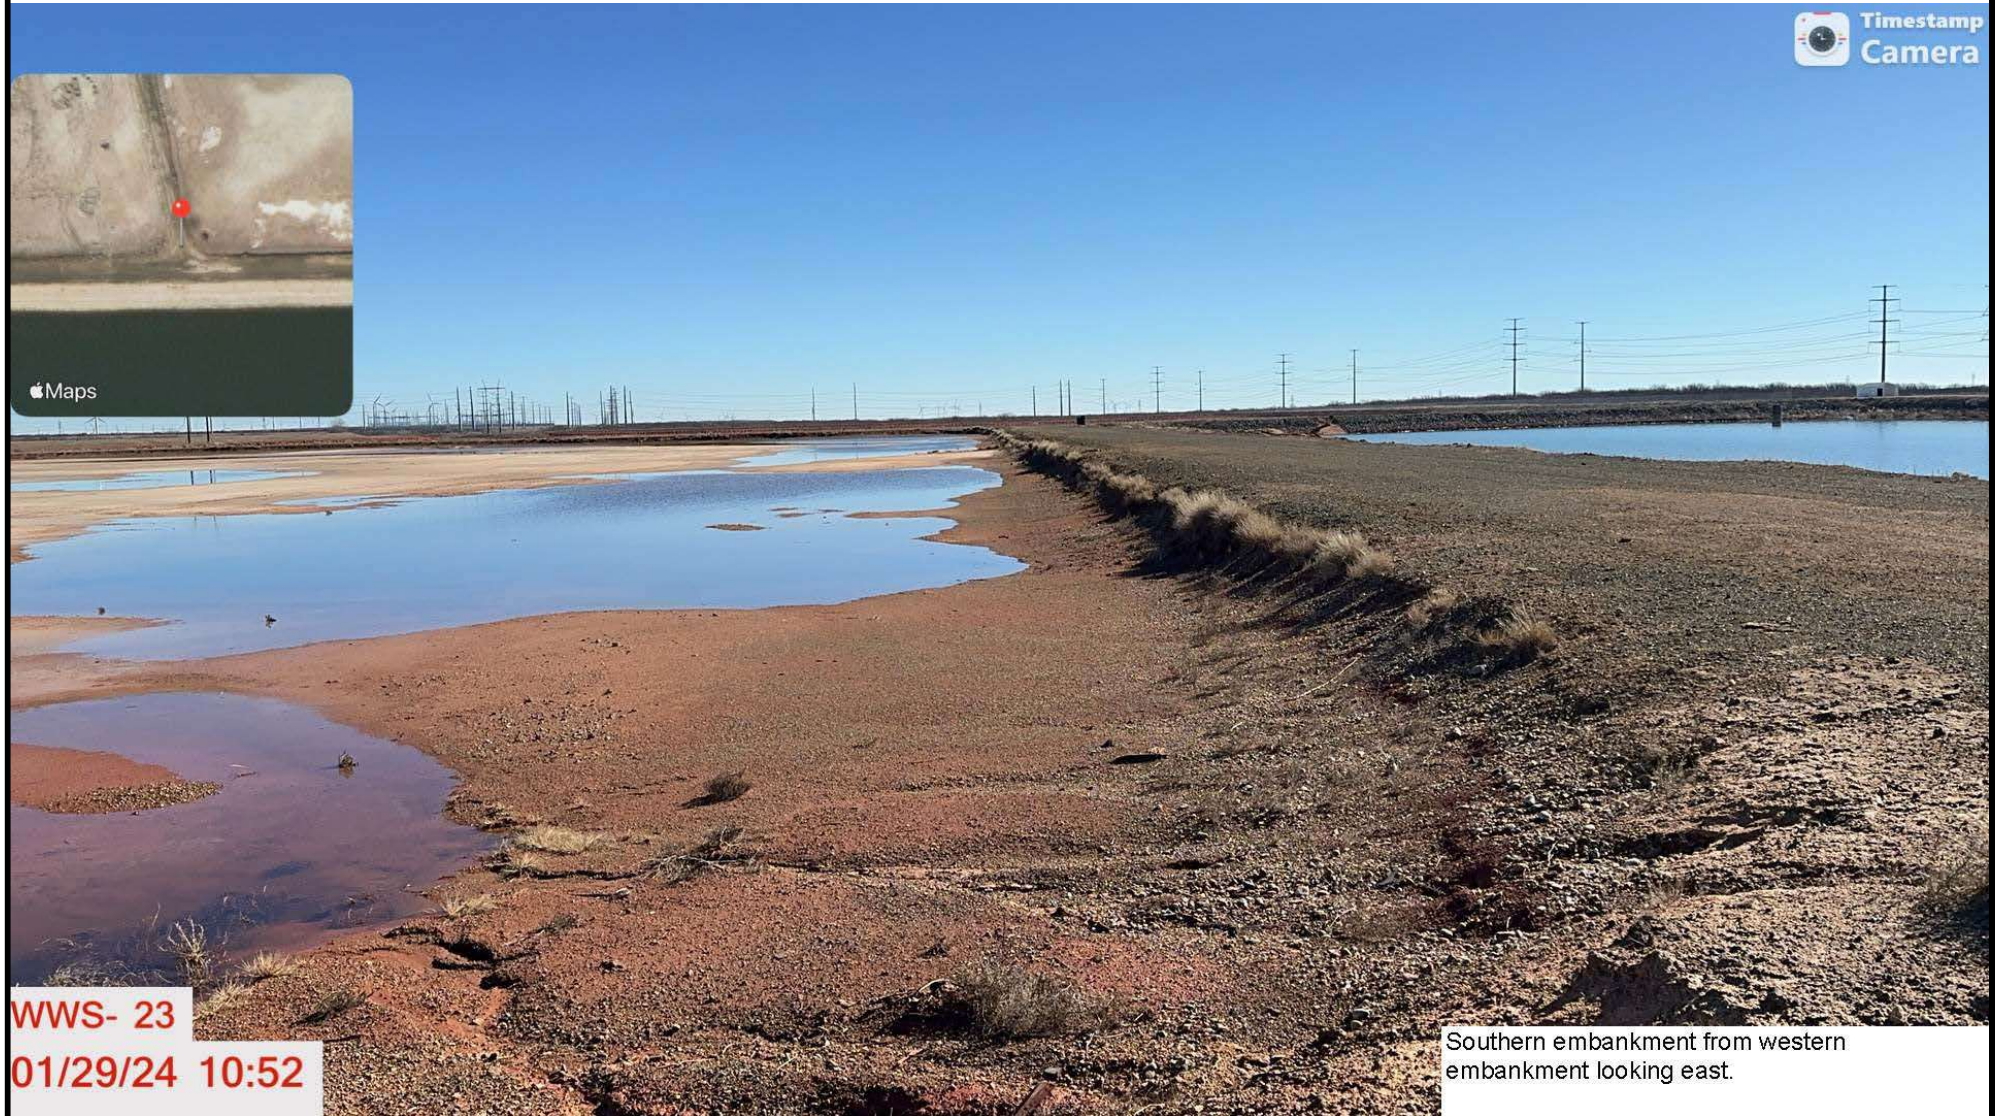
WWS- 23
01/29/24 10:52

Southern embankment from western
embankment looking east.
