# **2017 ANNUAL DAM AND DIKE INSPECTION REPORT**

**CCR PONDS COMPLEX**

**OKLAUNION POWER STATION  
VERNON, TEXAS**

**November, 2017**

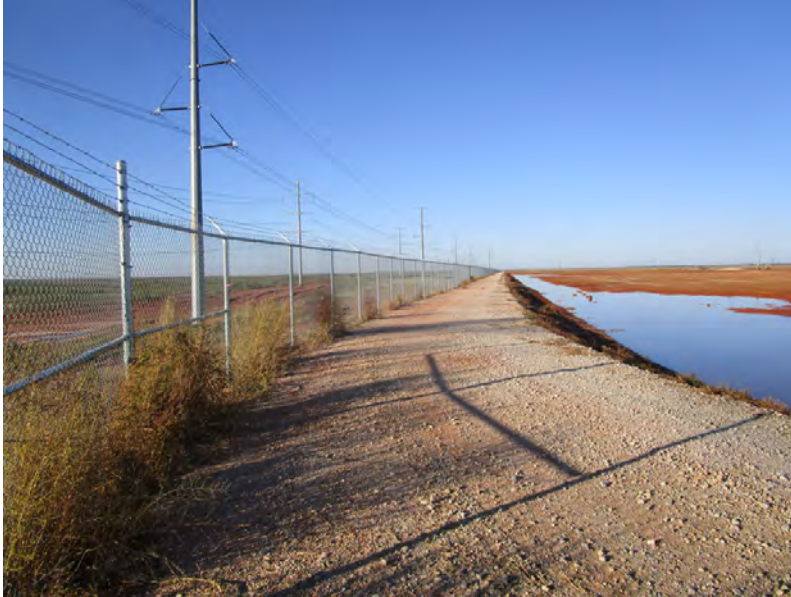
### Photo #3

The eastern slope of Pond #6 is also the western slope of the Pond #7 spillway discharge channel. The channel was in fair condition. The spillway of the adjacent Pond #7 has been substantially blocked and no discharge can occur. However, the discharge channel below, shown in Observation 2, Photo #3 and #4, also receives runoff from the surrounding area and should be monitored for erosion as part of the periodic visual inspections.
