OKLAUNION INDUSTRIAL PARK, LLC

2023 ANNUAL DAM AND DIKE INSPECTION REPORT

CCR PONDS COMPLEX
PROJECT NO. 135110

REVISION 0
FEBRUARY 2024

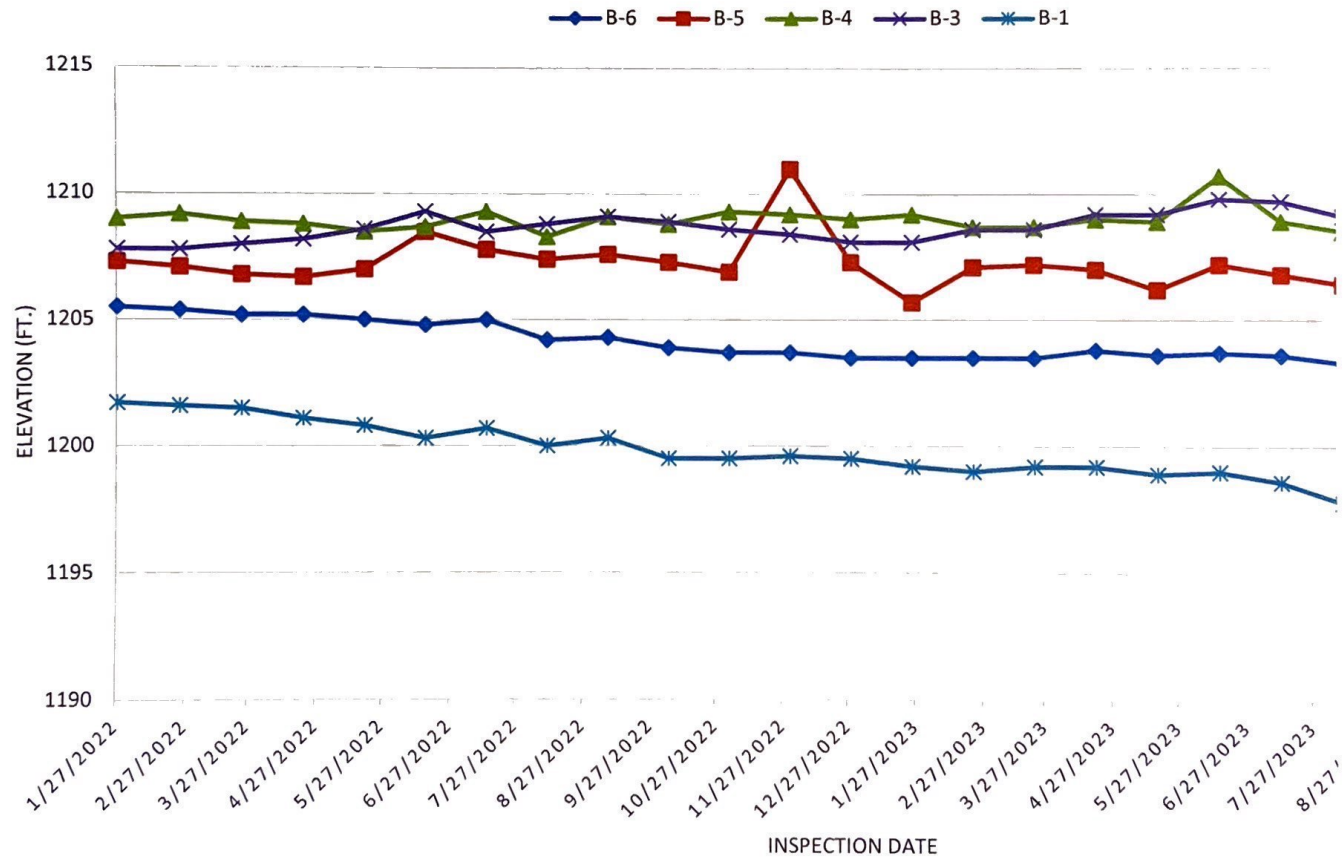
FIGURE 4
PIEZOMETER READINGS
POND 21, 22, 23 & WWSP

Five piezometers (B-1, B-3, and B-6) were installed in July 2016 around the Pond 21, 22, 23 and WWSP. Each piezometer was installed at the crest surrounding the ponds. **Figure 4** shows the static water levels of those piezometers measured during monthly inspections beginning in August 2016. Pond levels were not measured but are generally around 1213 feet. Over periods of monthly measurement data, the static water levels in the piezometers have indicated some fluctuations. All the piezometers except B-5 indicate static water levels below the nominal pond pool level (1, 2, 13 feet). The elevated static water levels in B-5 are related to elevated pool levels in Ponds 21 and 22 due to operations.

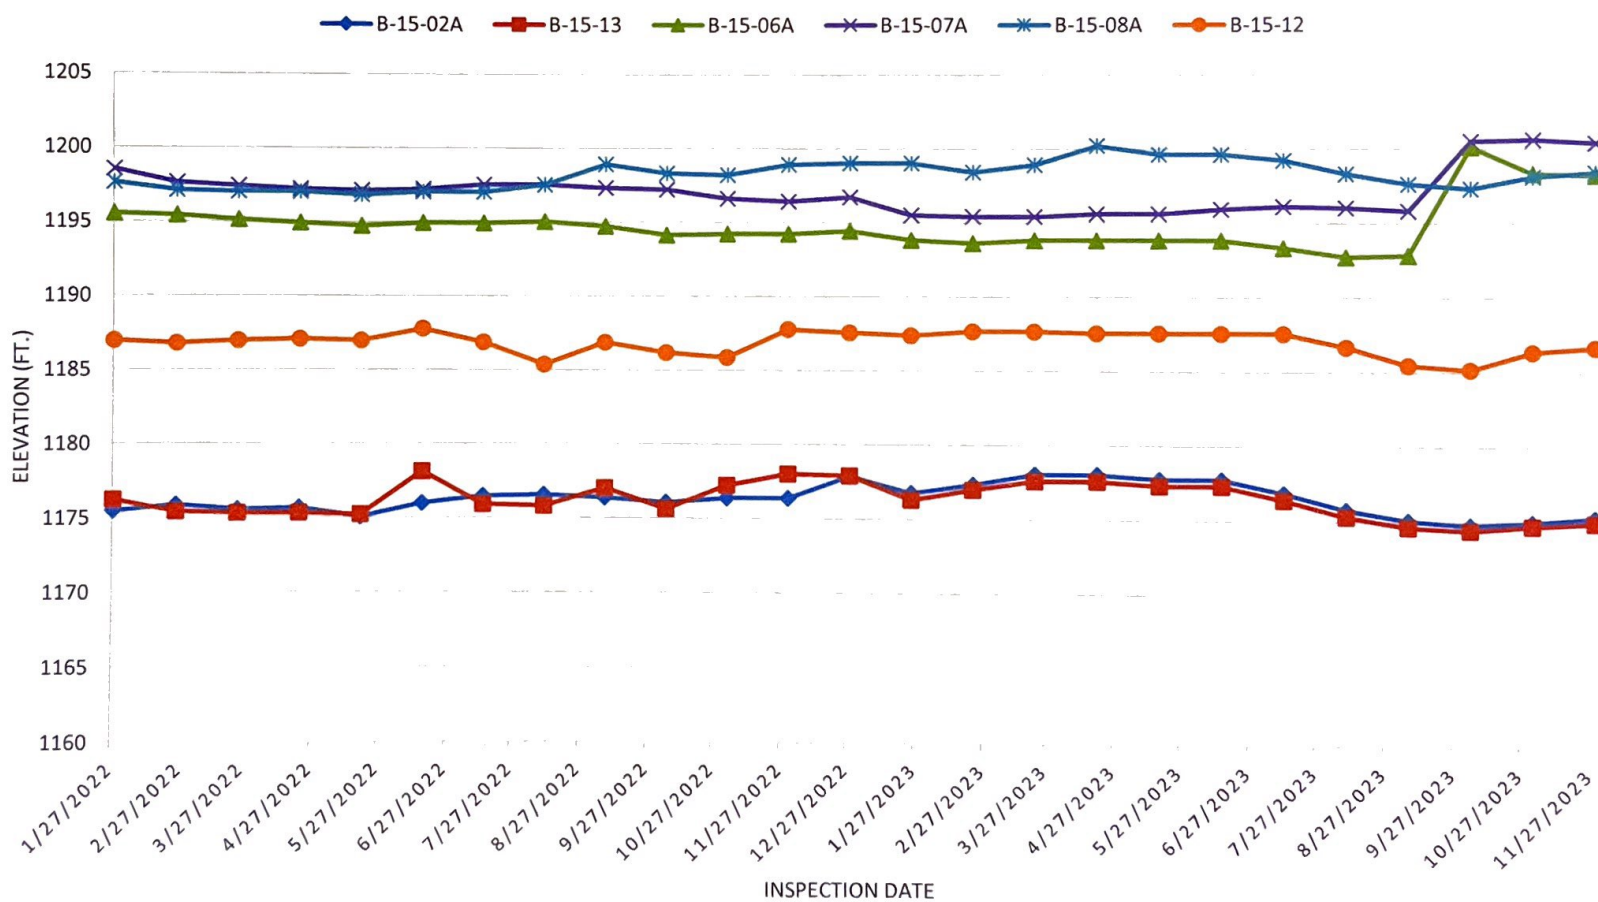
**FIGURE 5
PIEZOMETER READINGS
POND 6**

Piezometers (B-1502A, B-1506A, B-1507A, B-1508, 81512, and 81513) were installed in various locations along the crest of Pond 6 as a plan of raising the dikes in 2015. **Figure 5** shows the static water levels of those piezometers measured during monthly plant inspections. The pond level was not measured but is estimated to be around elevation 1200 feet at the time of this inspection, but it varies up to elevation 1213 during the year. All piezometers indicated static water levels within expected tolerance for this year's readings.

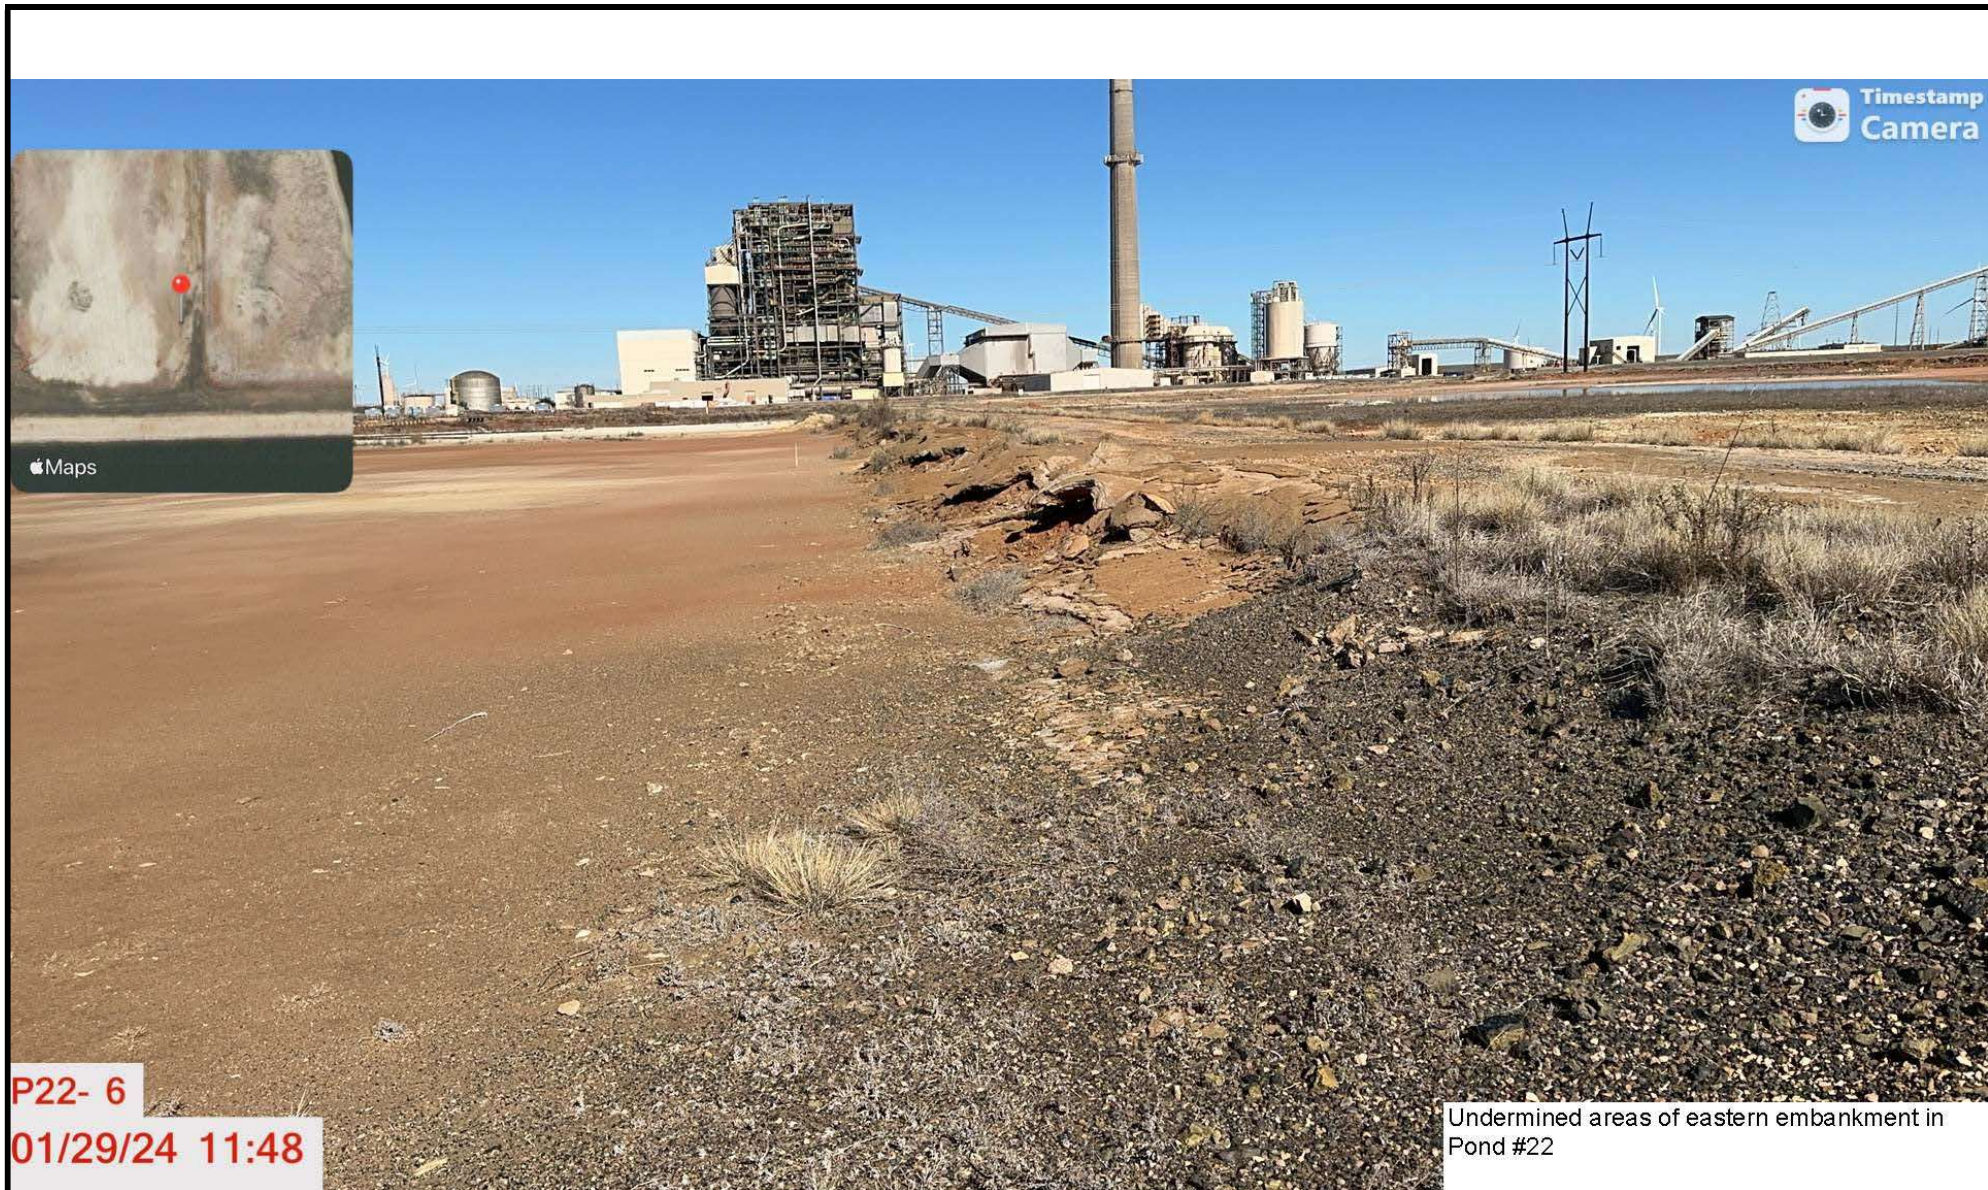
P22- 11
01/29/24 11:57

Eastern embankment looking southeast from
pipe bridge in northwest corner of Pond #22.
